## Troubleshooting Guide

# Fuller Transmissions TRTS0920

July 2011

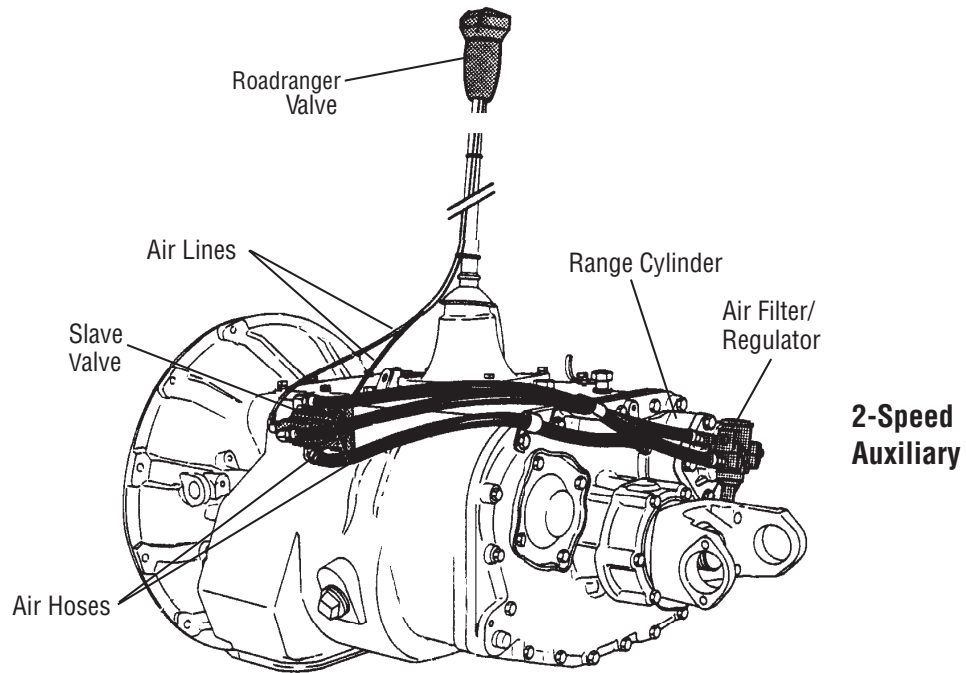
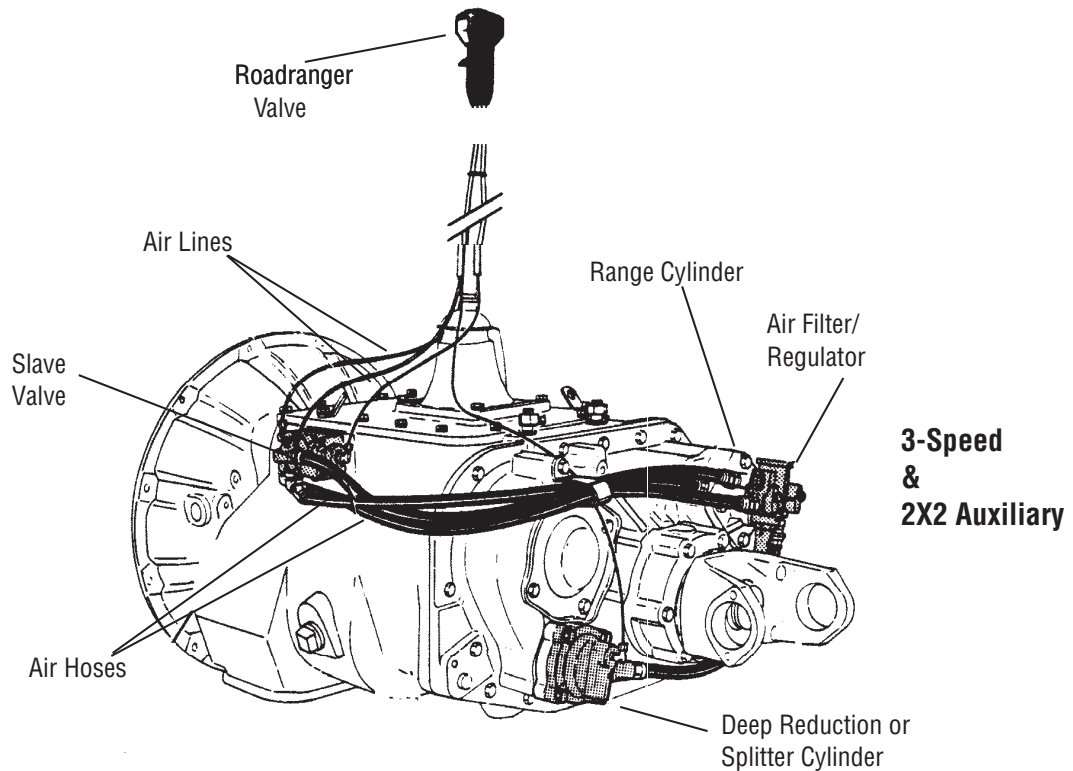
#### 2-Speed Auxiliary/3-Speed and 2x2 Auxiliary

### Transmission Identification

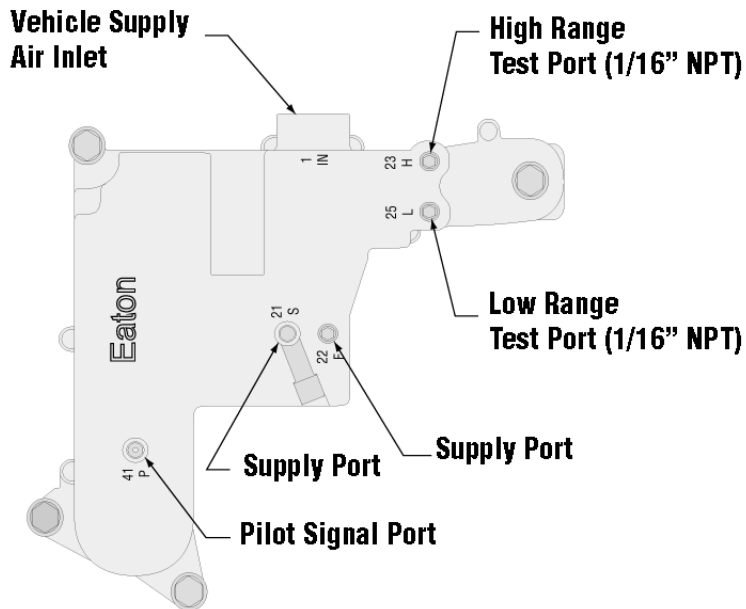
**Figure 4-1 Air Module Ports**

Figures 4-1 through 4-3 below show the air module, shift knob, and range alignment lock cover (earlier models) with their components labeled. These are the primary components used during troubleshooting. If necessary, refer to these figures while troubleshooting the air system.

5. Block off the air ports on the underside of the module. Use a piece of gasket material or rubber material to seal the bottom of the module as shown in Figure 4-1 under "Air System Nomenclature".

Reconnect the "P" line at the shift knob. Locate the two small pipe plugs on the rear of the air module. One is labeled "H" and the other "L". (See Figure 4-1 "Air System Nomenclature"). Install a 0-150 PSI (0-1034 kPa) air gauge in the port marked "H."

| Question | Result | What to do Next |
|---|---|---|
| | Less than 75 PSI (517 kPa) | On the top of the air module, remove the test port pipe plug for filtered vehicle air. (Marked "F" as shown in Figure 4-1.)<br>Install the test gauge in the "F" port, and check the pressure. If the pressure is less than 90 PSI (620 kPa), repair the vehicle air system to achieve full vehicle air pressure at the air module inlet, and repeat the test. If the pressures greater than 90 PSI (620 kPa) and no external air leaks were detected from the air module, shift knob, or transmission, replace the air module. |

### 4. Isolate and test the air module. Refer to Figure 4-1 "Air System Nomenclature" to see an example of an isolated air module.

Reconnect the "P" line at the air module. Locate the two small pipe plugs on the rear of the air module. One is labeled "H," and the other is labeled "L". (See Figure 4-1 "Air System Nomenclature"). Install a 0-150 PSI (0-1034 kPa) air gauge in the port marked "L".

| Question | Result | What to do Next |
|---|---|---|
| | Less than 75 PSI (517 kPa) | On the top of the air module, remove the test port pipe plug for filtered vehicle air. (Marked “F” as shown in Figure 4-1 “Air System Nomenclature”) Install the test gauge in the “F” port, and check the pressure. If the pressure is less than 90 PSI (620 kPa), repair the vehicle air system to achieve full vehicle air pressure at the module inlet, and repeat the test. If the pressure is greater than 90 PSI (620kPa) and no external air leaks were detected from the air module, shift knob, or transmission, replace the air module. |

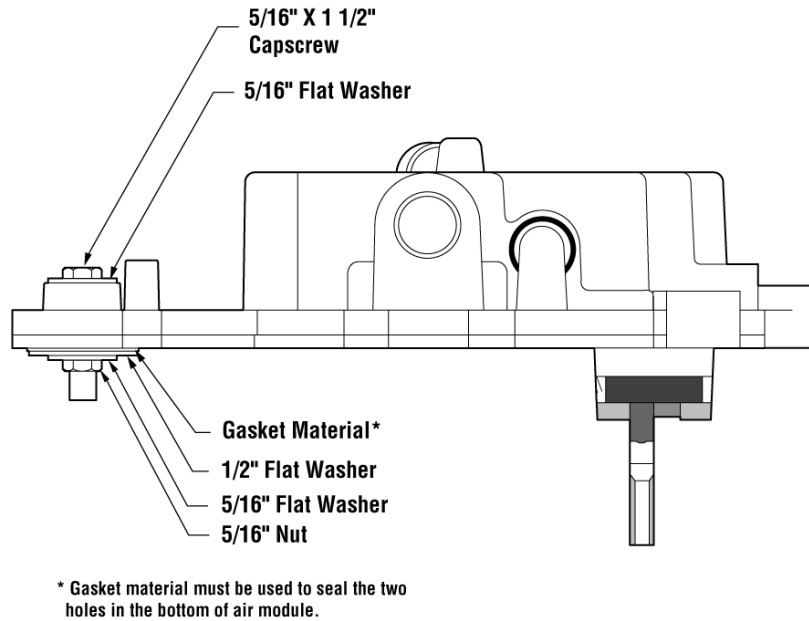
### **Figure 4-4 Air Module Isolation**

Figure 4-4 below shows how to isolate the air module. If necessary, refer to this figure when isolating the air module.

## 6. Isolate the air module from the transmission. Refer to Figure 4-4 “Air System Nomenclature” to see an example of an isolated air module.

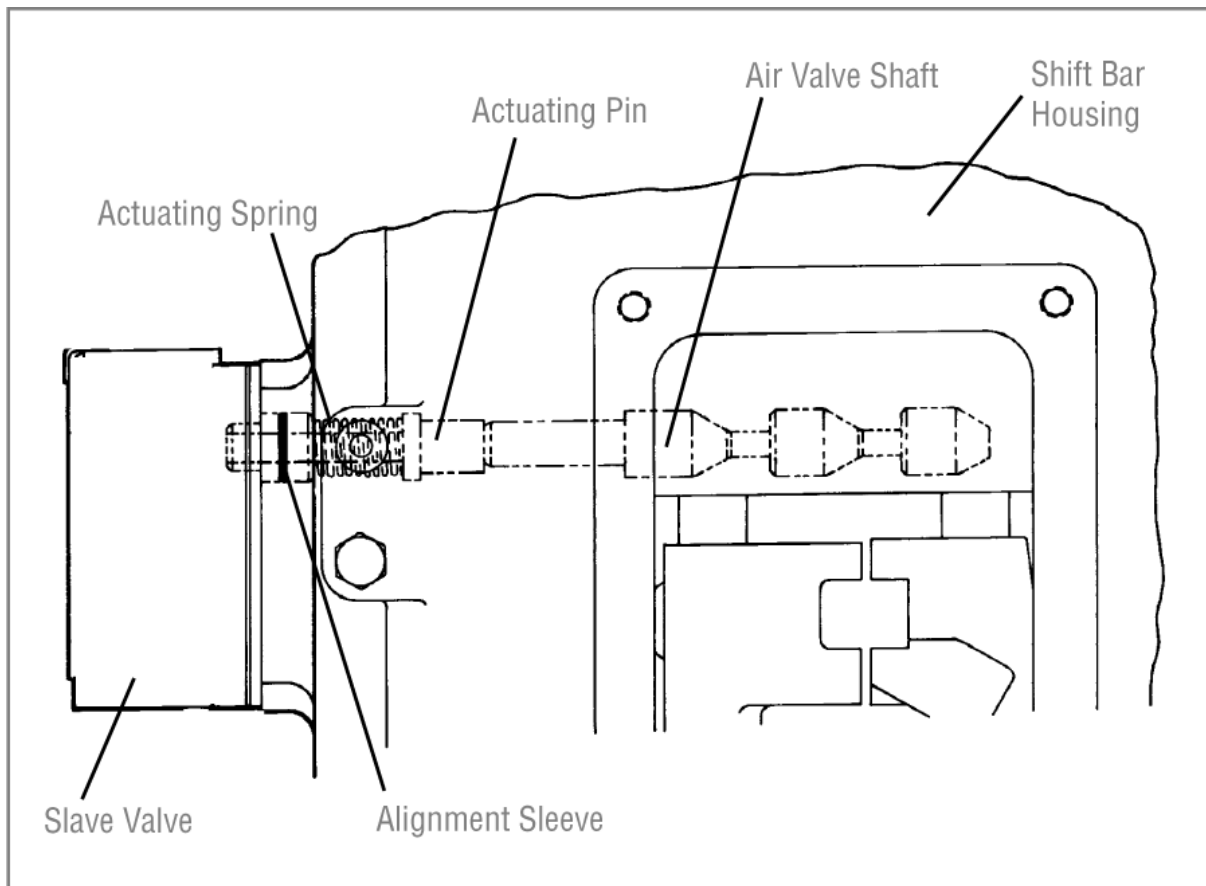
## Slave Valve Preselection System

An air valve shaft protruding from the shift bar housing prevents the actuating piston in the slave valve from moving while the gear shift lever is in a gear position and releases the piston when the lever is moved to or through neutral.

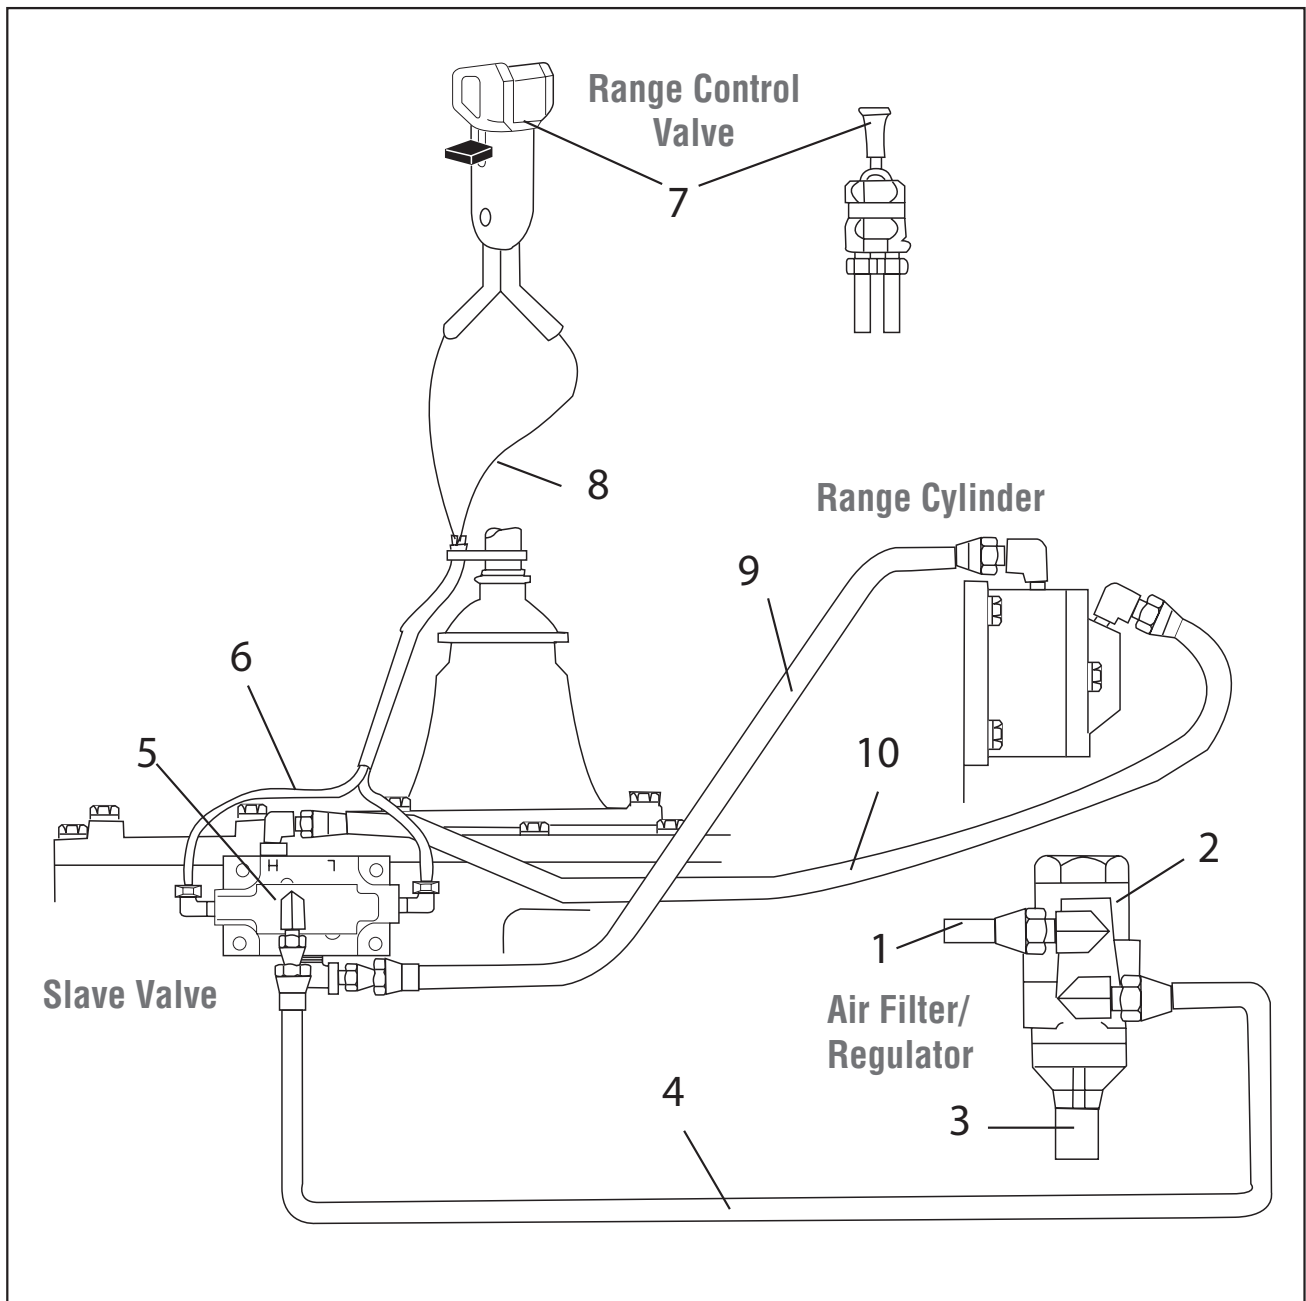
### 7, 8, 9 and 10-Speed Range Air Systems

Air is supplied to the system at the air supply port (1) by the vehicle's air system. The air filter (2) removes foreign matter from the air then allows it to pass through the air regulator (3) where the pressure is adjusted for 58 to 63 PSI (4.0 daN/cm<sup>2</sup>). From there the air passes through the supply air hose (4) and the slave valve supply port (5) through the supply air line (6) to the range control valve (7). With the range control valve lever or knob down (LO range), air passes through the air line connected to the slave valve "P" port (8). The slave valve then directs air to the LO range hose (9) and exhausts the HI range hose (10). With the range control valve lever or knob up (HI range,) the air line connected to the slave valve "P" port (8) is exhausted. The slave valve then directs air to the HI range hose (10) and exhausts the LO range hose (9).

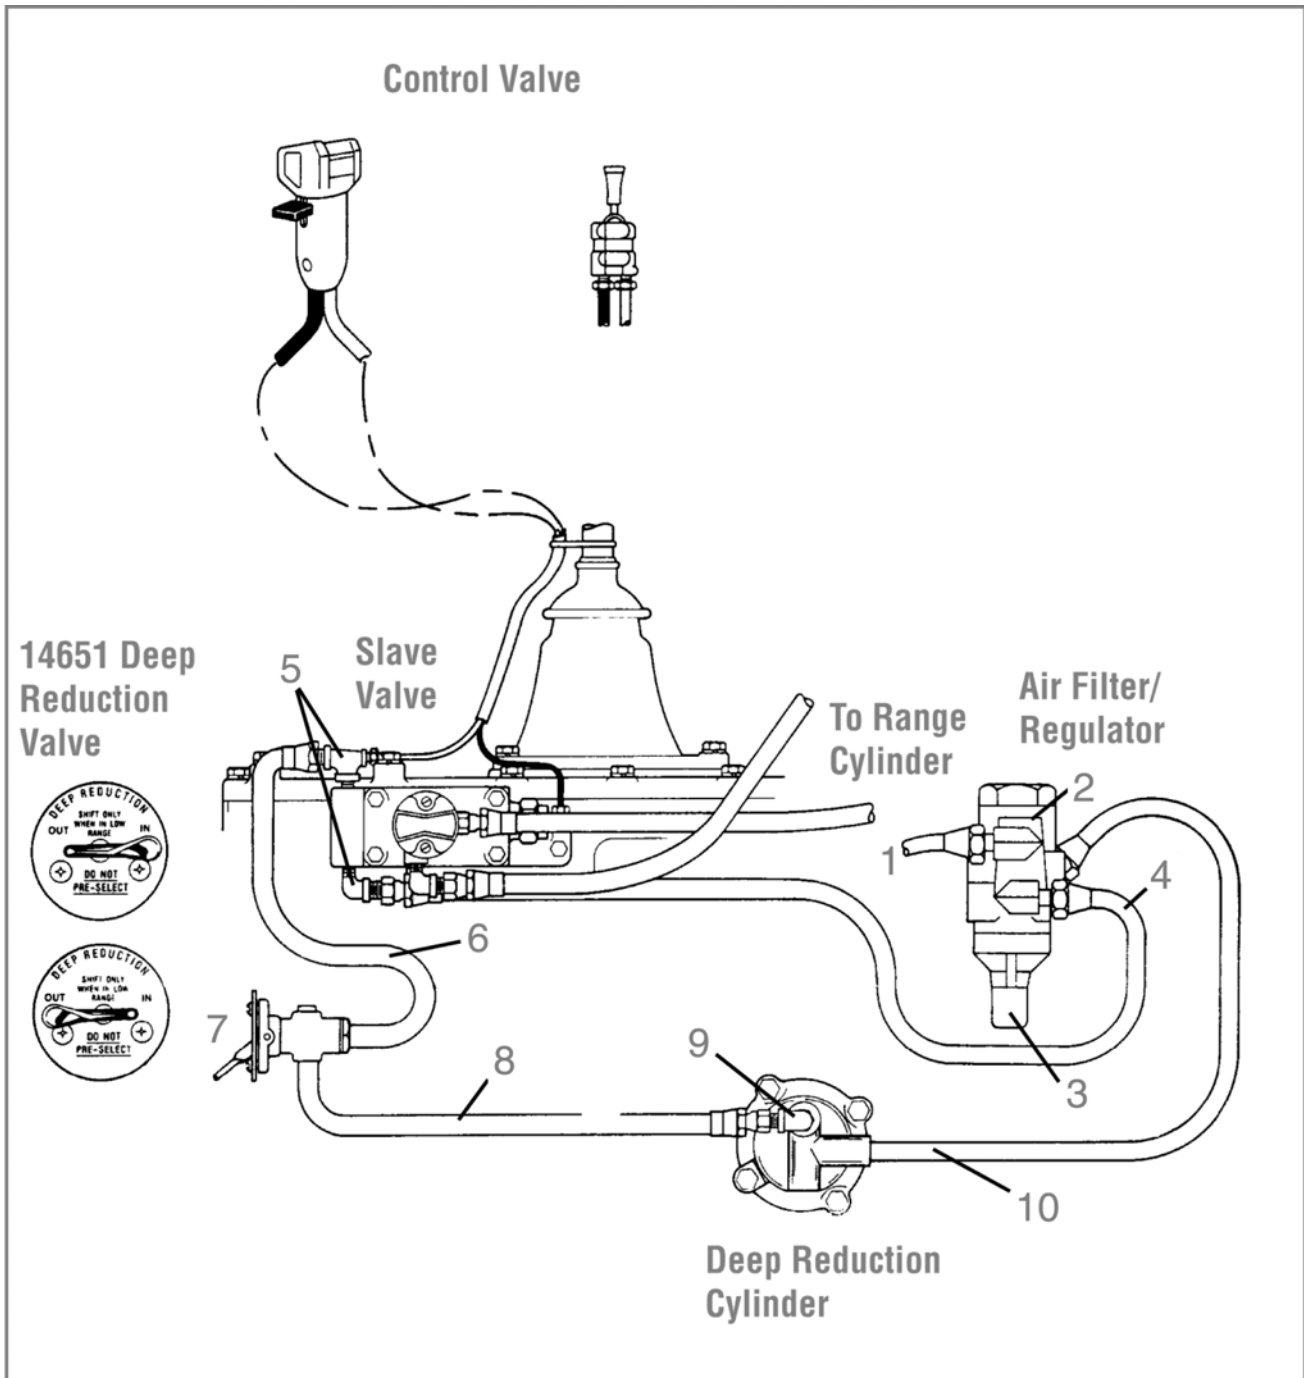
## Deep Reduction Air System (with Dash Mounted Valve)

In addition to the components of the range air system, the deep reduction air system utilizes a reduction cylinder and a separate dash mounted deep reduction valve. Air is supplied to the system at the air supply port (1) by the vehicle's air system. The air filter (2) removes foreign matter from the air then allows it to pass through the air regulator (3) where the pressure is adjusted for 58 to 63 PSI. From there the air passes through the supply air hose (4) to the slave valve supply port (5) through the supply air hose (6) to the deep reduction valve (7). Depending upon the position of the deep reduction valve lever, if air passes through the air hose (8) connected to the reduction cylinder center port (9) then the deep reduction gearing is disengaged. If there is no air, the constant air from the air filter/regulator assembly (10) moves the reduction piston rearward to engage deep reduction gearing.

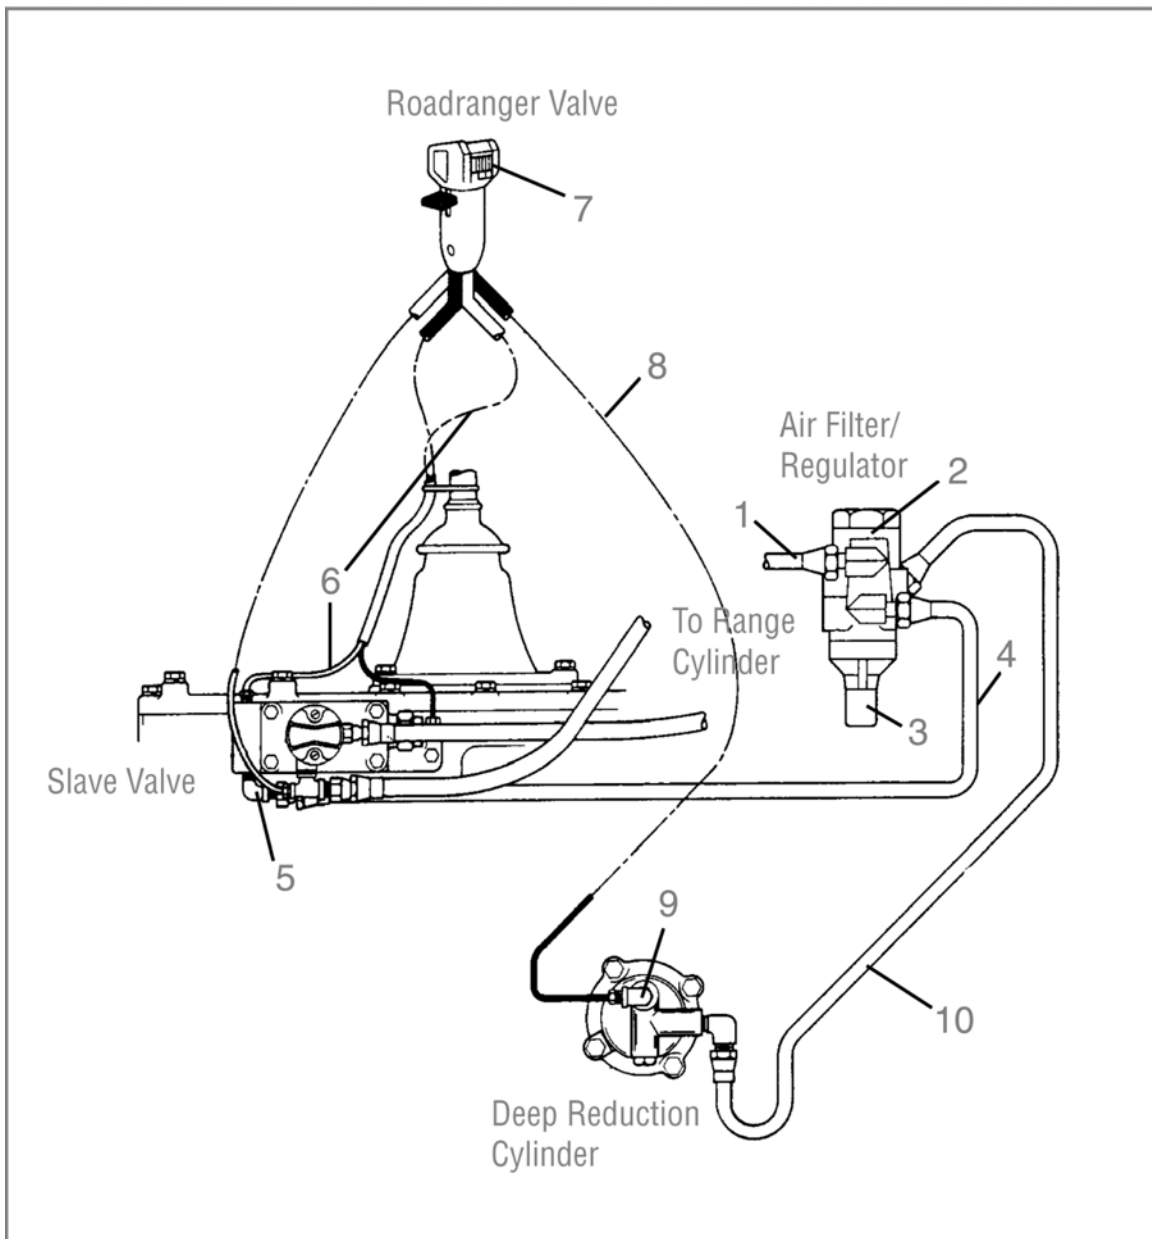
Depending upon the position of the Roadranger valve button (7), if air passes through the air line (8) connected to the reduction cylinder center port (9), then the deep reduction gearing is engaged. If there is no air, the constant air from the air filter/regulator assembly (10) moves the reduction piston rearward to disengage deep reduction gearing.

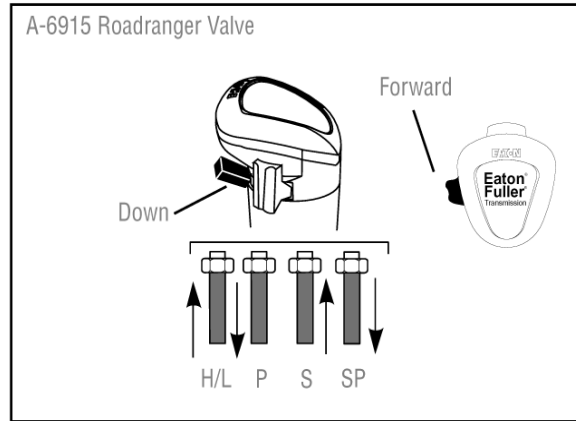
### Deep Reduction

In addition to the range air system components, the deep reduction air system uses a reduction cylinder and the Roadranger Valve A-6915.

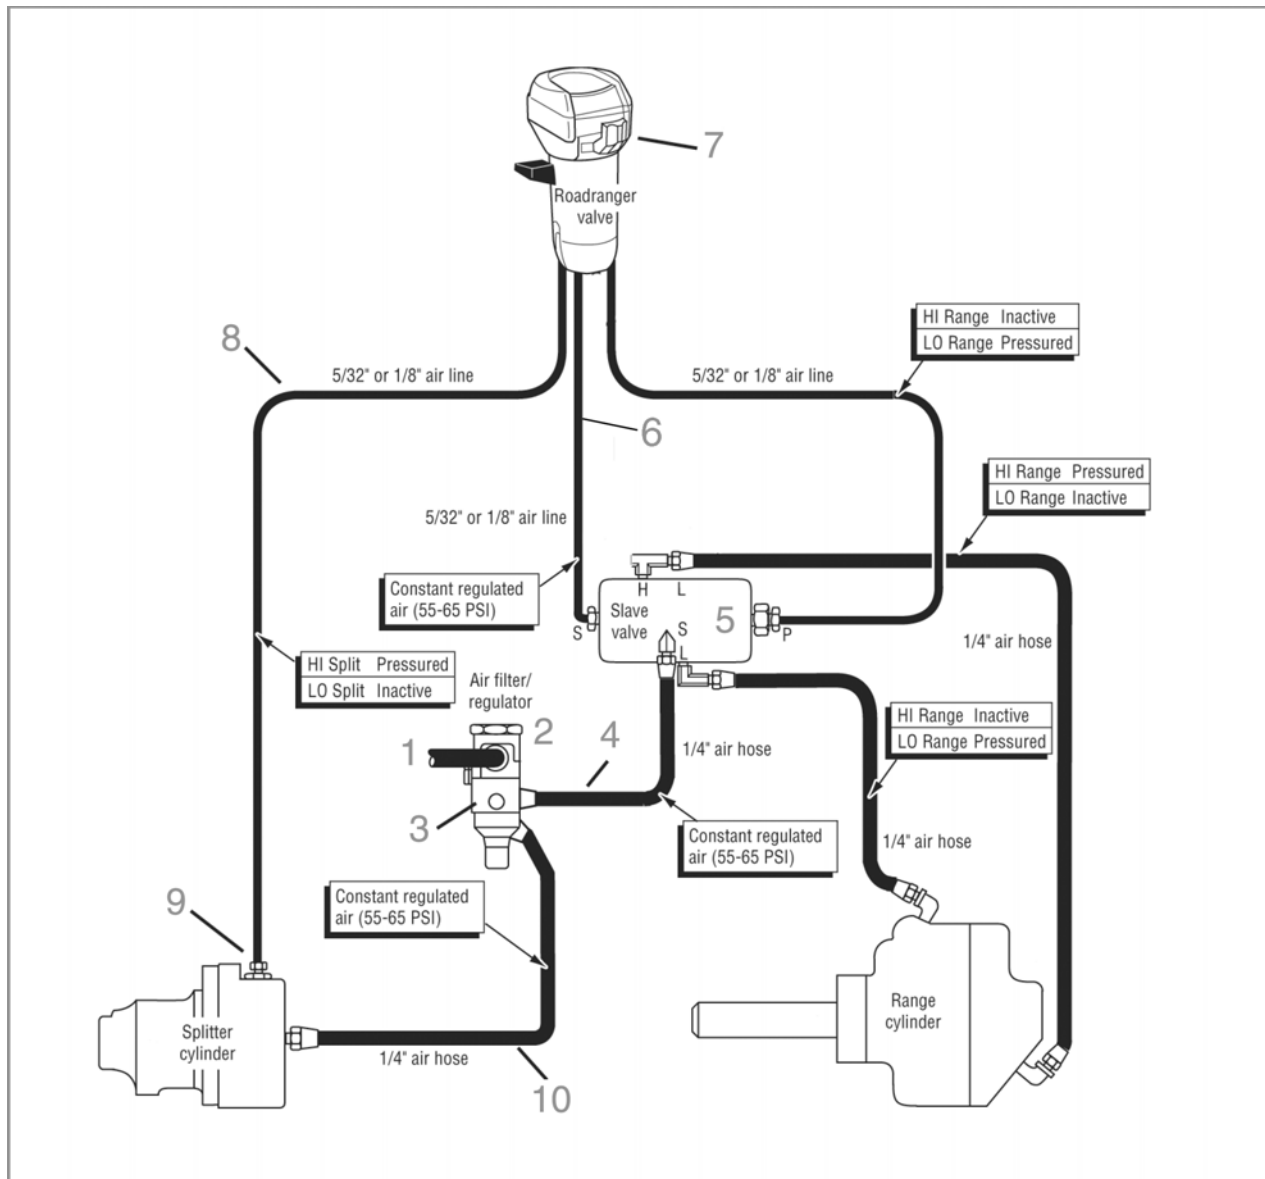
### 18-Speed

In addition to the range air system components, the splitter air system uses a splitter cylinder and the Roadranger Valve A-4900/ A-6913 or the Two-Position Selector Valve.

Depending upon the position of the splitter button (7), if air passes through the air line (8) connected to the splitter cylinder center port (9) then the underdrive/overdrive gearing is engaged. If there is no air, the constant air from the air filter/regulator assembly (10) moves the splitter piston forward to disengage underdrive or overdrive gear.

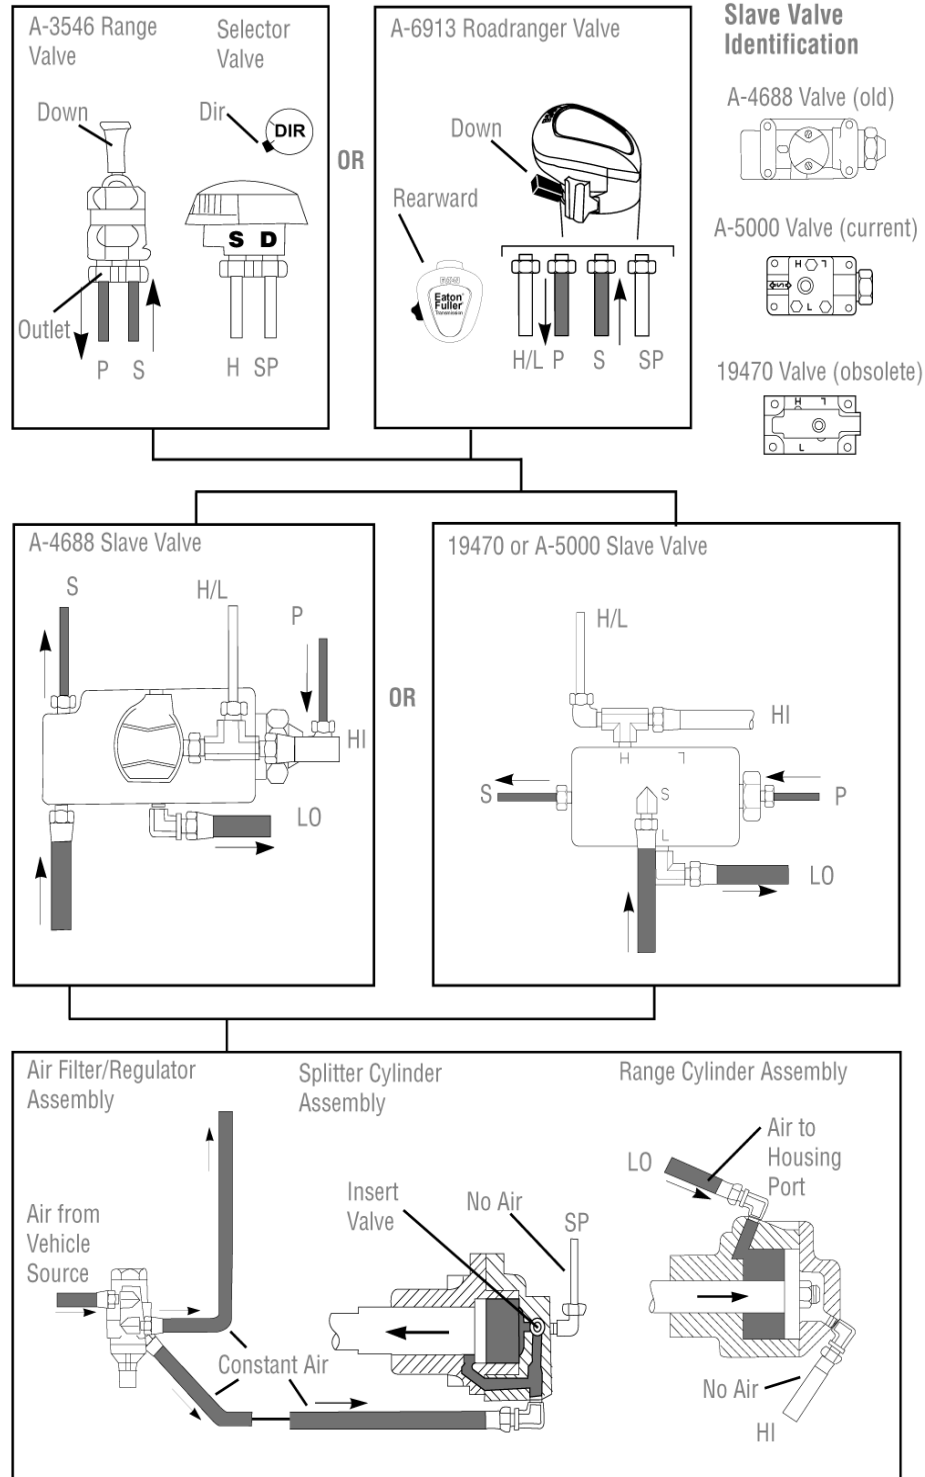
Range—LO

## RT, RTO, & RT00 xx613 and xx813 Models

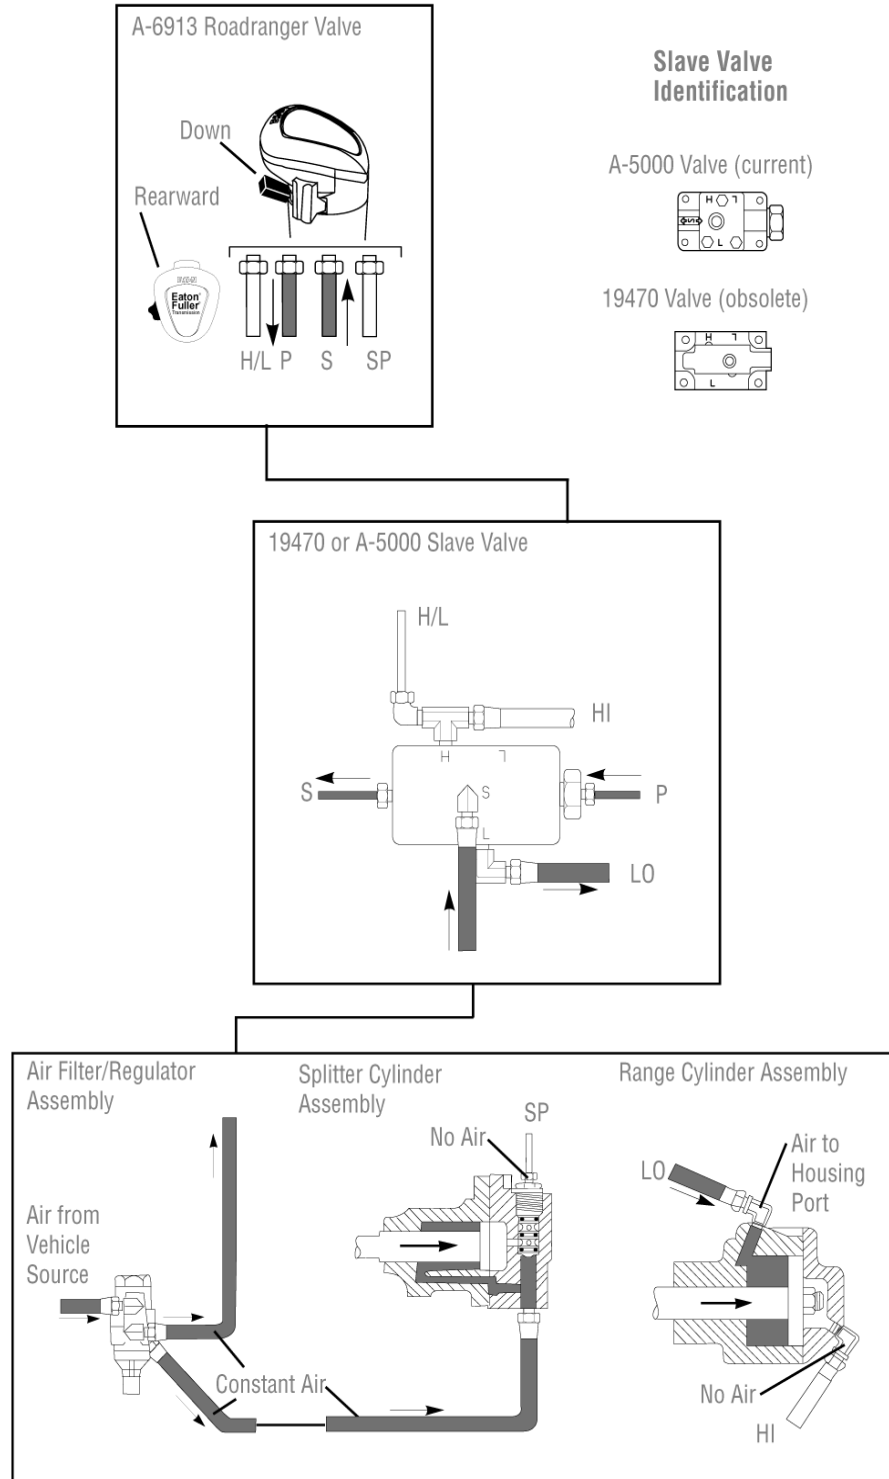
### LO Range

## RTLO-xx613 Models

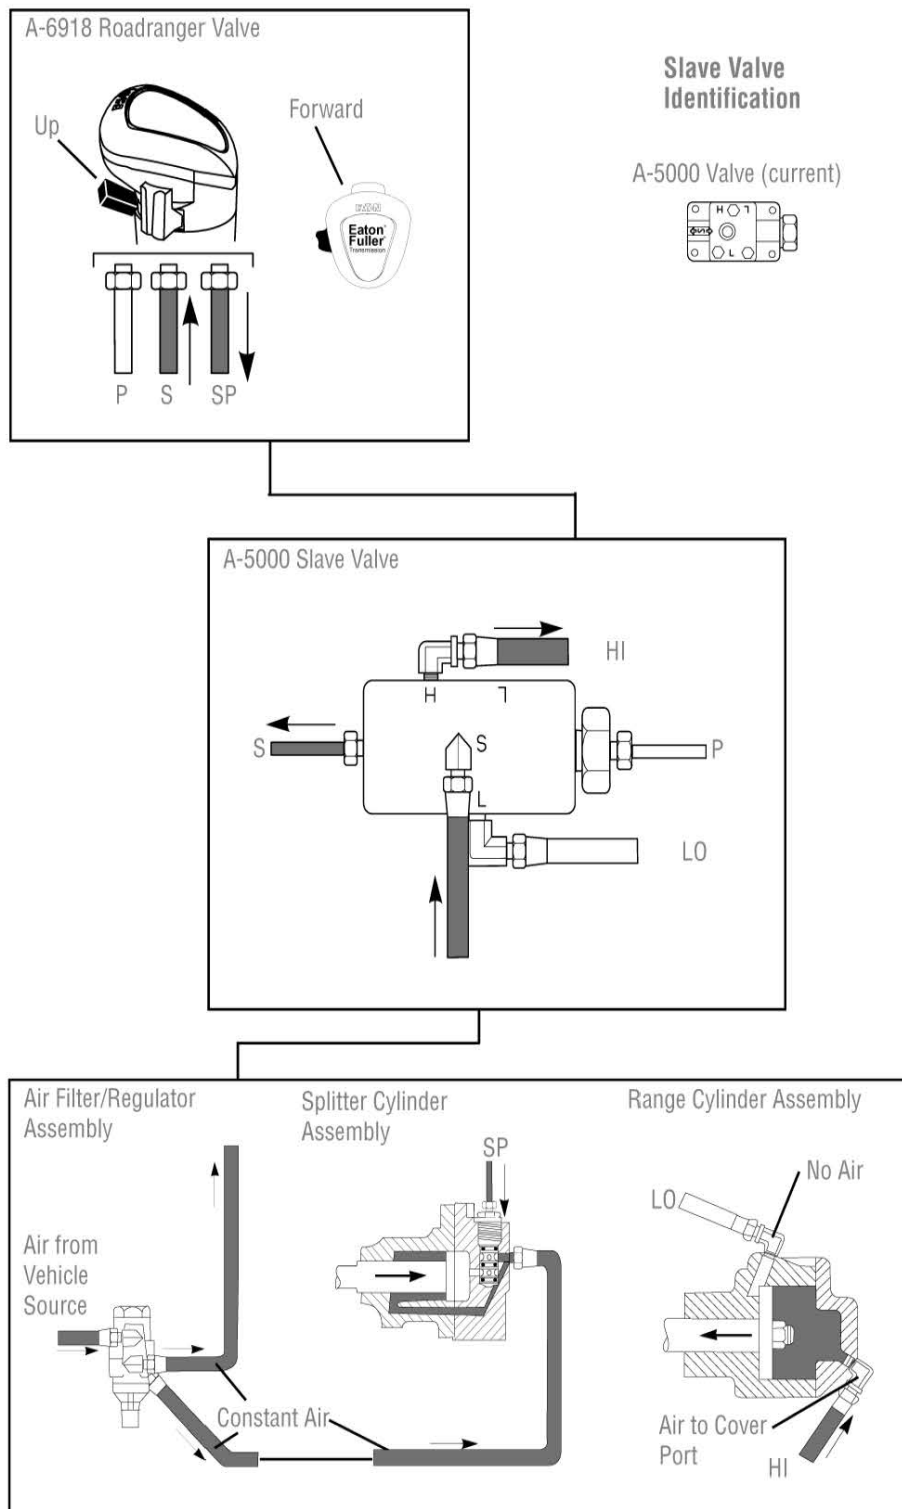
## HI Range H

## RTLO-xx918 Models

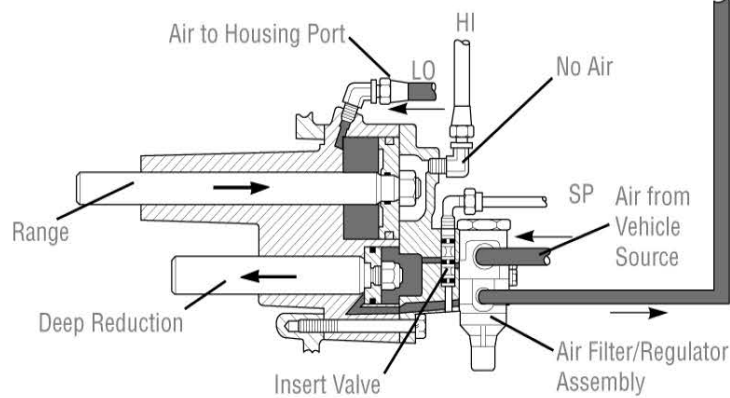
### Cylinder Assembly

The combination cylinder air system functions much like the other air systems except the range cylinder and the deep reduction cylinder are located side by side in the same housing.

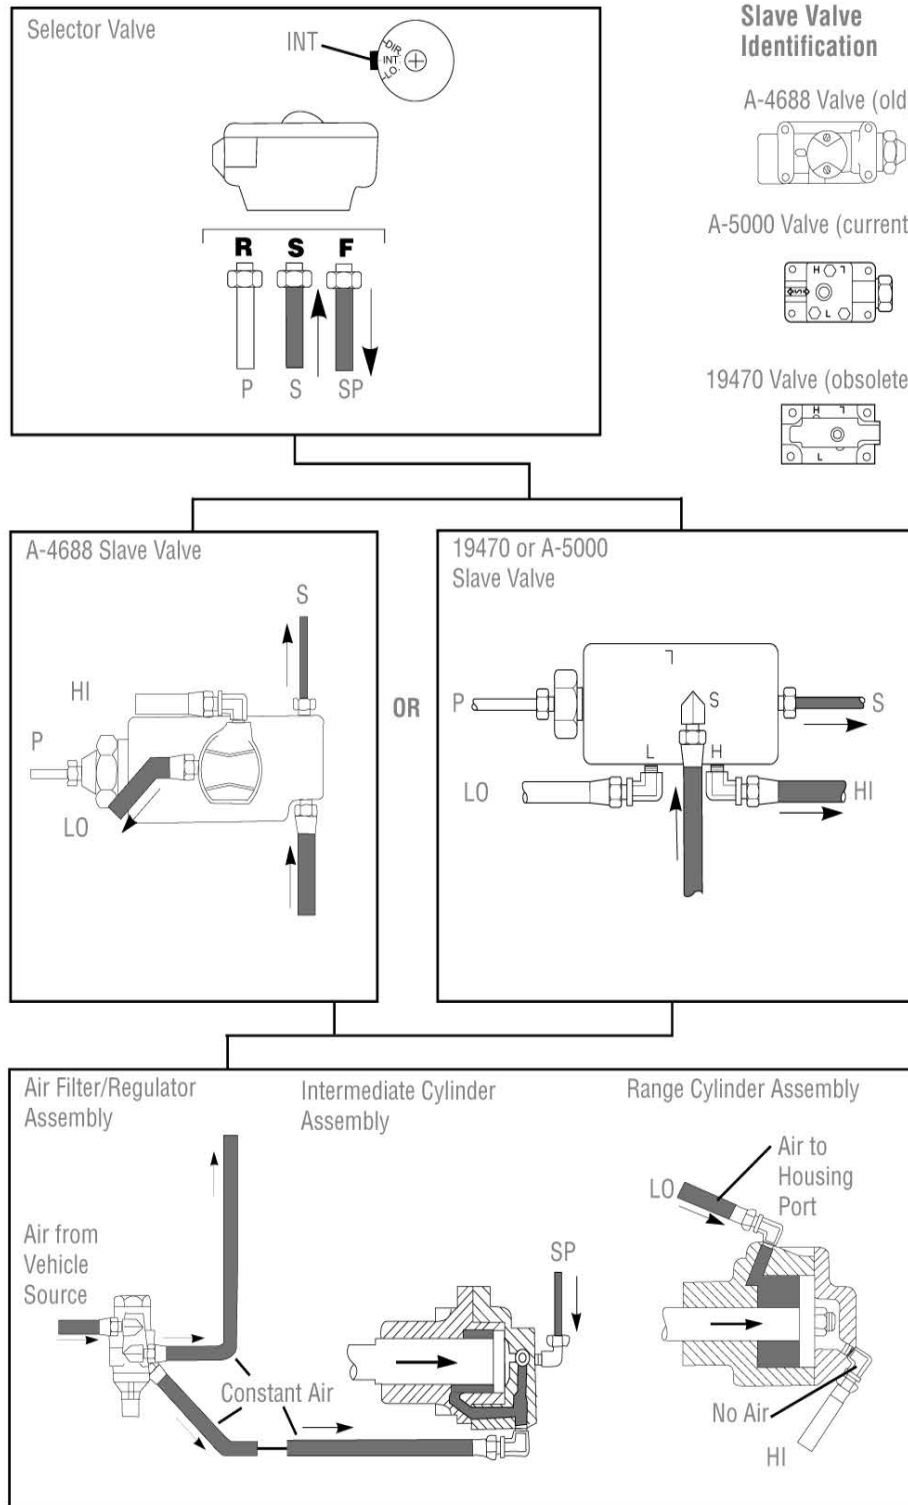
## Intermediate

Depending upon the position of the control button (7), if air passes through the air line (8) connected to the intermediate shift cylinder center port (9) then the intermediate/direct gearing is disengaged. If there is no air, the constant air from the air filter/regulator assembly (10) moves the intermediate piston forward to engage LO gearing.

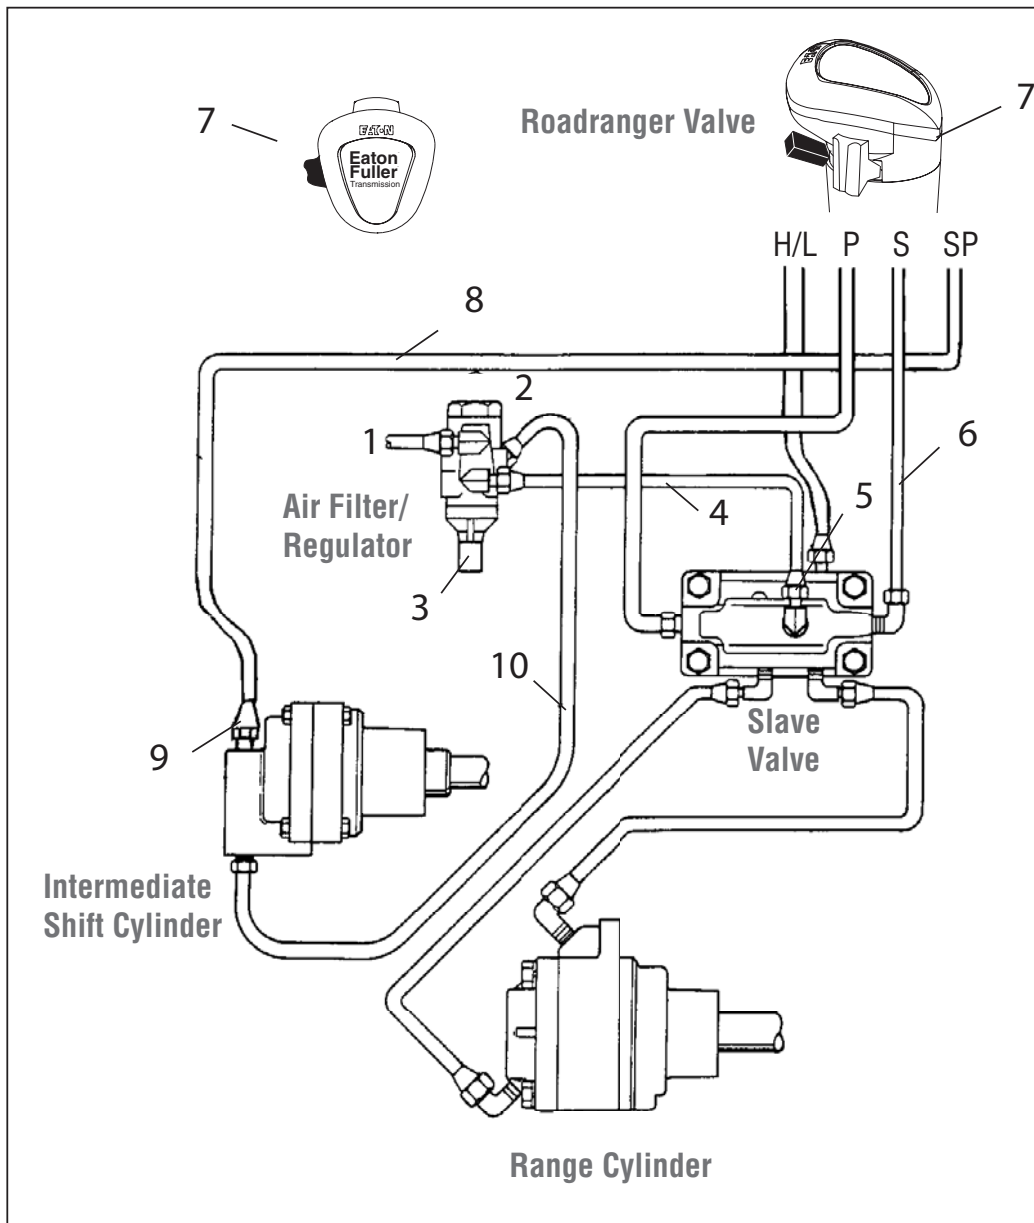
Depending upon the position of the splitter button (7), if air passes through the air line (8) connected to the intermediate shift cylinder top port (9) then the deep reduction gearing is engaged. If there is no air, the constant air from the air filter/regulator assembly (10) moves the intermediate piston rearward to disengage deep reduction gearing.

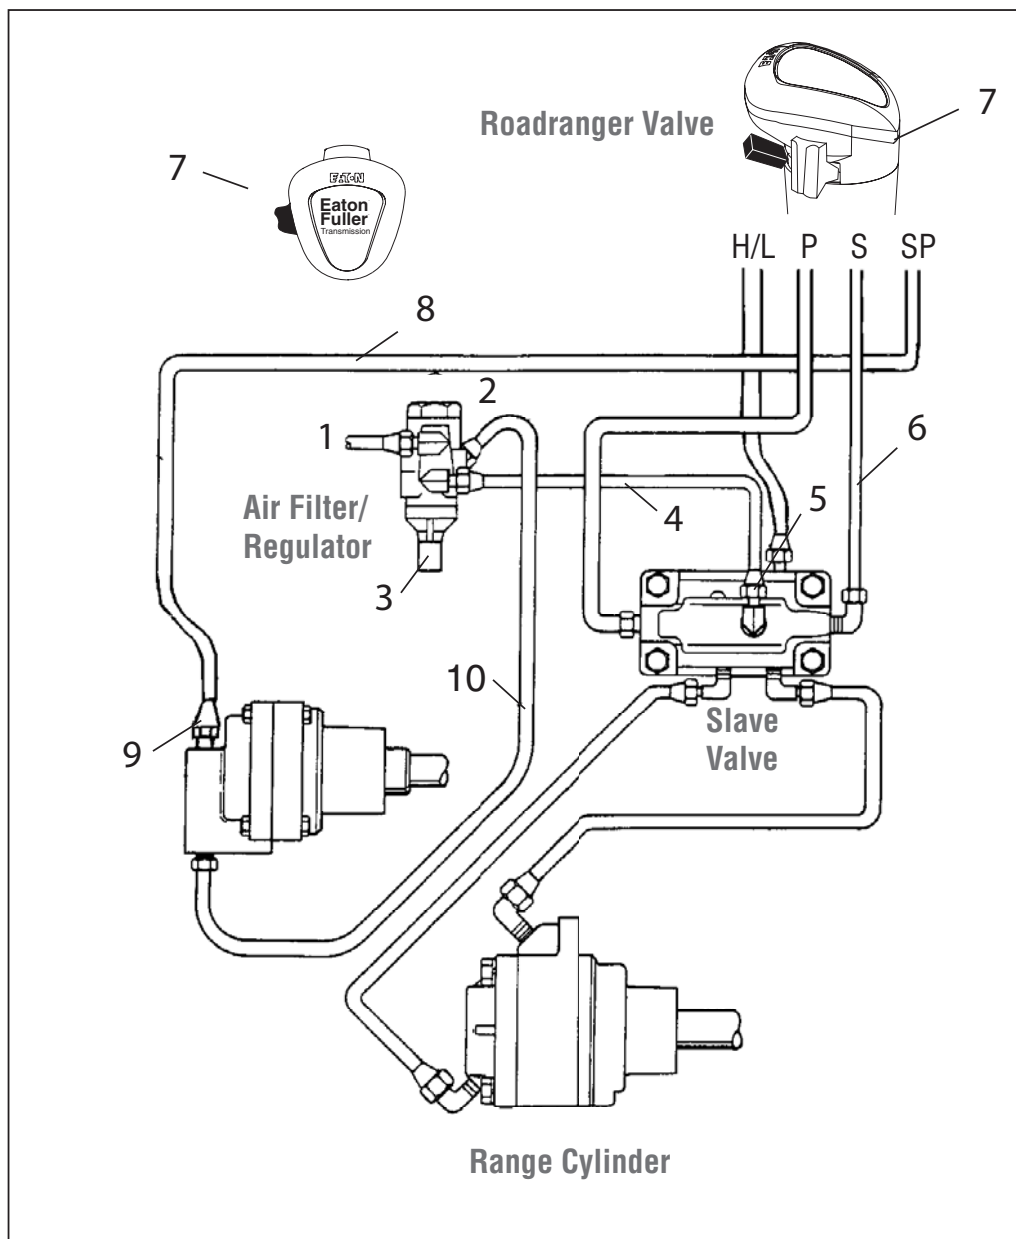
Depending upon the position of the splitter button (7), if air passes through the air line (8) connected to the deep reduction cylinder top port (9) then the deep reduction gearing is engaged. If there is no air, the constant air from the air filter/regulator assembly (10) moves the piston forward to disengage deep reduction gearing.

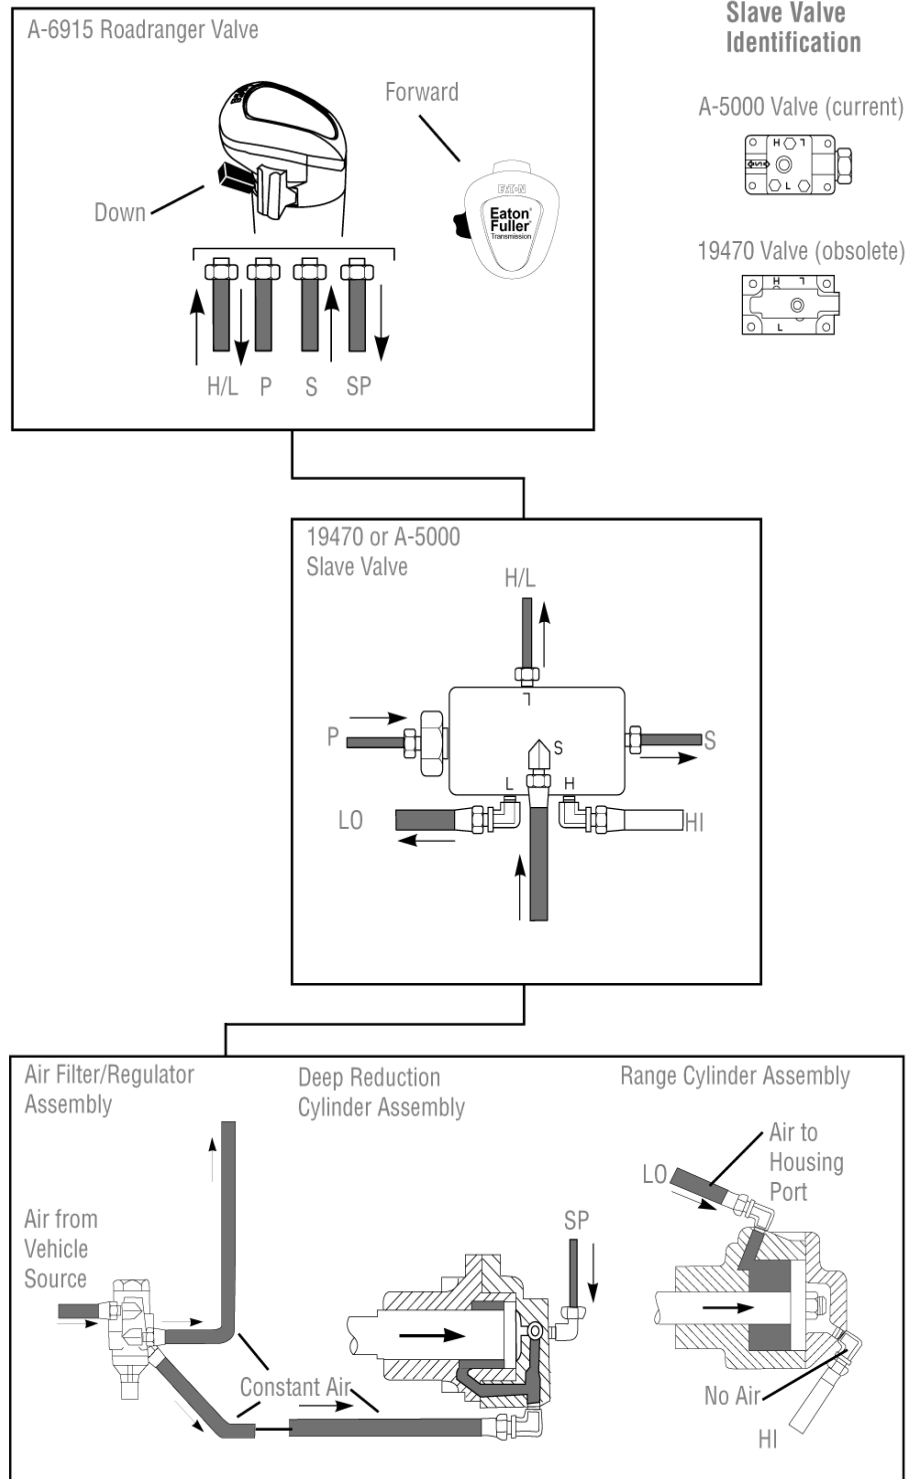
### Deep Reduction

This system consists of a A-6915 Roadranger valve and a deep reduction cylinder in addition to the range cylinder. The deep reduction cylinder shifts the transmission between deep reduction and LO range. The range cylinder shifts the transmission between LO and HI range.

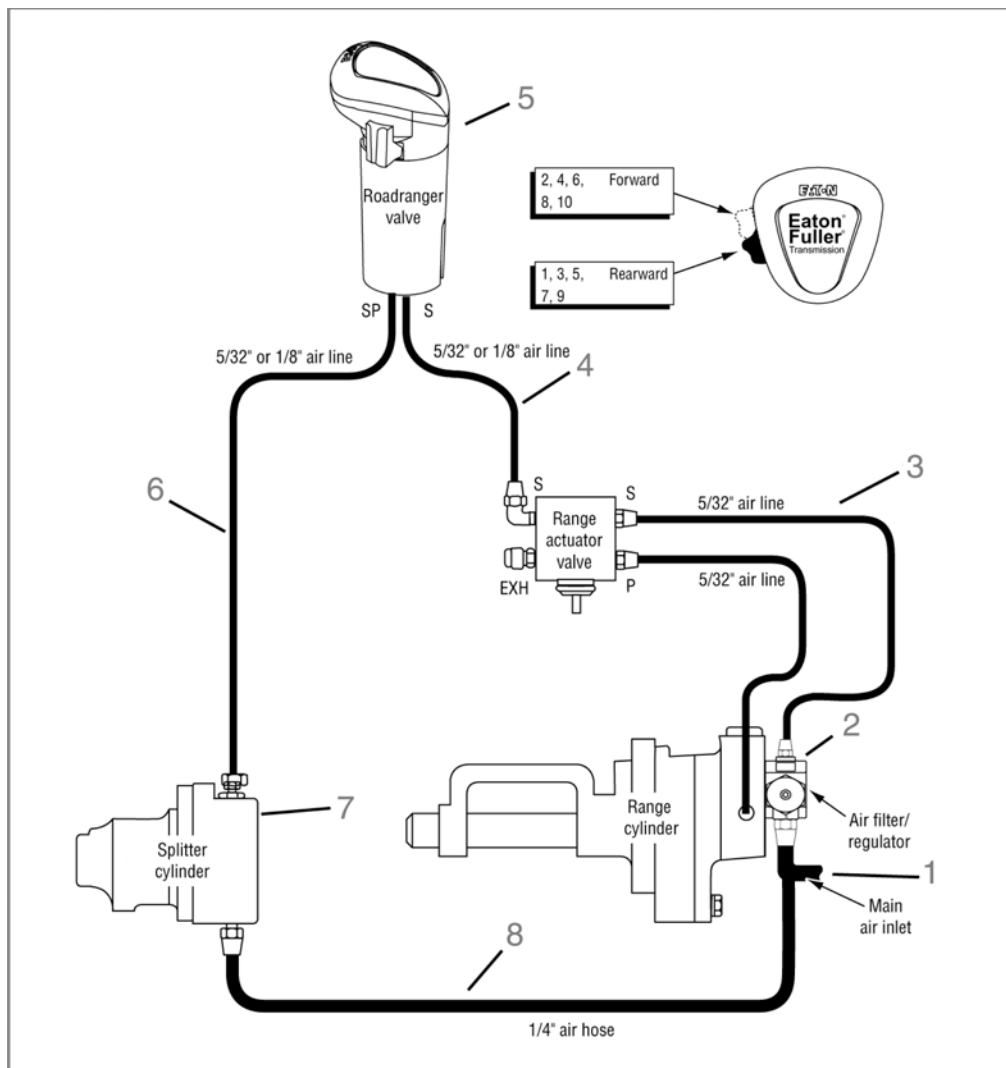
## Latest Design

This system consists of a A-6910 Roadranger valve, range actuator valve, a splitter shift cylinder and a range cylinder. The splitter cylinder shifts the transmission between odd and even numbered gear positions. The range cylinder shifts the transmission between LO and HI range.

The transmission shift lever automatically activates LO and HI range depending on gear position.
