## Troubleshooting Guide

# Fuller Transmissions TRTS0920

July 2011

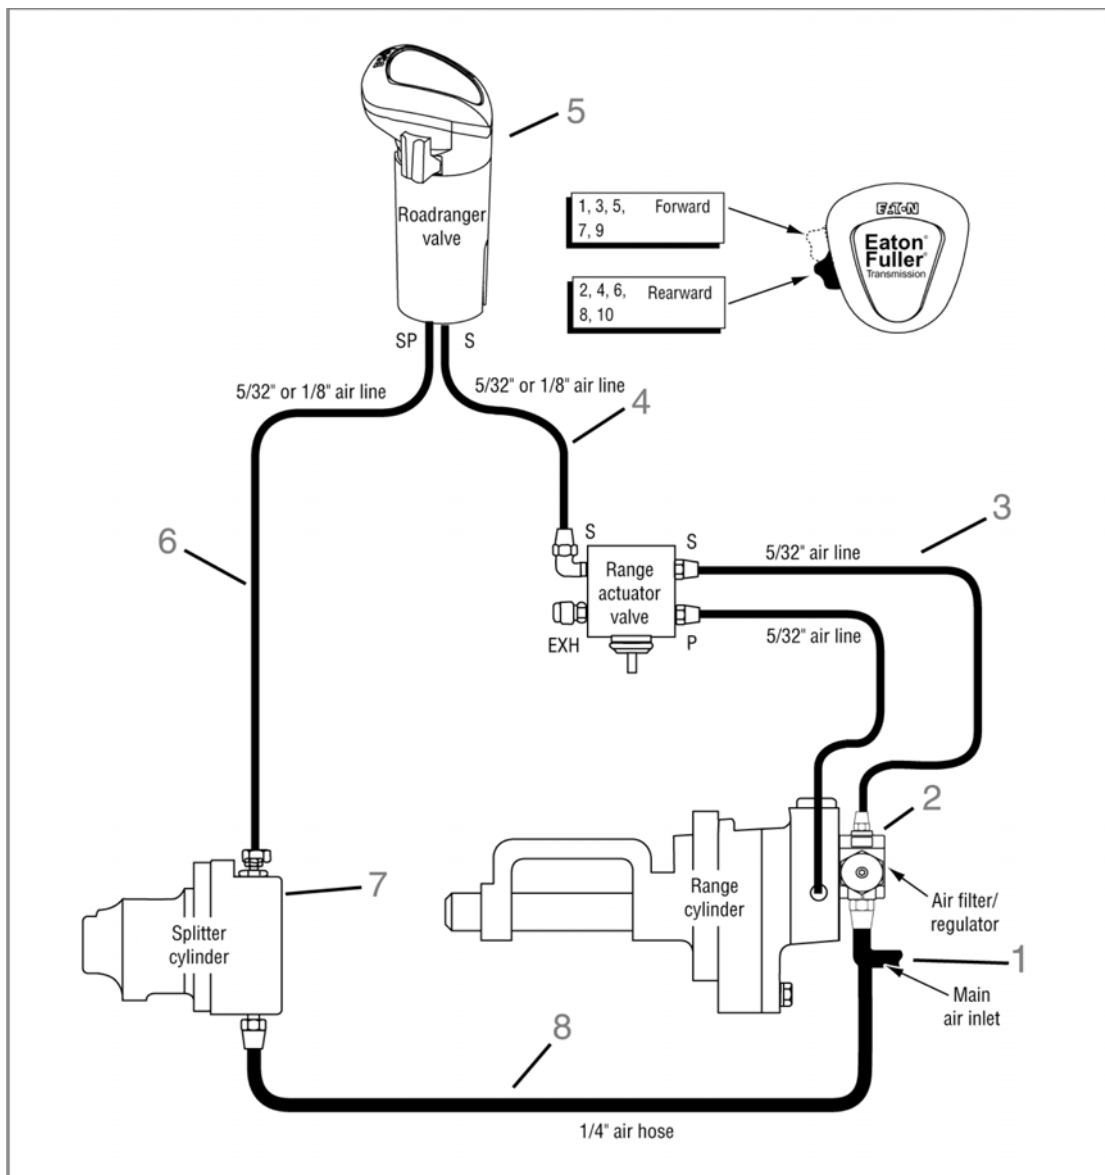
## RTL-xx710 Speed Models

This system consists of a A-6910 Roadranger valve, range actuator valve, a splitter shift cylinder and a range cylinder. The splitter cylinder shifts the transmission between odd and even numbered gear positions. The range cylinder shifts the transmission between LO and HI range.

Depending upon the position of the splitter button (5), if air passes through the air line (6) connected to the splitter cylinder top port (7) then the even numbered gear positions are engaged. If there is no air, the constant air from the air filter/regulator assembly (8) moves the splitter piston forward to engage odd numbered gear positions.

The transmission shift lever automatical activates LO and HI range depending on gear position.

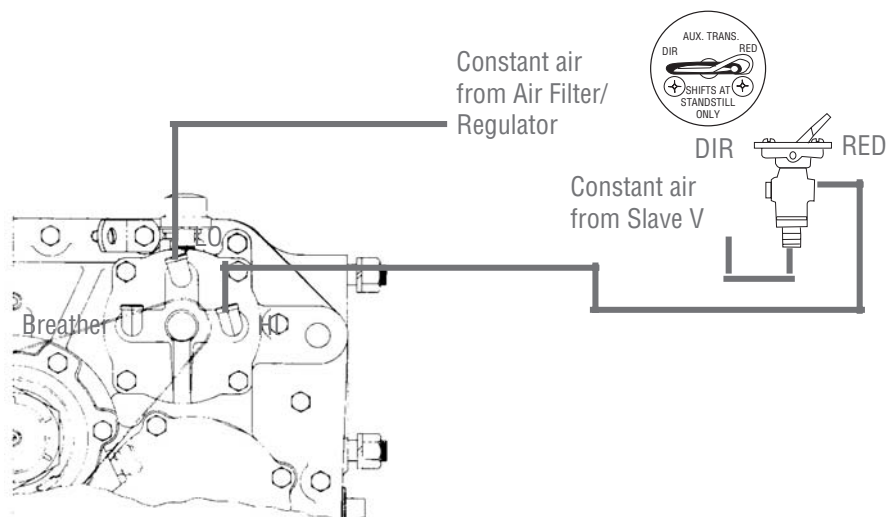
#### *LO Range*

When the lever is moved to the Reduction (RED) position, air is shut off to piston rear side. The constant air moves the range piston rearward and shifts the auxiliary transmission into Reduction.

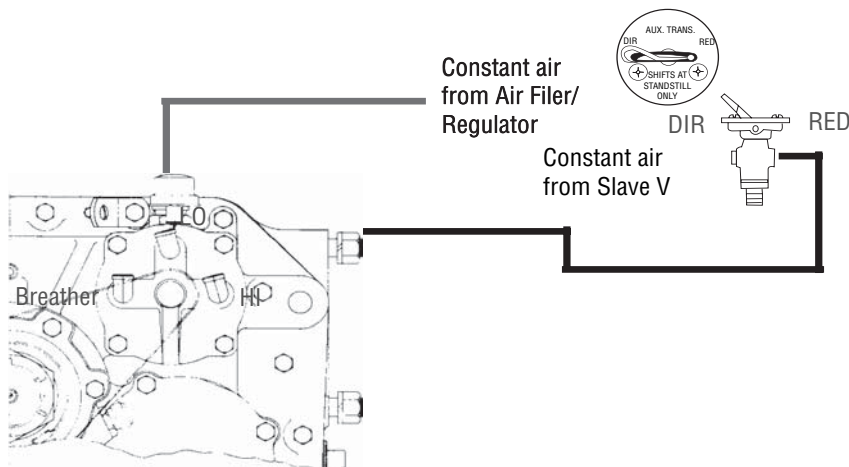
#### *High Range*

When the lever is moved to the direct (DIR) position, the valve allows air to flow through to the piston rear side. The constant air moves the range piston forward and shifts the auxiliary transmission into Direct.

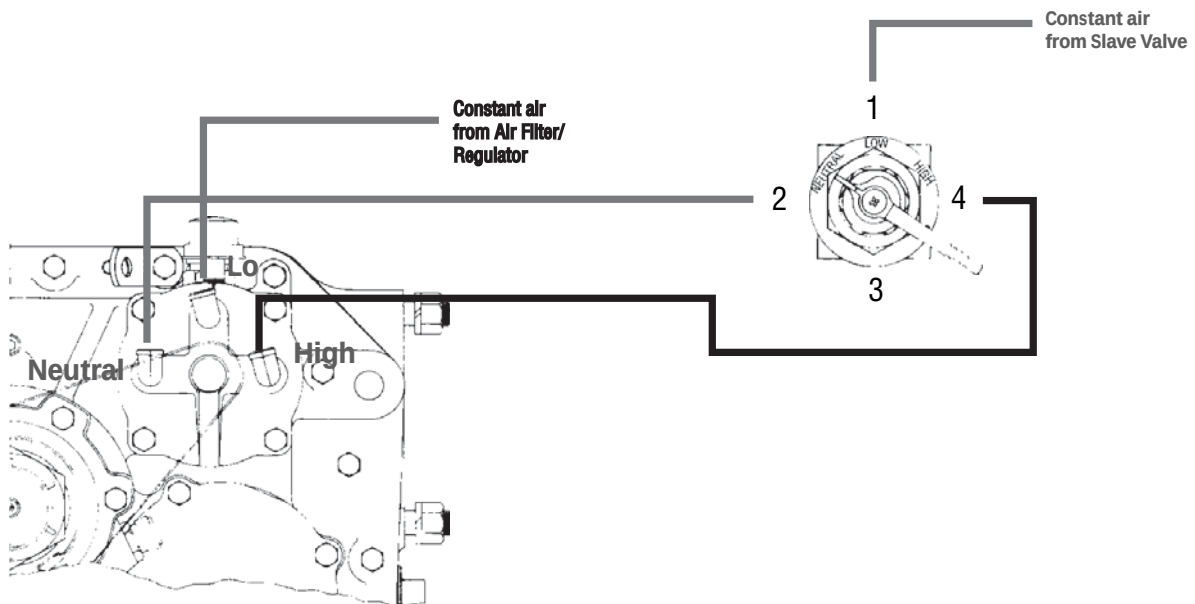
### *Neutral*

The valve allows air to pass from #1 to #2 placing the auxiliary transmission in neutral.

#4 is connected to #3 to exhaust the air.

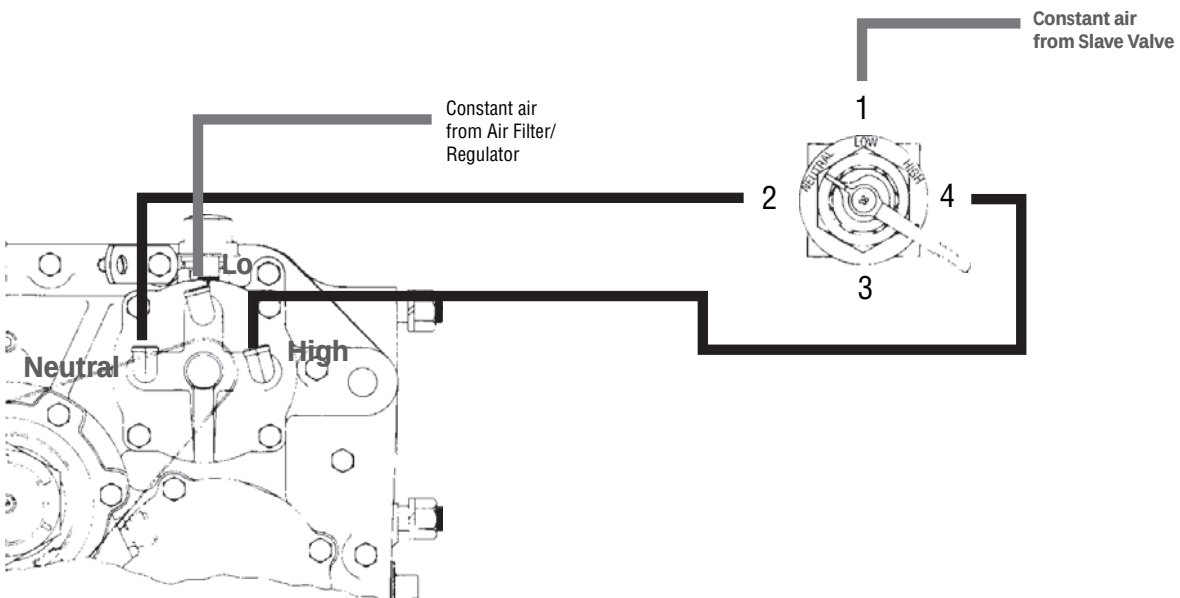
### *Reduction*

When the switch is moved to the LOW position, the valve closes and stops the air at #1 placing the auxiliary transmission in LO.

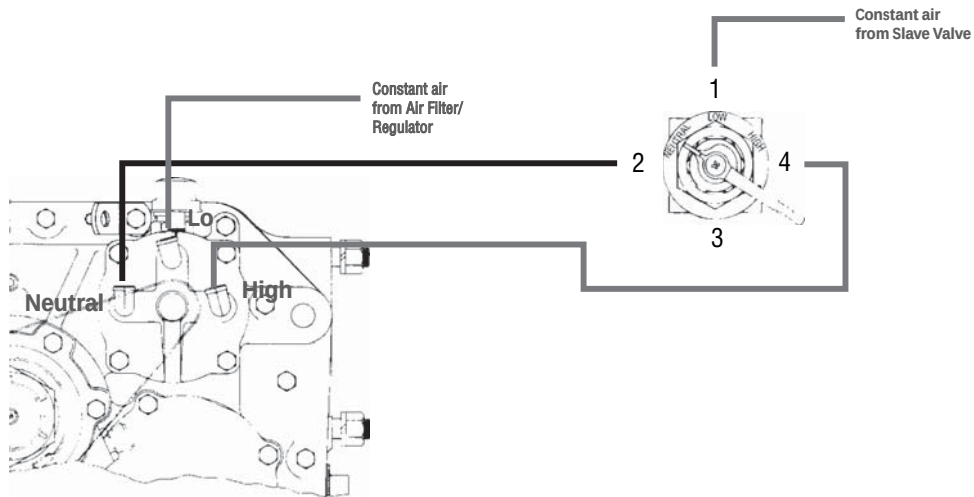
### ***Direct***

When the switch is moved to the HIGH position, the valve opens and allows the air from #1 to pass to #4, placing the auxiliary transmission in HI.

#2 is connected to #3 to exhaust the air.

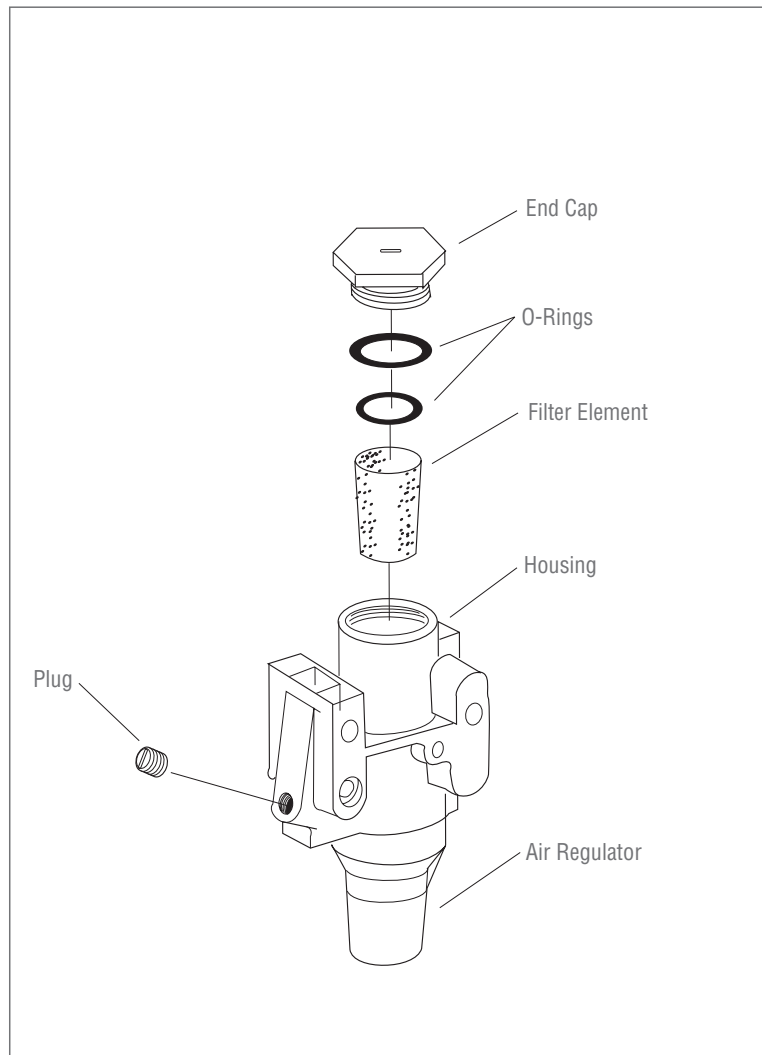
### A-4740 Air Filter/Regulator Assembly

The air filter removes foreign matter from the air then allows it to pass through the air regulator where the pressure is adjusted to 58 to 63 PSI. The output air pressure will not be in range if the truck's air pressure is incorrect.

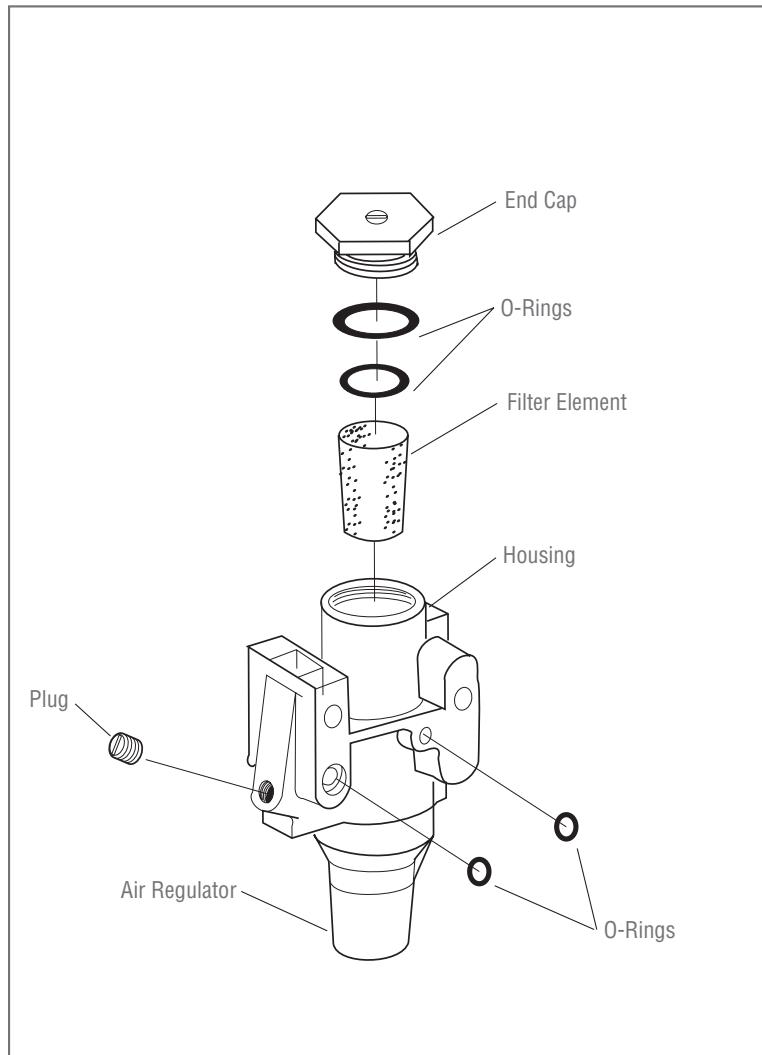
### A-5161/A-5454 Air Filter/Regulator Assembly

The air filter removes foreign matter from the air then allows it to pass through the air regulator where the pressure is adjusted to 58 to 63 PSI. The output air pressure will not be in range if the truck's air pressure is incorrect.

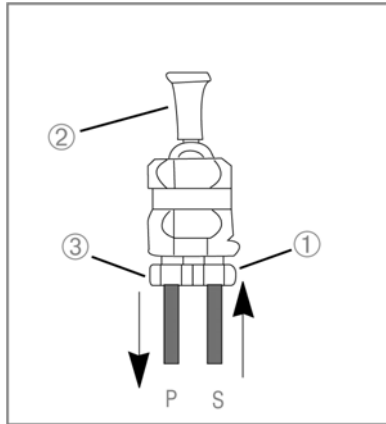
Constant air pressure is supplied from the slave valve to the Range valve inlet or "S" port (1).

In LO range (range knob down (2), air passes through the valve and out the range valve outlet or "P" port (3). This air returns to the slave valve end port or "P" port depending on the slave valve used.

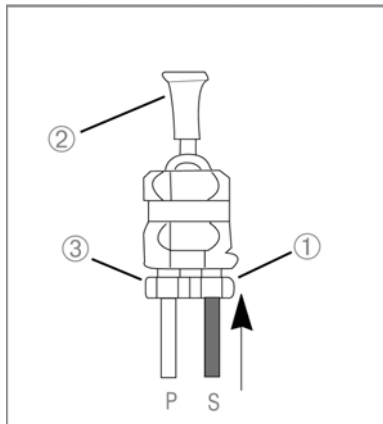
In HI range (range knob up (2) the knob prevents the air from passing through the Range valve. Air pressure which was in the outlet line (3) is exhausted out the bottom.

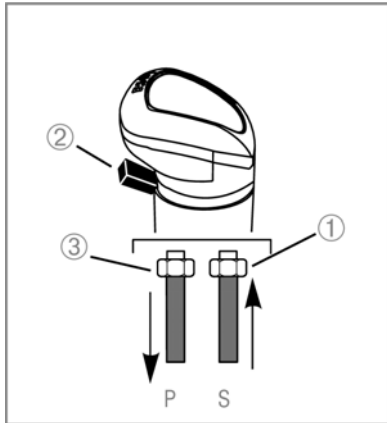
Constant air pressure is supplied from the slave valve to the Roadranger valve inlet or "S" port (1).

In LO range (range lever down (2), air passes through the lever and out the Roadranger valve outlet or "P" port (3). This air returns to the slave valve end port or "P" port depending on the slave valve used.

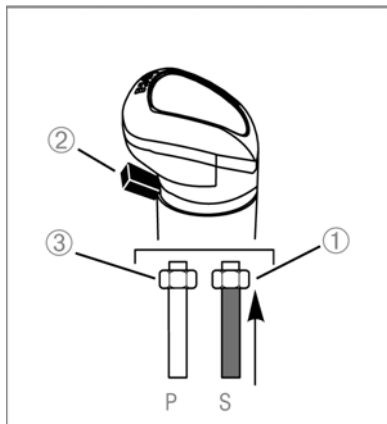
In HI range (range lever up (2) the lever prevents the air from passing through the Roadranger valve. Air pressure which was in the outlet line (3) is exhausted out the Roadranger valve "E" port.

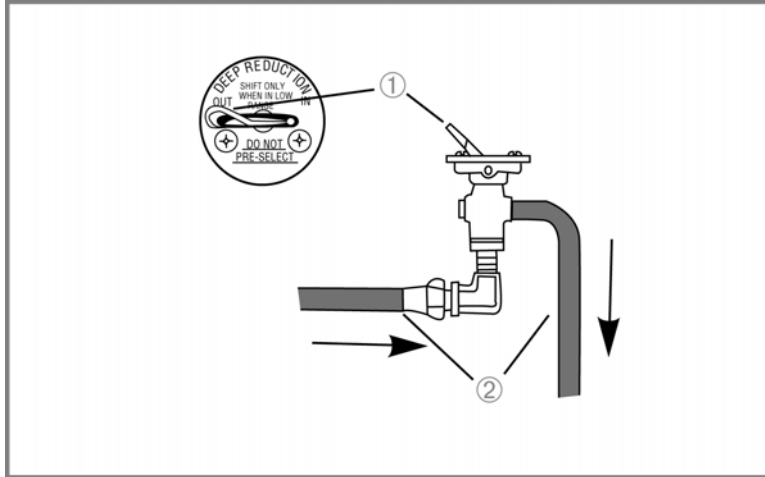
### 14651 Reduction Valve (Dash-Mounted)

With the deep reduction lever in the "OUT" position (1), the valve is opened (2) and air is supplied to the deep reduction cylinder cover center port, moving the reduction piston forward to disengage deep reduction gearing.

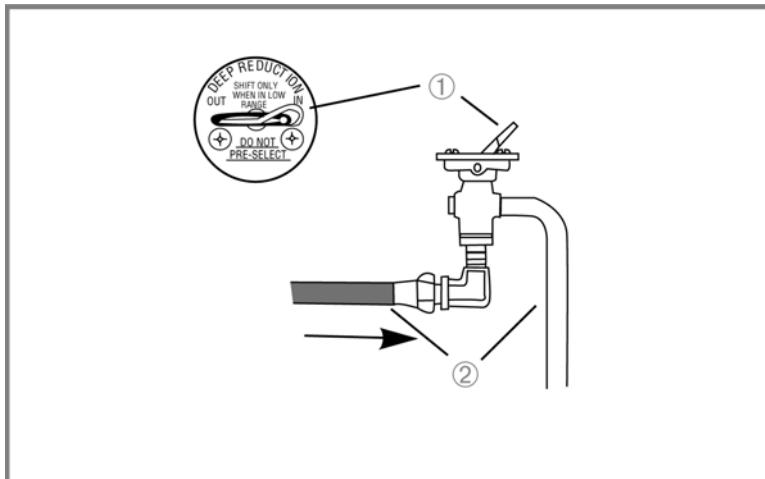
With the deep reduction lever in the "IN" position (1), the valve is closed (2) and no air is supplied to the deep reduction cylinder cover center port. The constant air from the air filter/regulator assembly moves the reduction piston rearward to engage deep reduction gearing.

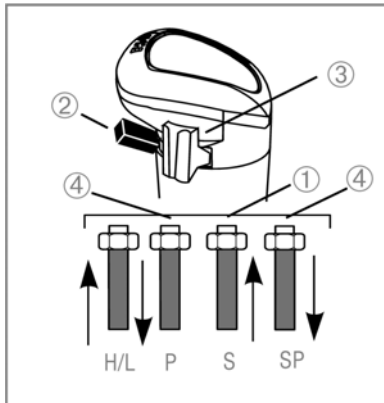
### A-5015/A-6915 Roadranger Valve

Constant air pressure is supplied from the slave valve to the Roadranger valve “S” port and “H/L” port (for deep reduction and LO range (1)).

For deep reduction (range lever down (2), deep reduction button forward (3), air flows out of the roadranger valve “P” port and “SP” port (4).

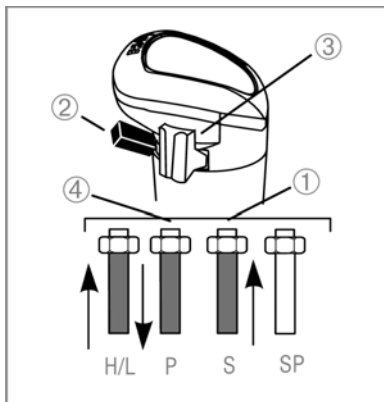
For LO range (range lever down (2), deep reduction button rearward (3), air flows out of the roadranger valve “P” port (4).

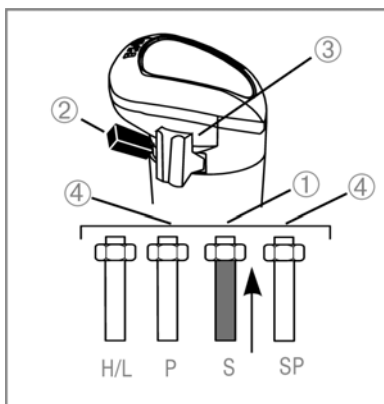
For HI range (range lever up (2), deep reduction button rearward (3), the lever stops the air from passing through the Roadranger valve. Air pressure which was in the outlet line is exhausted out the Roadranger valve bottom.

The Roadranger valve mechanical interlock prevents forward movement of the deep reduction button while in HI range.

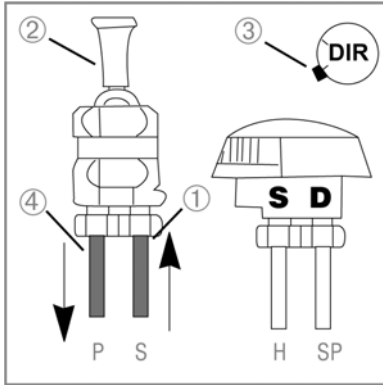
Constant air pressure is supplied from the slave valve to the A-3546 range valve “S” port (1).

For LO range (range knob down (2), selector valve button in the “DIR” position (3), air flows out of the range valve “P” port (4).

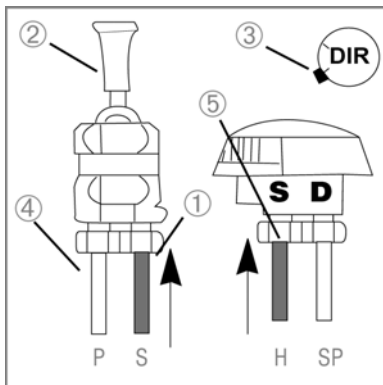
For direct operation (range knob up (2), selector valve button in the “DIR” position (3), the knob prevents the air from passing through the selector valve: air now flows through the “H” port and into the selector valve (5).

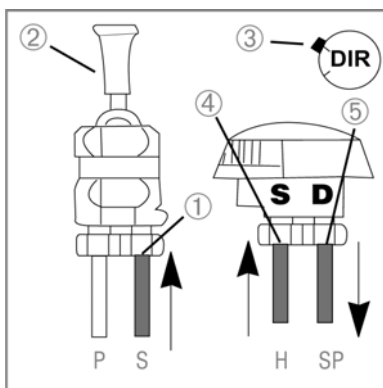
For Underdrive and Overdrive operation (range knob up (2), selector valve button in the forward position (3) air flows through the selector valve “H” port (4) and out the “SP” port (5).

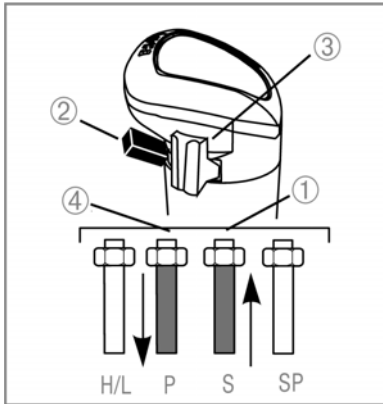
Constant air pressure is supplied from the slave valve to the Roadranger valve “S” port (1).

For LO range (range lever down (2), splitter button rearward (3), air flows out of the Roadranger valve “P” port (4).

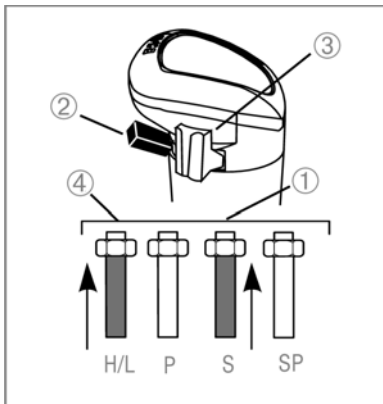
For HI range (range lever up (2), splitter button rearward (3), the lever prevents the air from passing through the Roadranger valve: air now flows through the “H/L” port (4) into the Roadranger valve.

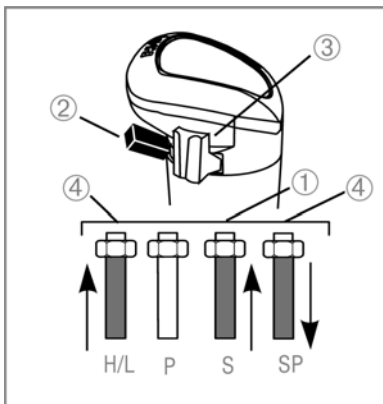
For splitter operation (range lever up (2), splitter button forward (3), air flows through the “H/L” port and air flows out of the Roadranger valve “SP” port (4). Air pressure which was in the outlet line is exhausted out the bottom of the Roadranger valve.

The roadranger valve mechanical interlock prevents forward movement of the splitter button while in LO range.

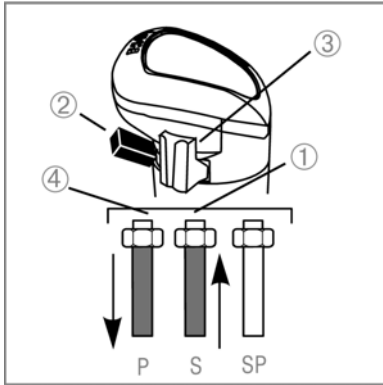
Constant air pressure is supplied from the slave valve to the roadranger valve “S” port (1).

For LO range direct (range lever down (2), actuator button rearward (3), air flows out of the Roadranger valve “P” port (4).

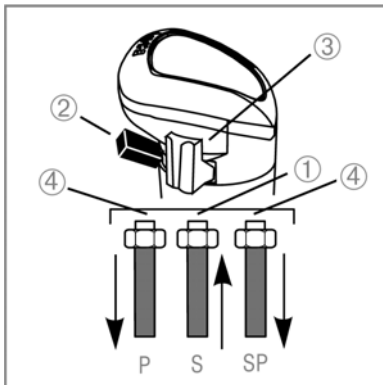
For LO range overdrive (range lever down (2), actuator button forward (3) air flows out of the roadranger valve “P” port and “SP” port (4).

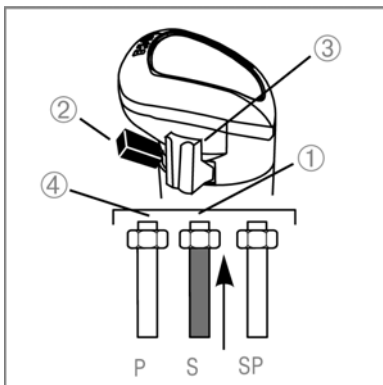
For HI range direct (range lever up (2), actuator button rearward (3), the lever prevents the air from passing through the Roadranger valve (4).

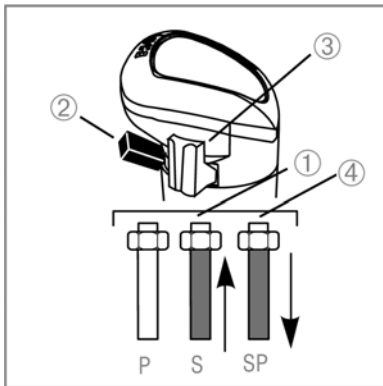
For HI range overdrive (range lever up (2), actuator button forward (3), air flows out of the Roadranger valve “SP” port (4). Air pressure which was in the outlet line is exhausted out the Roadranger valve bottom.

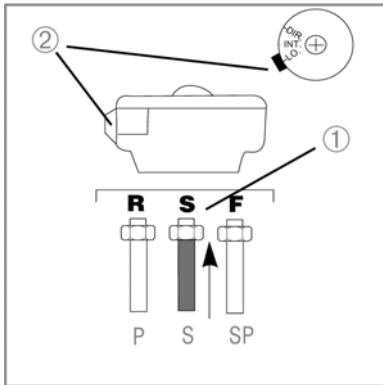
Constant air pressure is supplied from the slave valve to the Roadranger valve “S” port (1).

For LO range (selector button in the “LO” position (2), the air is stopped from passing through the selector valve.

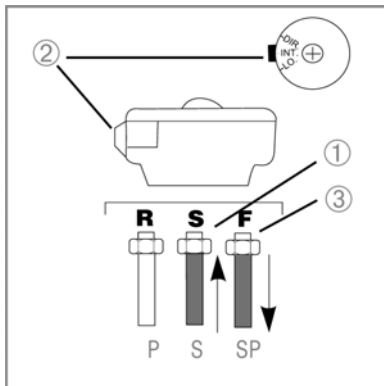
For Intermediate range (selector button in the “INT” position (2), air flows out the “SP” port (3).

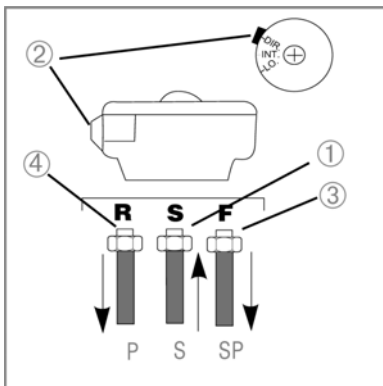
For HI range (selector button in the “DIR” position (2), air flows out the “P” port (3) and the “SP” port (4).

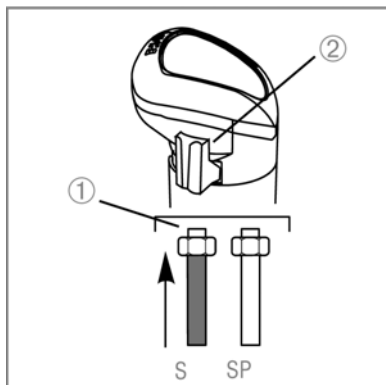
Constant air pressure is supplied from the slave valve to the Roadranger valve “S” port (1).

For LO range 1, 3, 5 gear positions (gear select button in the rearward position (2), the button prevents air from passing through the Roadranger valve.

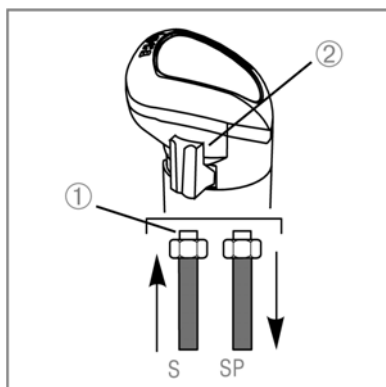
For LO range 2, 4, 6 gear positions (gear select button in the forward position (2), air flows out the roadranger “SP” port.

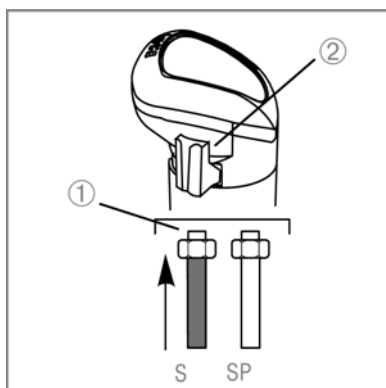
For HI range 7, 9 gear position (gear select button in the rearward position (2), air is again prevented from passing through the Roadranger valve.

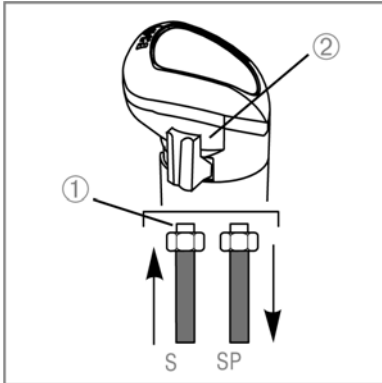
For HI range, 8 and 10 gear positions (gear select button in the forward (2) air flows out the roadranger valve “SP” port.

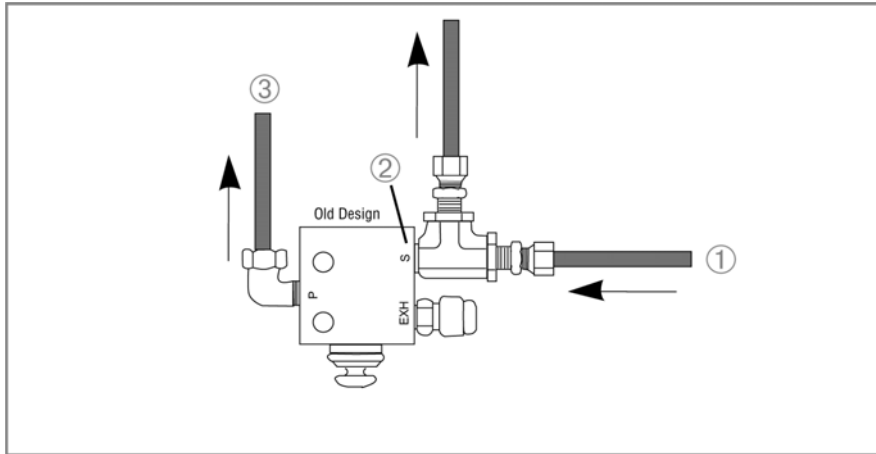
Constant air pressure is supplied from the air filter/regulator to the range actuator valve "S" port tee (1).

For LO range (1, 2, 3, 4, 5, and 6 gear positions) the "S" port (2) is open and the air is allowed to pass through the range actuator valve and out the LO range air line (3).

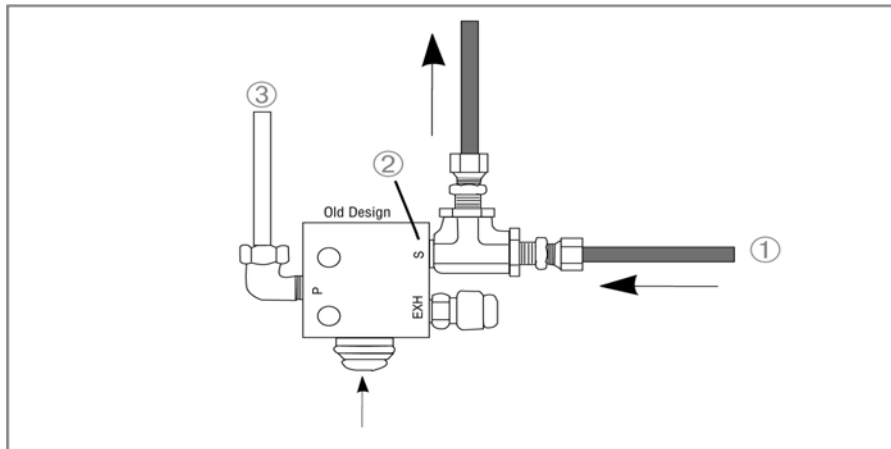
For HI range (7, 8, 9, and 10 gear positions) the "S" port (2) is closed and no air passes through the range actuator valve (3).

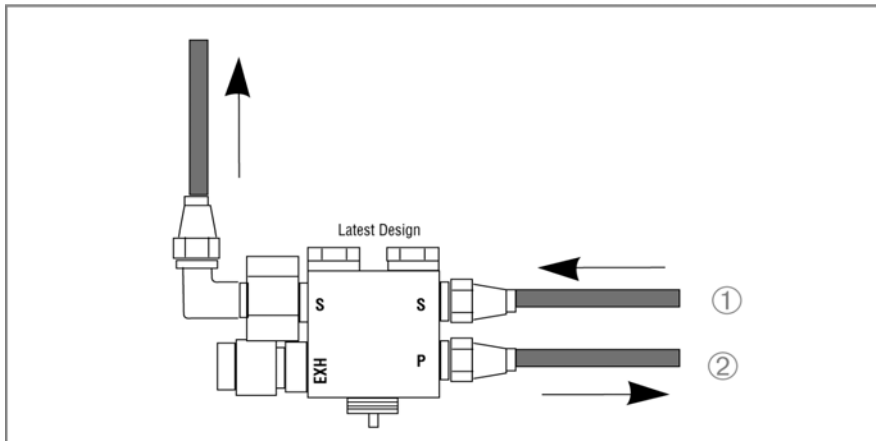
Constant air pressure is supplied from the air filter/regulator to the range actuator valve "S" port tee (1).

For LO range (1, 2, 3, 4, 5, and 6 gear positions) the "S" port is open and the air is allowed to pass through the range actuator valve and out the LO range air line (2).

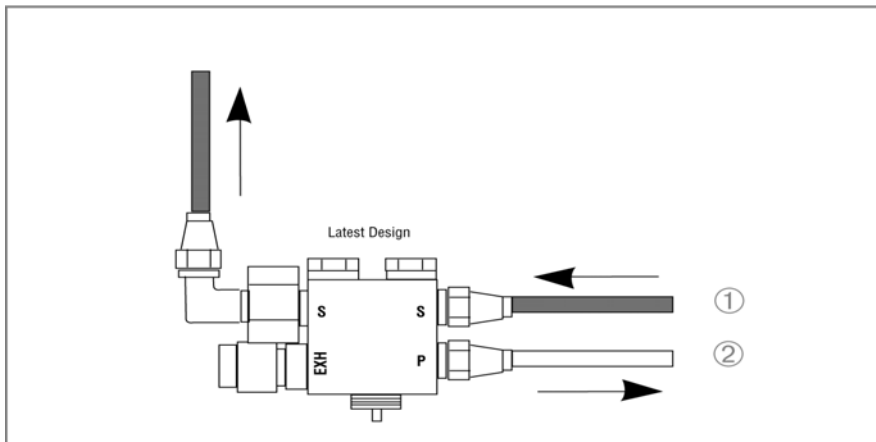
For HI range (7, 8, 9, and 10 gear positions) the "S" port is closed and no air passes through the range actuator valve (2).

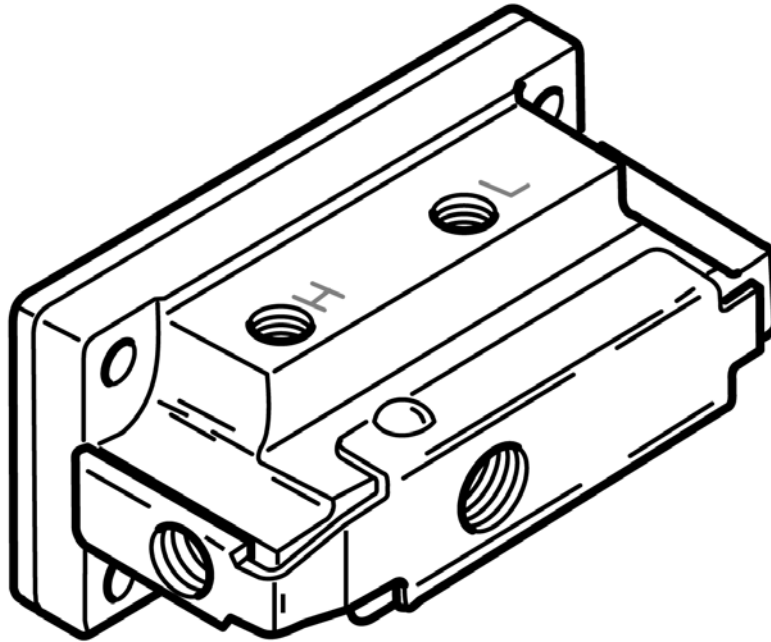
Obsolete

The poppet-type slave valve is a non-serviceable valve. Should this valve prove to be defective replace the complete assembly with A-5000. There are some preliminary checks to make before replacing the slave valve: check air fittings for restrictions, check torque of the four (4) mounting capscrews (8-12 lbs. ft.), if valve continues to leak replace.

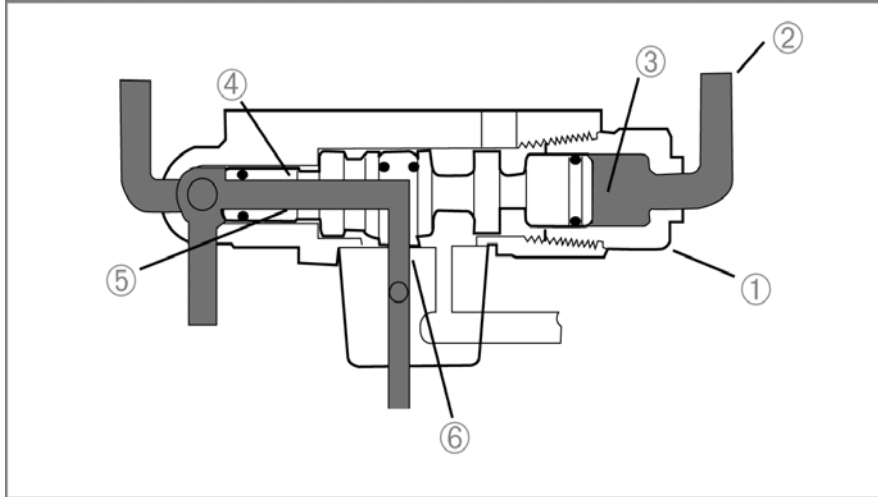
**LO Range** - Air pressure is supplied to the end cap (1) from the selector/master/Roadranger valve (2). The piston is held forward since the surface area is larger on this end (3) than the surface area at the other end (4) and is exposed to constant air pressure. The constant air flows through the piston center passage (5) which is aligned with the side cap LO range port (6). In normal operation, exhaust occurs only for an instant as the range shift is made.

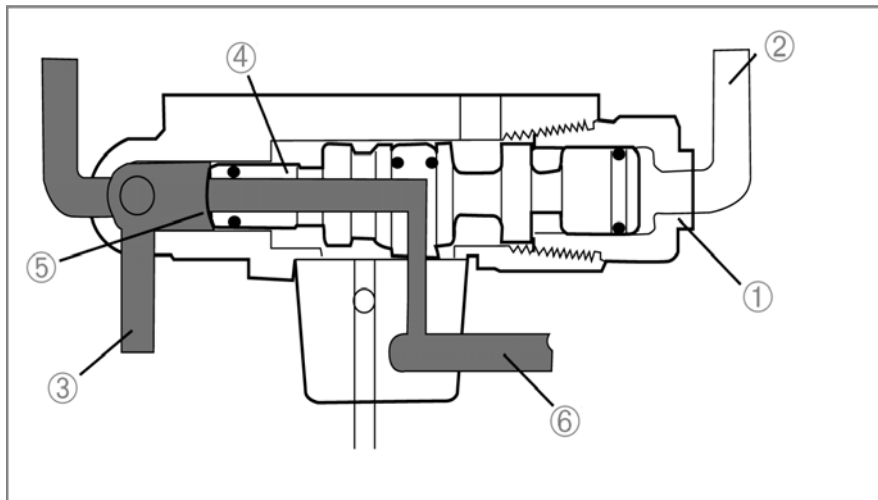
**HI Range** - No air pressure is supplied to the end cap (1) from the selector/master/Roadranger valve (2). The constant air pressure entering the supply port (3) moves the piston to the rear position (4). The constant air flows through the piston center passage (5) which is aligned with the side cap HI range port (6). In normal operation, exhaust occurs only for an instant as the range shift is made.

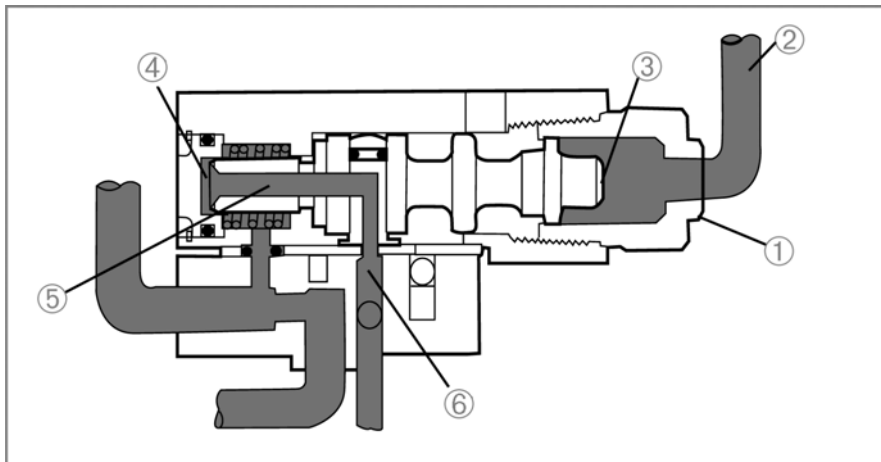
**LO Range** - Air pressure is supplied to the end cap (1) from the selector/master/Roadranger valve (2). The piston is held forward since the surface area is larger on this end (3) than the surface area at the other end (4) and is exposed to constant air pressure. The constant air flows through the piston center passage (5) which is aligned with the side cap LO range port (6). In normal operation, exhaust occurs only for an instant as the range shift is made.

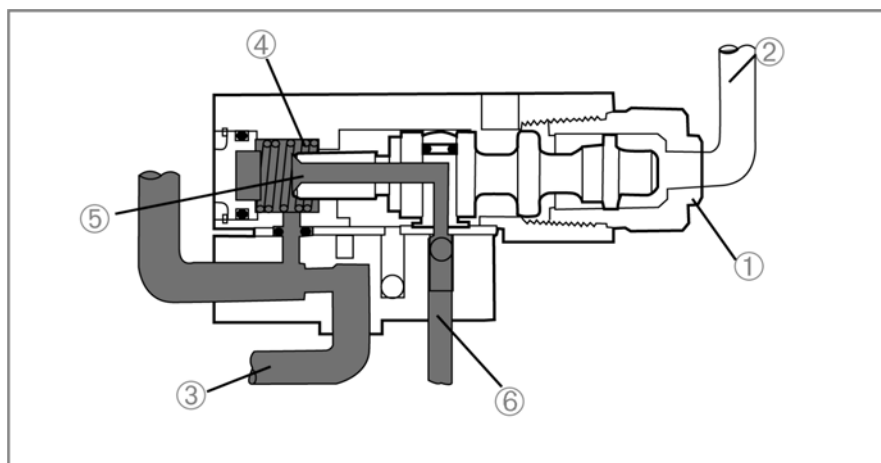
**HI Range** - No air pressure is supplied to the end cap (1) from the selector/master/Roadranger valve (2). The constant air pressure entering the supply port (3) moves the piston to the rear position (4). The constant air flows through the piston center passage (5) which is aligned with the side cap HI range port (6). In normal operation, exhaust occurs only for an instant as the range shift is made.

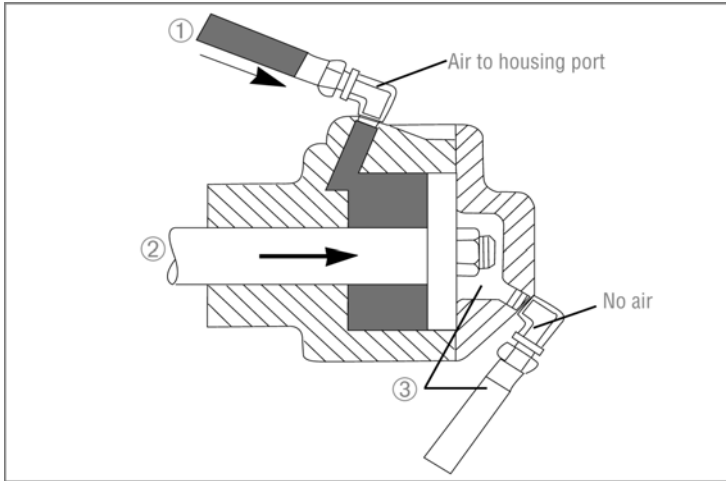
**LO Range** - With the control valve lever down, air is supplied from the slave valve to the range cylinder LO range port (1). This air pressure forces the range cylinder piston to the rear (2), engaging the LO range gearing. Air pressure on the piston back, and in the HI range air hose (3), is exhausted out the slave valve.

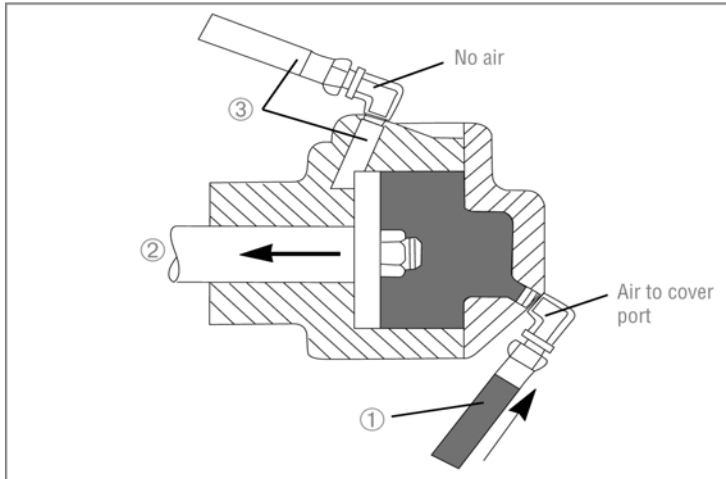
**HI Range** - With the control valve lever up, air is supplied from the slave valve to the range cylinder cover HI range port (1). This air pressure forces the range cylinder piston forward (2), engaging the HI range gearing. Air pressure on the piston front side and in the LO range air hose (3), during LO range operation, is exhausted out the slave valve.

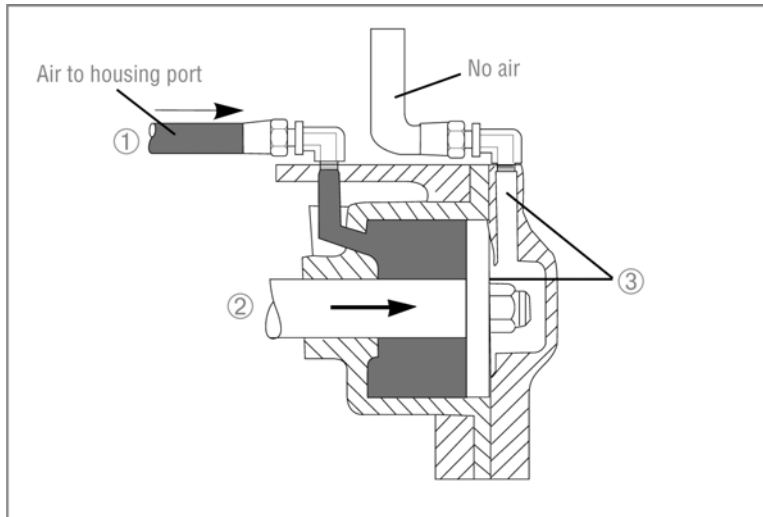
**LO Range** - With the control valve lever down, air is supplied from the slave valve to the range cylinder LO range port (1). This air pressure forces the range cylinder piston to the rear (2), engaging the LO range gearing. Air pressure on the piston back, and in the HI range air hose (3), is exhausted out the slave valve.

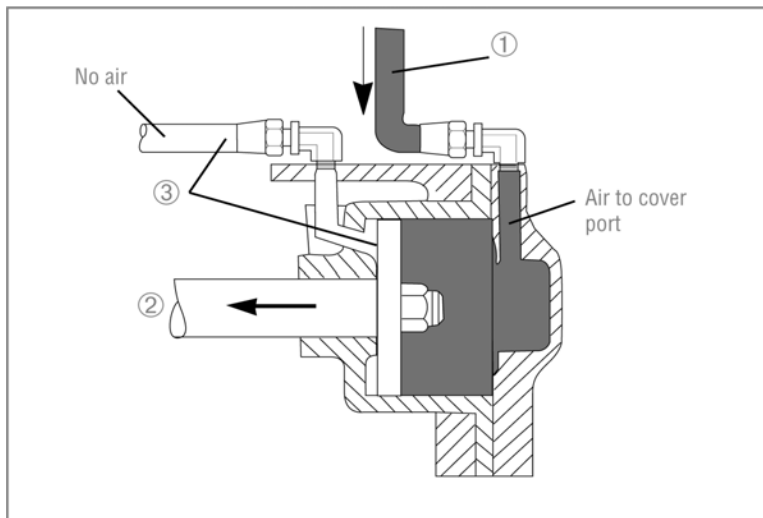
**HI Range** - With the control valve lever up, air is supplied from the slave valve to the range cylinder cover HI range port (1). This air pressure forces the range cylinder piston forward (2), engaging the HI range gearing. Air pressure on the piston front side and in the LO range air hose (3), during LO range operation, is exhausted out the slave valve.

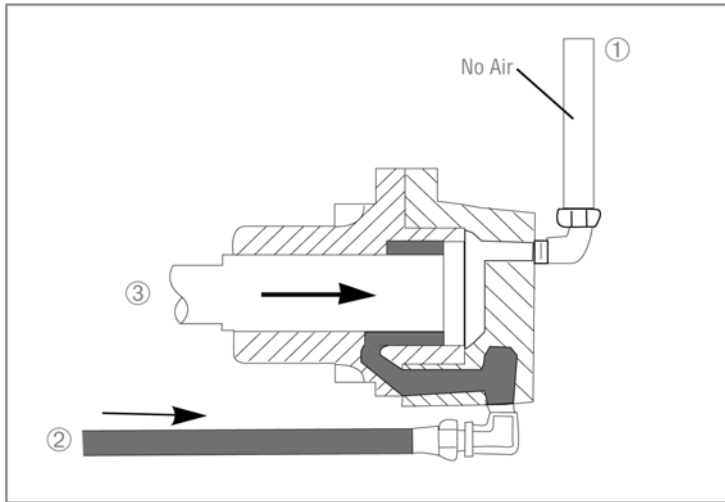
**Deep Reduction** - With the deep reduction lever in the "IN" position, no air is supplied to the cylinder cover center port (1). Constant air from the air filter/regulator assembly (2) moves the reduction piston rearward (3), engaging deep reduction gearing.

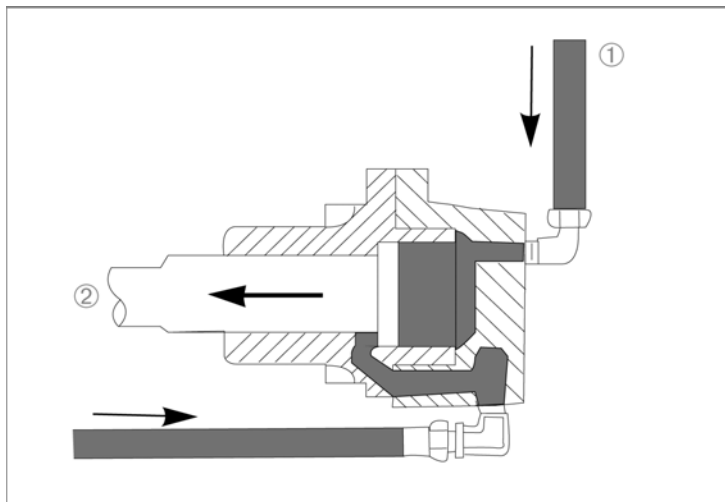
**LO Range or HI Range** - With the deep reduction lever in the "OUT" position, air is supplied to the cylinder cover center port (1), moving the reduction piston forward (2), disengaging deep reduction gearing.

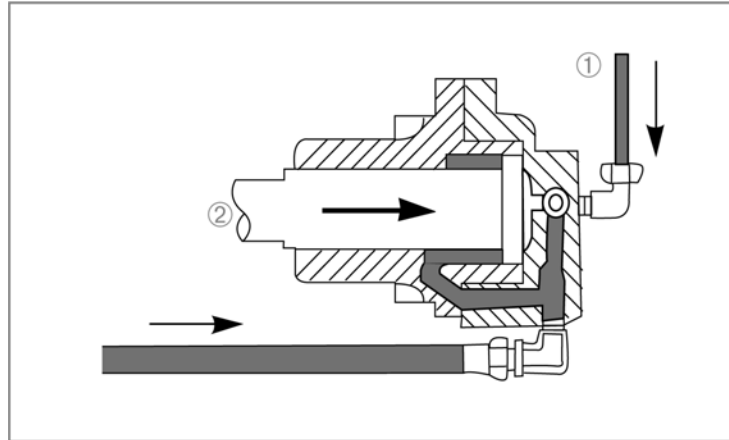
**Deep Reduction** - With the deep reduction button in the "forward" position, air is supplied to the deep reduction cylinder cover center port (1), moving the reduction piston rearward, engaging deep reduction gearing (2).

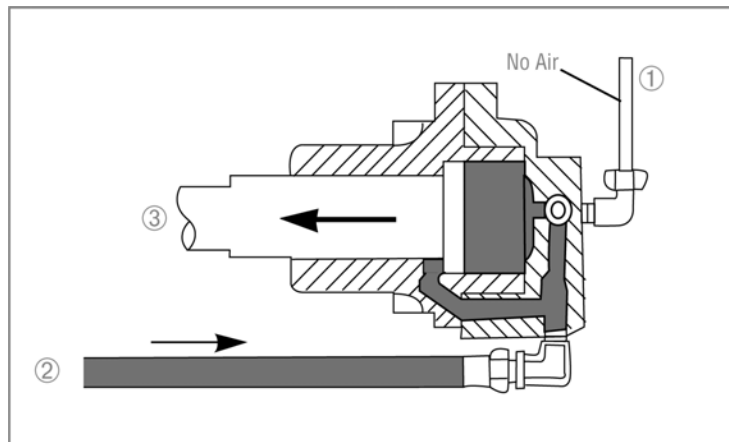
**LO or HI Range** - With the deep reduction lever in the "rearward" position, no air is supplied to the deep reduction cylinder cover center port (1). The constant air from the air filter/regulator assembly (2) moves the reduction piston forward, disengaging deep reduction gearing (3).

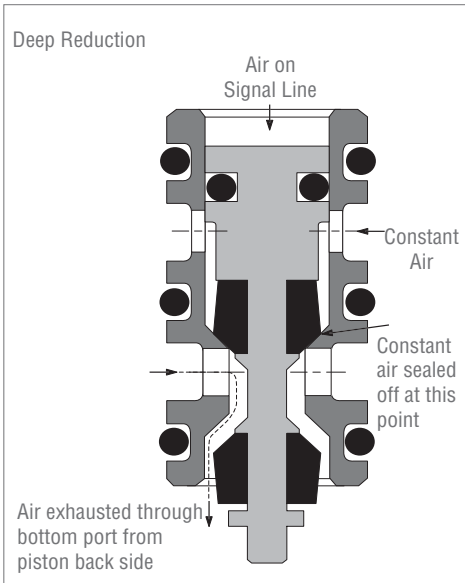
The insert valve is a self-contained 1-13/16" valve assembly located in the reduction cylinder cover. It cannot be disassembled except for the three (3) o-rings on the outer diameter. The o-rings provide a stationary seal and do not move in the cylinder.

Insert valve piston travel is only 1/32". When air is applied to the valve piston top side through the signal line, the piston moves down to cut off air supplied to the cylinder piston backside. This air is exhausted out the cover bottom port when constant air supplied from the regulator is directed to the cylinder piston front side, moving the yoke bar rearward to engage deep reduction gearing.

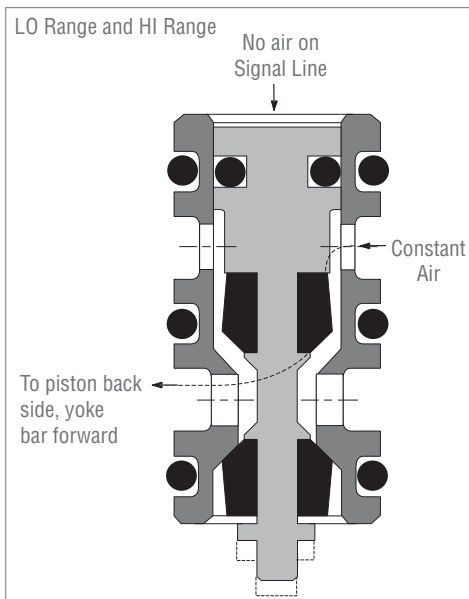
When no air is applied to the valve piston top side, constant air supplied from the air filter/regulator passes freely through the insert valve and to the cylinder piston backside, moving the yoke bar forward to disengage deep reduction gearing.

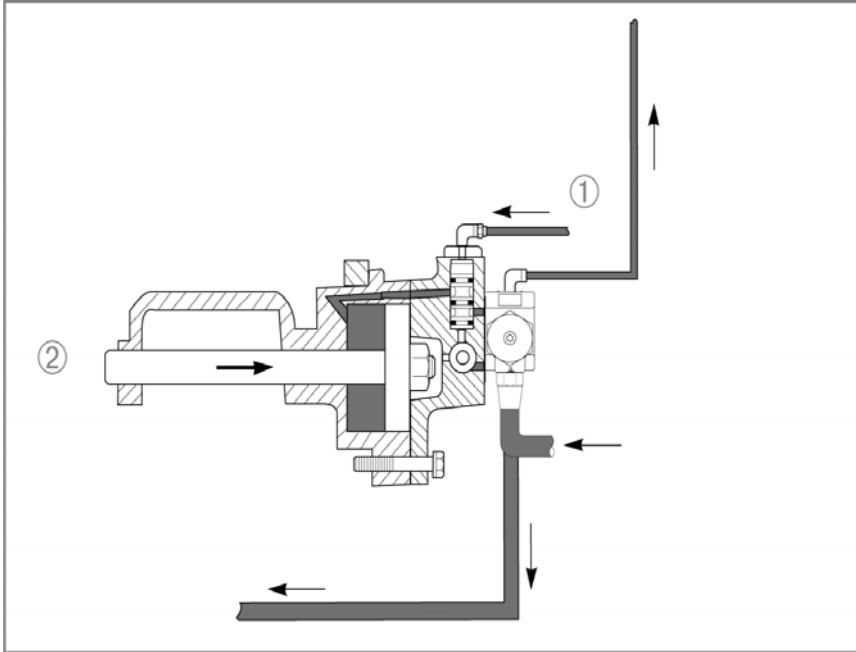
**LO Range** - When the shift lever is moved laterally from 7th to 6th gear, air is supplied to the range cylinder housing port (1), moving the piston rearward, engaging LO range gearing (2).

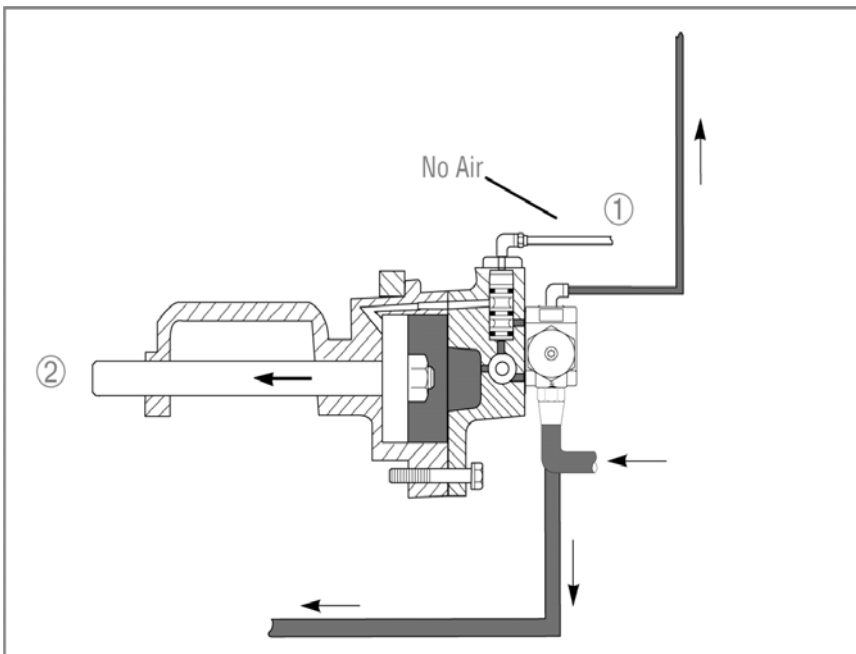
**HI Range** - When the shift lever is moved laterally from 6th to 7th gear, no air is supplied to the range cylinder housing port (1), moving the piston forward, engaging HI range gearing (2).
