## Troubleshooting Guide

# Fuller Transmissions TRTS0920

July 2011

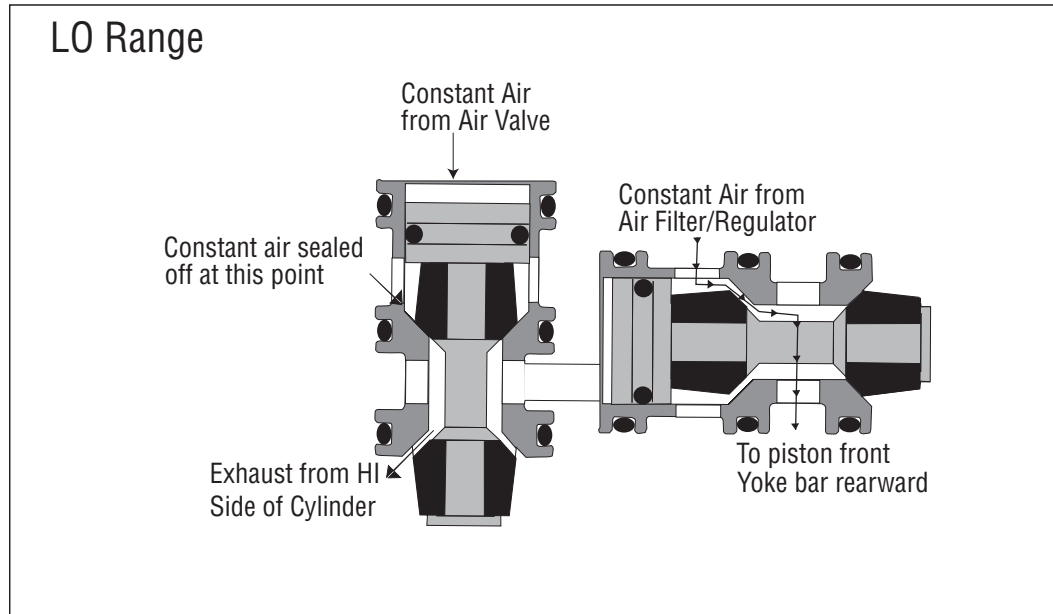
Insert valve piston travel is only 1/16". When air is applied to the valve piston top side, one piston moves down sealing off the constant air supplied from the air filter/regulator, the other piston allows the constant air supplied from the air filter/regulator to pass freely through the insert valve, to the cylinder piston front side, moving the yoke bar rearward to engage the LO range gearing.

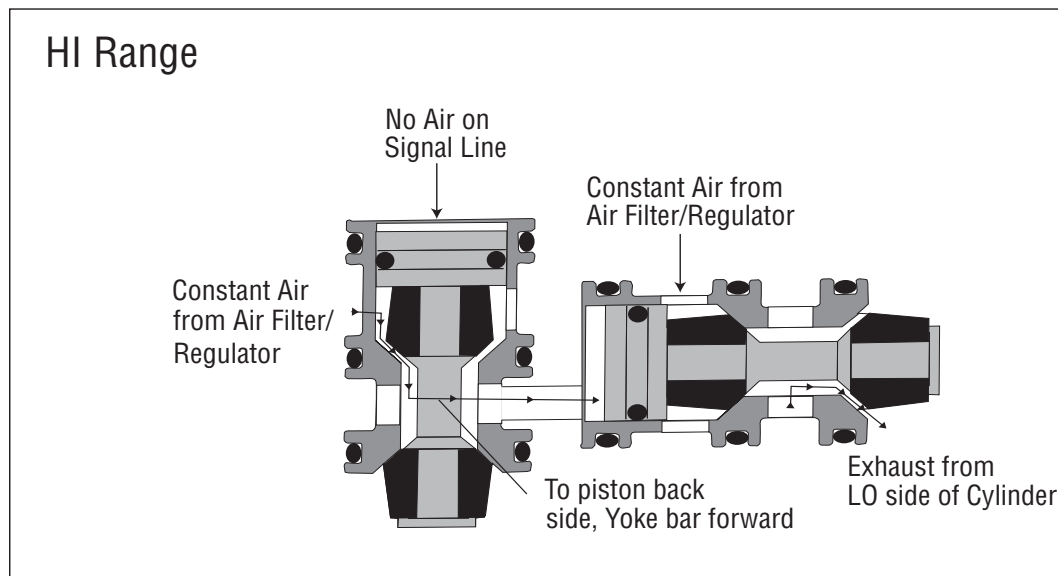
When no air is applied to the signal line, the piston moves up allowing the constant air supplied from the air filter/regulator to pass freely through one insert valve to the piston back side, moving the yoke bar forward to engage HI range gearing and sealing off the constant air from the air filter/regulator to allow the air from the piston front side to exhaust.

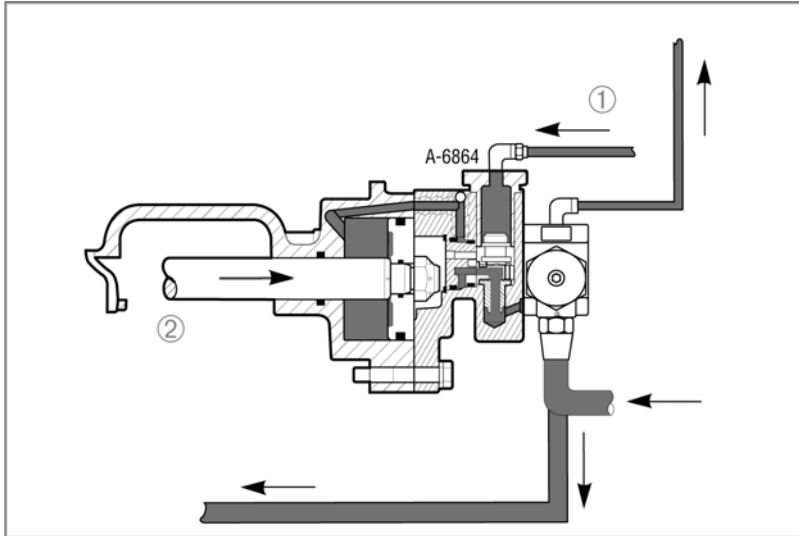
**LO Range** - When the shift lever is moved laterally from 7th to 6th gear, air is supplied to the range cylinder housing port (1), moving the the piston rearward, engaging LO range gearing (2).

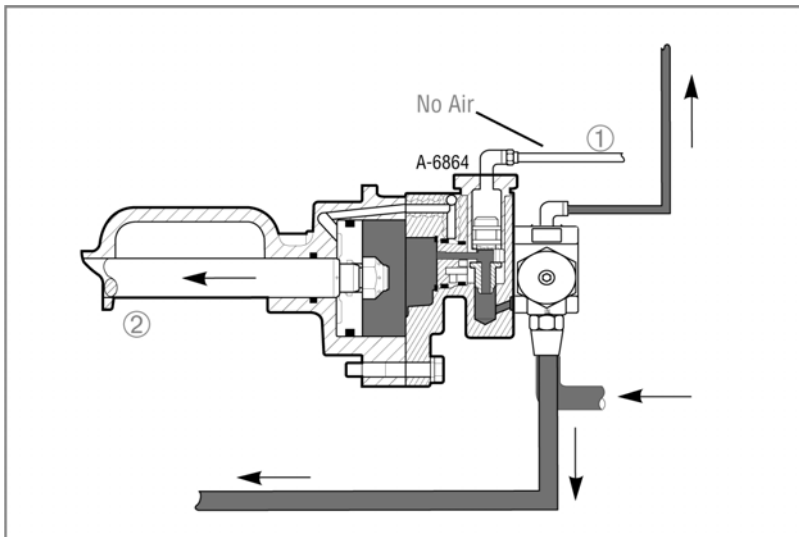
**HI Range** - When the shift lever is moved laterally from 6th to 7th gear, no air is supplied to the range cylinder housing port (1), moving the piston forward, engaging HI range gearing (2).

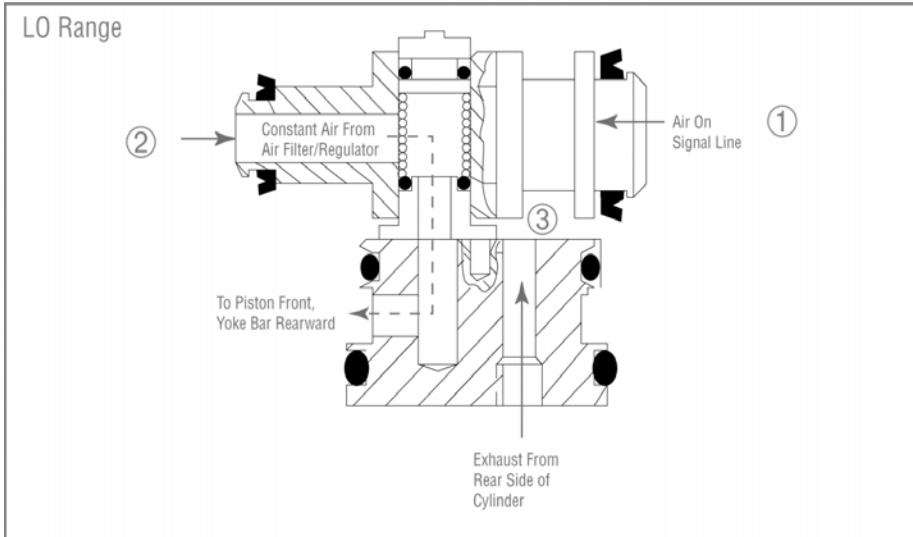
The spool valve piston travel is approximately 1/2". When filtered air is supplied from the 4303110 valve to the valve spool right side (1), constant air from the filter/regulator (2) flows through the valve spool and seal plate to the range cylinder piston front side moving the yoke bar rearward. Air is exhausted from the range cylinder rear (3).

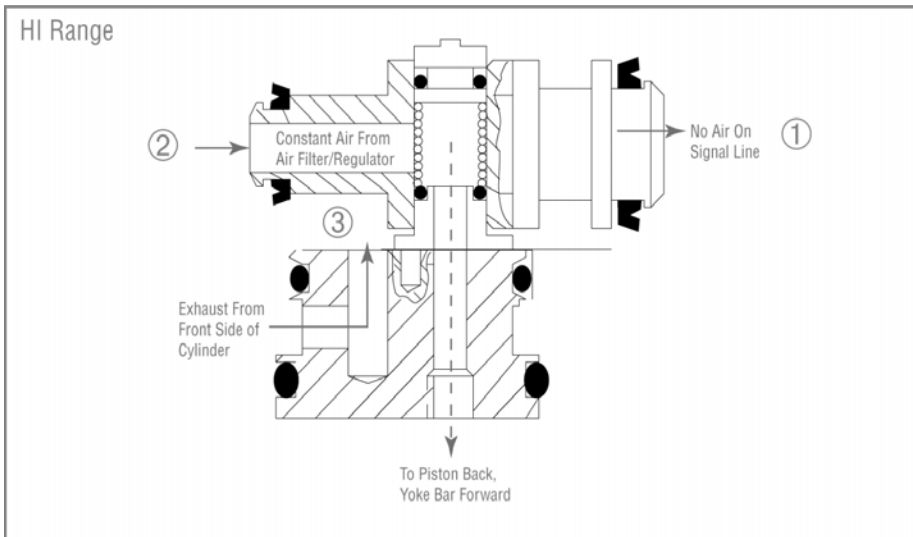
When no filtered air is supplied from the 4303110 valve to the valve spool right side (1), constant air from the filter/regulator (2) flows through the valve spool and seal plate to the range cylinder piston back side moving the yoke bar forward. Air is exhausted from the range cylinder front (3).

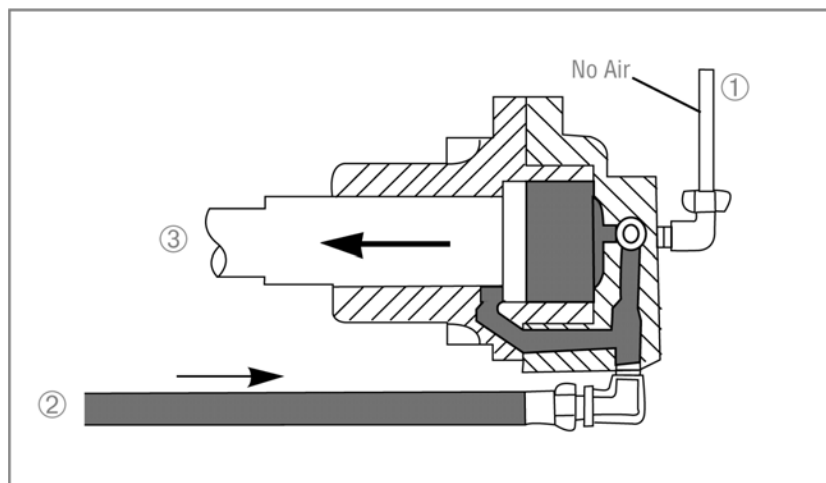
**LO Range** - With the Selector valve button in the "LO" position, no air is supplied to the Intermediate cylinder cover center port (1). The constant air from the air filter/regulator assembly (2) moves the piston forward (3), disengaging underdrive/overdrive gearing.

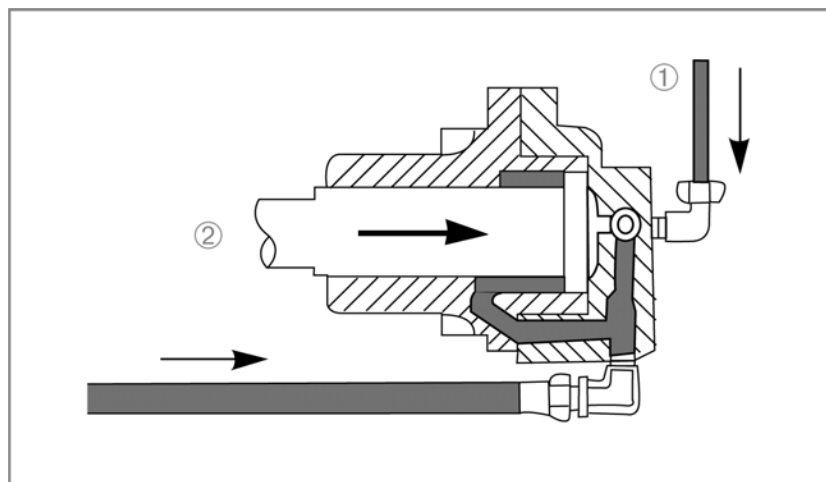
**Intermediate or Direct Range** - With the Selector valve button in the "INT" or "DIR" position, air is supplied to the Intermediate cylinder cover center port (1), moving the piston rearward, engaging underdrive/overdrive gearing (2).

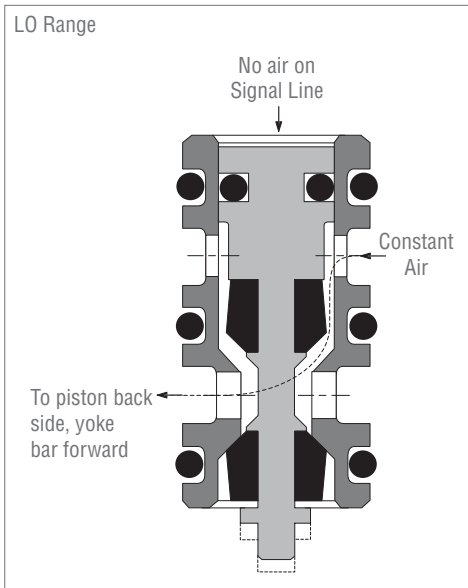
The insert valve is a self-contained 1-13/16" valve assembly located in the intermediate cylinder cover. It cannot be disassembled except for the three (3) O-rings on the outer diameter. The O-rings provide a stationary seal and do not move in the cylinder.

Insert valve piston travel is only 1/32". When no air is applied to the valve piston top side, constant air supplied from the air filter/regulator passes freely through the insert valve and to the cylinder piston backside, moving the yoke bar forward to disengage underdrive/overdrive gearing.

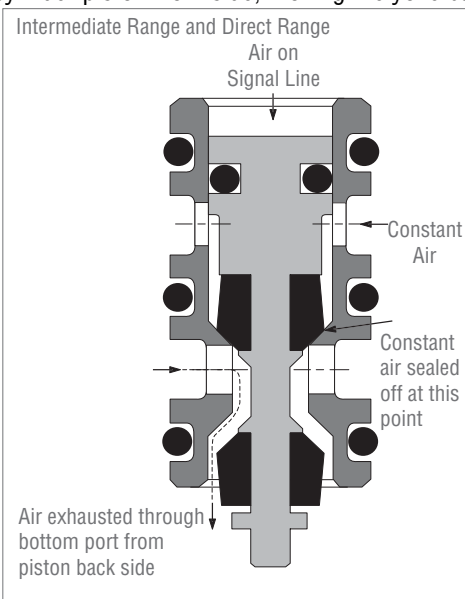
When air is applied to the valve piston top side through the signal line, the piston moves down to cut off air supplied to the cylinder piston backside. This air is exhausted out the cover bottom port when constant air supplied from the regulator is directed to the cylinder piston front side, moving the yoke bar rearward to engage intermediate or direct gearing.

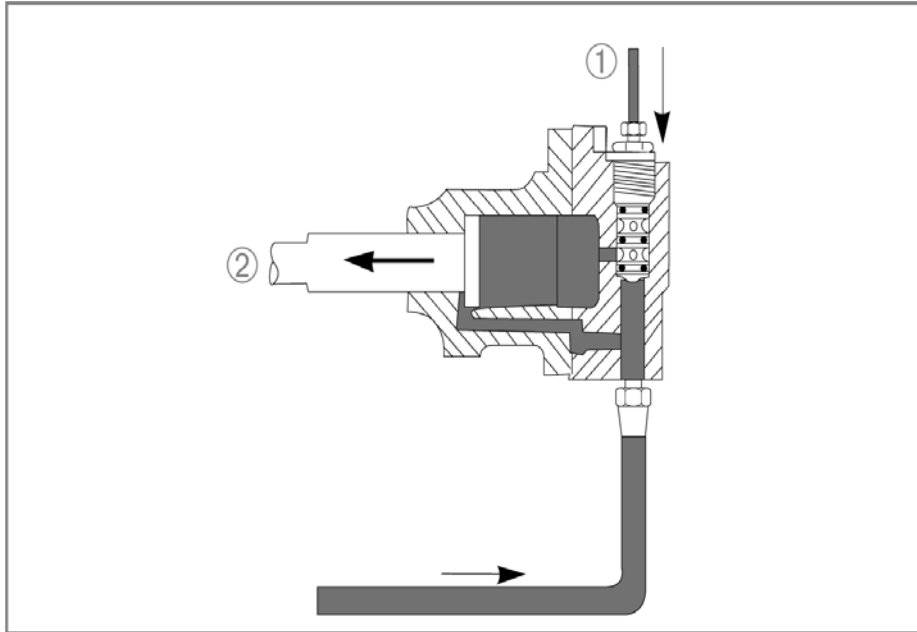
**Deep Reduction** - With the Roadranger valve lever in the up position, air is supplied to the Intermediate cylinder cover port (1), moving the the piston forward, engaging deep reduction gearing (2).

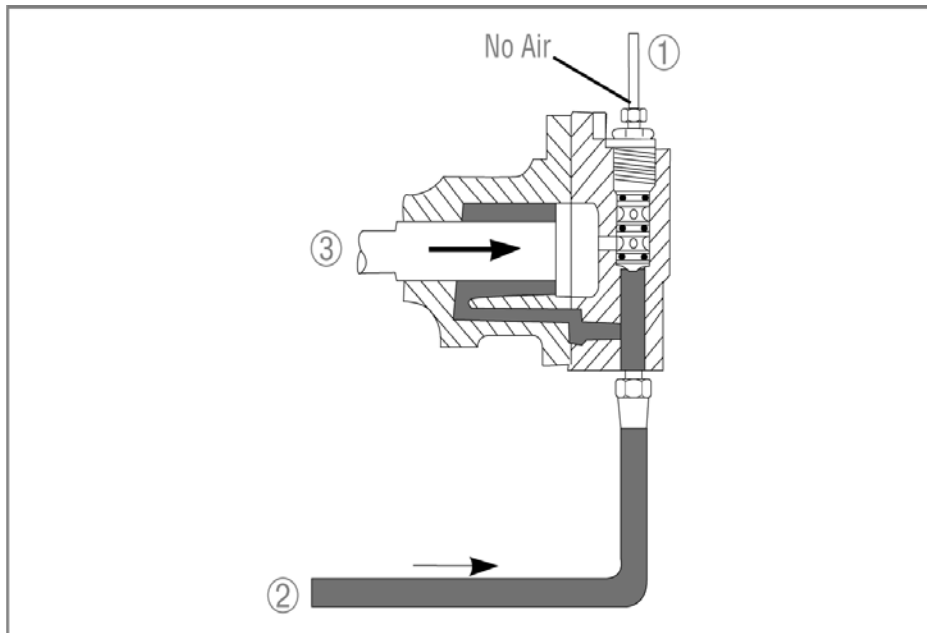
**LO or HI Range** - With the Roadranger valve lever in the down position, no air is supplied to the Intermediate cylinder cover port (1). The constant air from the air filter/regulator assembly (2) moves the piston rearward (3), disengaging deep reduction gearing.

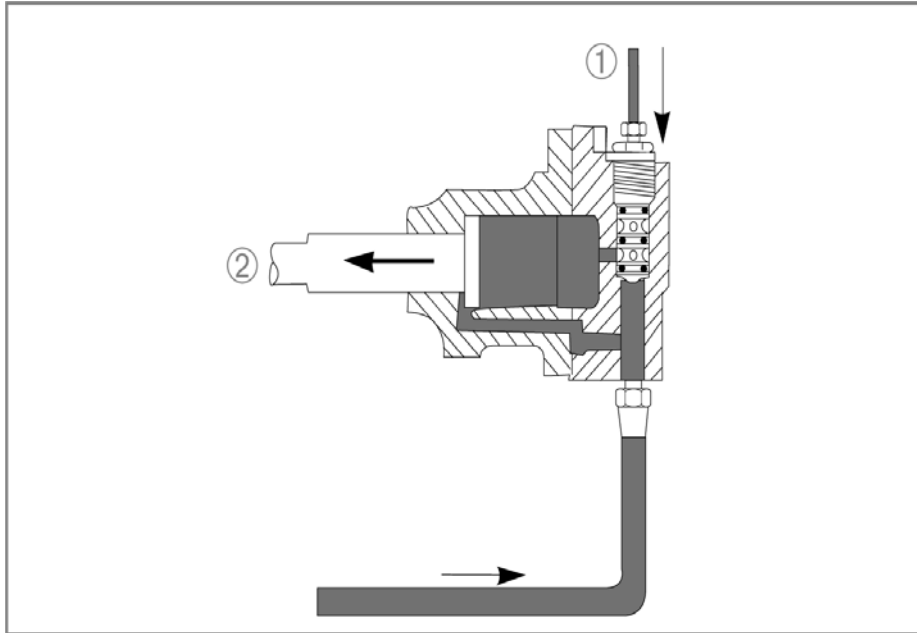
The insert valve is a self-contained 1-13/16" valve assembly located in the intermediate cylinder cover. It cannot be disassembled except for the three (3) O-rings on the outer diameter. The O-rings provide a stationary seal and do not move in the cylinder.

Insert valve piston travel is only 1/32". When air is applied to the valve piston top side through the signal line, constant air supplied from the air filter/regulator passes freely through the insert valve and to the cylinder piston backside, moving the yoke bar forward to engage deep reduction gearing.

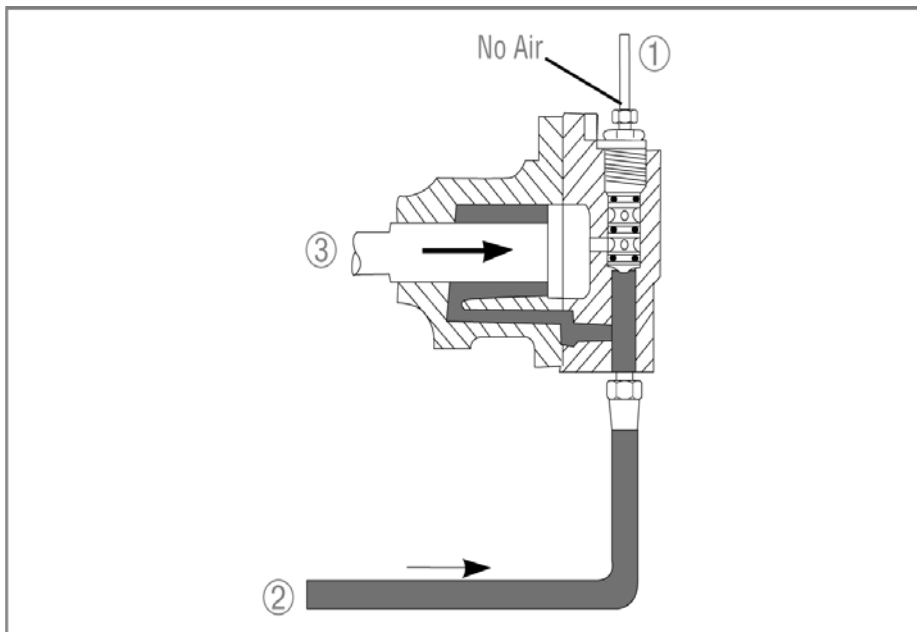
When no air is applied to the valve piston top side, the piston moves up to cut off air supplied to the cylinder piston backside. This air is exhausted out the cover back center bore, when constant air supplied from the cylinder is directed to the cylinder piston front side, the yoke bar moves rearward to disengage deep reduction gearing.

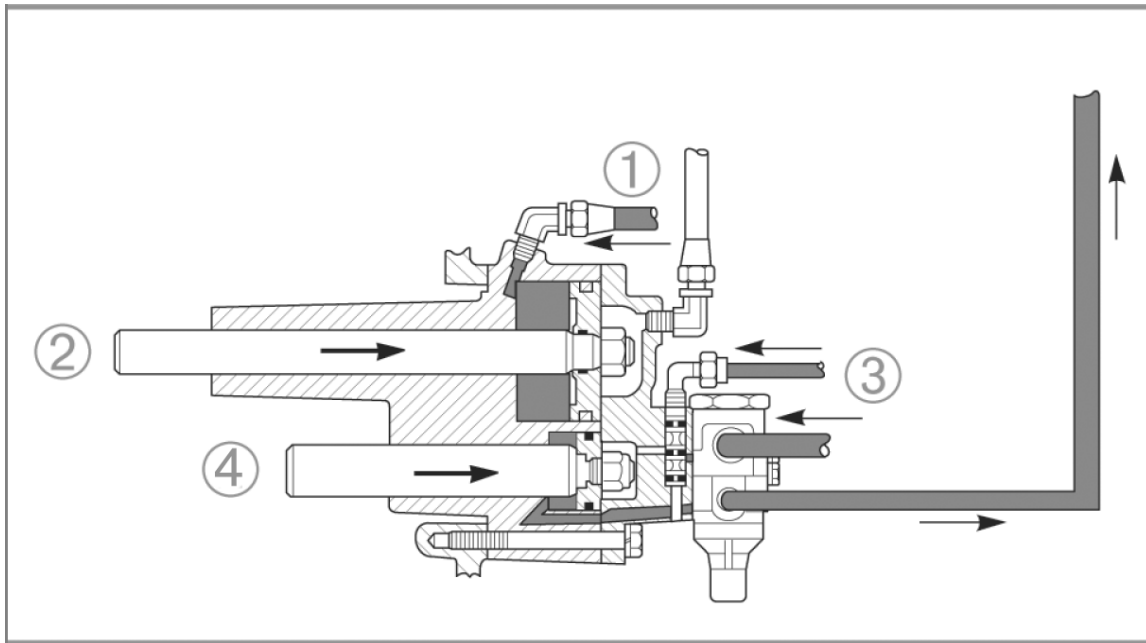
**Deep Reduction** - With the range lever in the "down" position, air is supplied to the LO range port (1), moving the range piston rearward to engage LO range gearing (2), and the deep reduction button is in the "forward" position. Air is supplied to the deep reduction cylinder cover center port (3), moving the reduction piston rearward (4), and engaging deep reduction gearing.

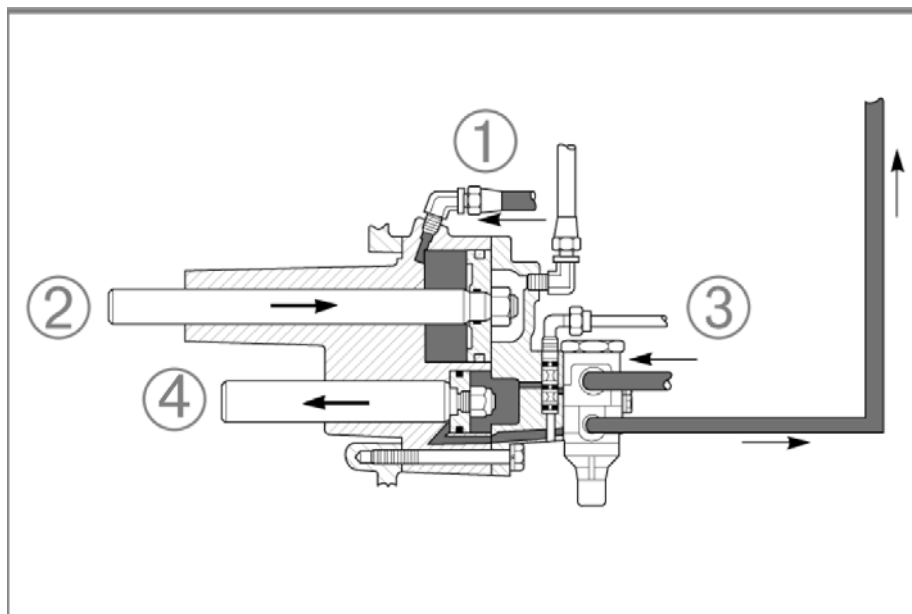
**LO Range** - With the range lever in the "down" position, air is supplied to the LO range port (1), moving the range piston rearward (2), engaging LO range gearing AND the deep reduction button is in the "rearward" position. No air is supplied to the deep reduction cylinder cover center port (3). The constant air from the air filter/regulator assembly moves the reduction piston forward (4), disengaging deep reduction gearing.

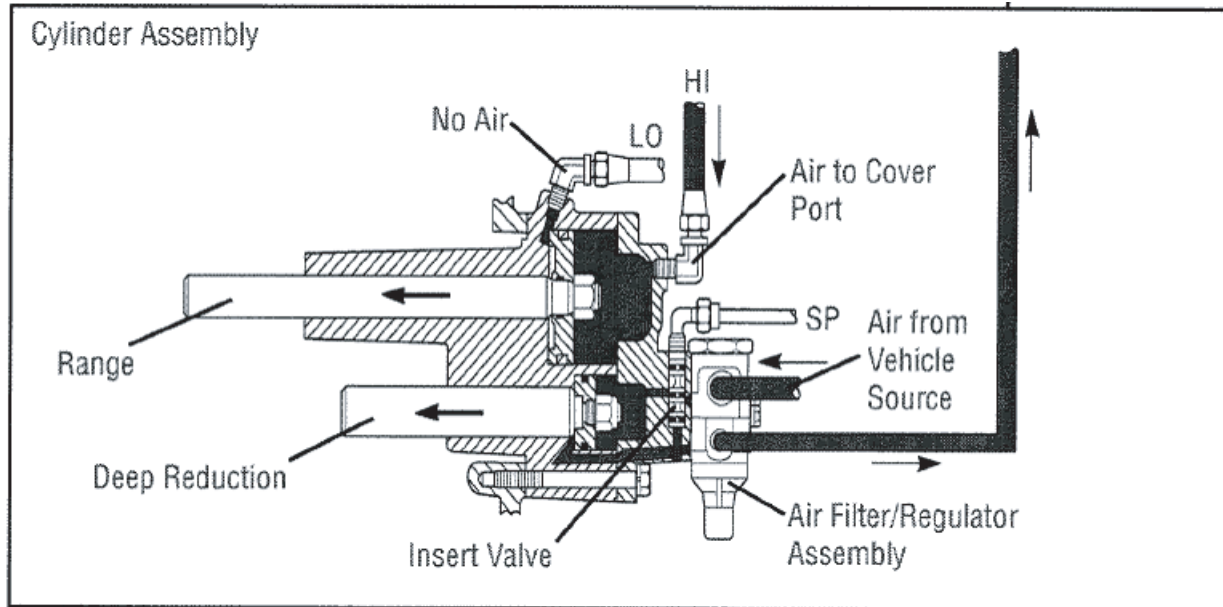
**HI Range** - With the range lever in the "up" position, air is supplied to the HI range port (1), moving the range piston forward (2), engaging HI range gearing AND the deep reduction button is in the "rearward" position. No air is supplied to the deep reduction cylinder cover center port (3). The constant air from the air filter/regulator assembly moves the reduction piston forward (4), disengaging deep reduction gearing.

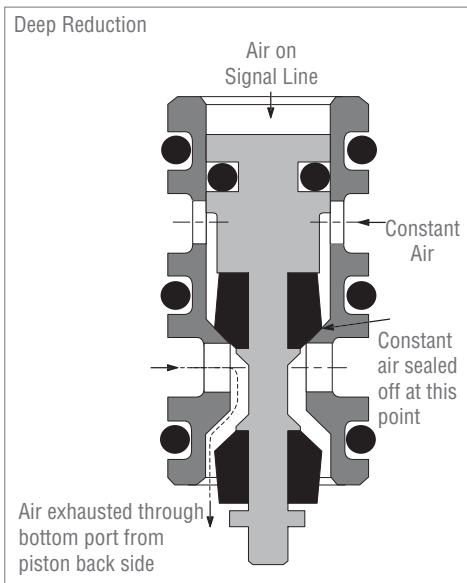
The insert valve is a self-contained 1-13/16" valve assembly located in the intermediate cylinder cover. It cannot be disassembled except for the three (3) O-rings on the outer diameter. The O-rings provide a stationary seal and do not move in the cylinder.

Insert valve piston travel is only 1/32". When air is applied to the valve piston top side through the signal line, the piston moves down to cut off air supplied to the cylinder piston backside. This air is exhausted out the cover bottom port when constant air, supplied from the regulator, is directed to the cylinder piston frontside, moving the yoke bar rearward to engage deep reduction gearing.

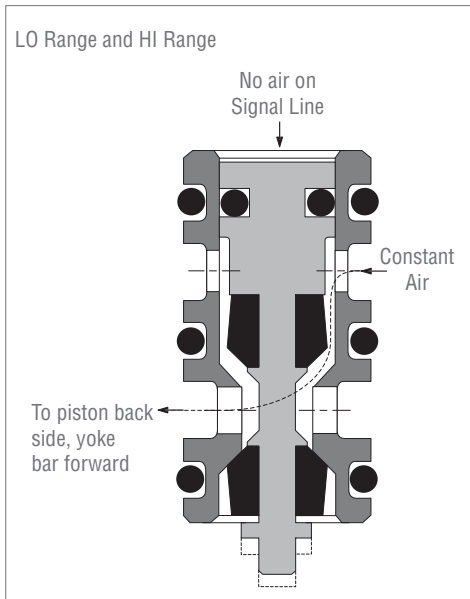
When no air is applied to the valve piston top side, constant air supplied from the air filter/regulator passes freely through the insert valve and to the cylinder piston backside, moving the yoke bar forward to disengage deep reduction gearing.

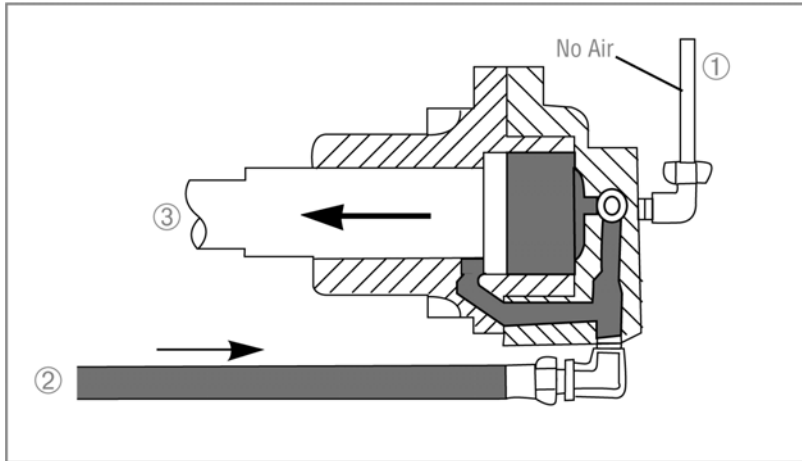
**LO Range or Direct** - With the splitter button in the "rearward" position, no air is supplied to the splitter cylinder cover center port (1). The constant air from the air filter/regulator assembly (2) moves the splitter piston forward, disengaging underdrive/overdrive gearing (3).

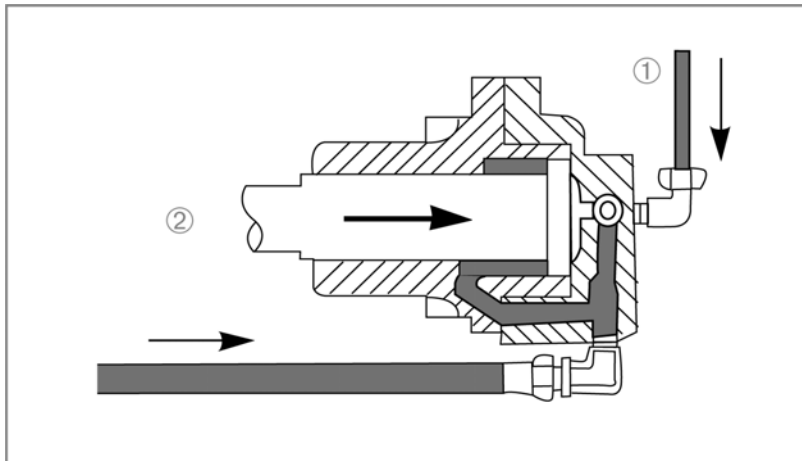
**Underdrive/Overdrive** - With the splitter button in the "forward" position, air is supplied to the splitter cylinder cover center port (1), moving the splitter piston rearward, engaging underdrive/overdrive gearing (2).

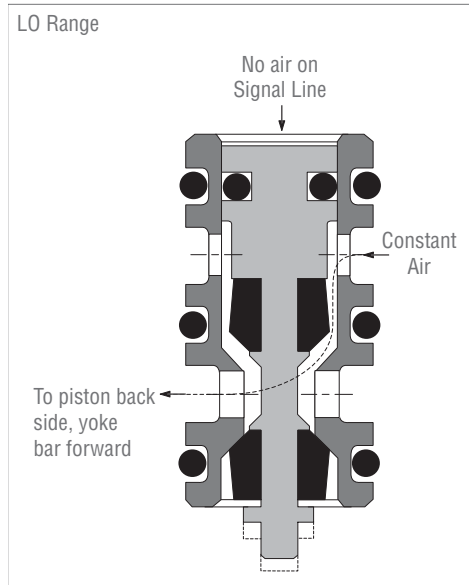
The insert valve is a self-contained 1-13/16" valve assembly located in the intermediate cylinder cover. It cannot be disassembled except for the three (3) O-rings on the outer diameter. The O-rings provide a stationary seal and do not move in the cylinder.

Insert valve piston travel is only 1/32". When no air is applied to the valve piston top side, constant air supplied from the air filter/regulator passes freely through the insert valve and to the cylinder piston backside, moving the yoke bar forward to disengage underdrive/overdrive gearing.

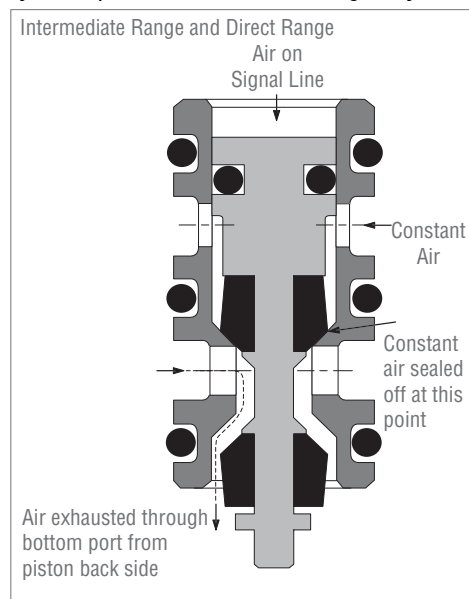
When air is applied to the valve piston top side through the signal line, the piston moves down to cut off air supplied to the cylinder piston backside. This air is exhausted out the cover bottom port when constant air supplied from the regulator is directed to the cylinder piston front side, moving the yoke bar rearward to engage underdrive/overdrive gearing.

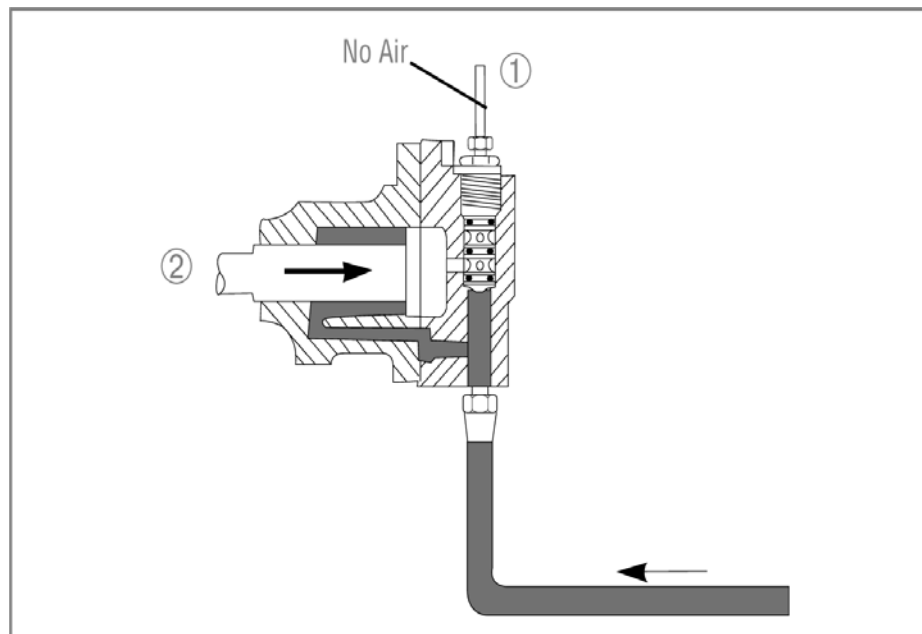
**Odd Numbered Gear Positions (1, 3, 5, 7, 9)** With the Roadranger valve button in the rearward position, no air is supplied to the splitter cylinder cover port (1), moving the piston rearward, disengaging splitter gearing (2).

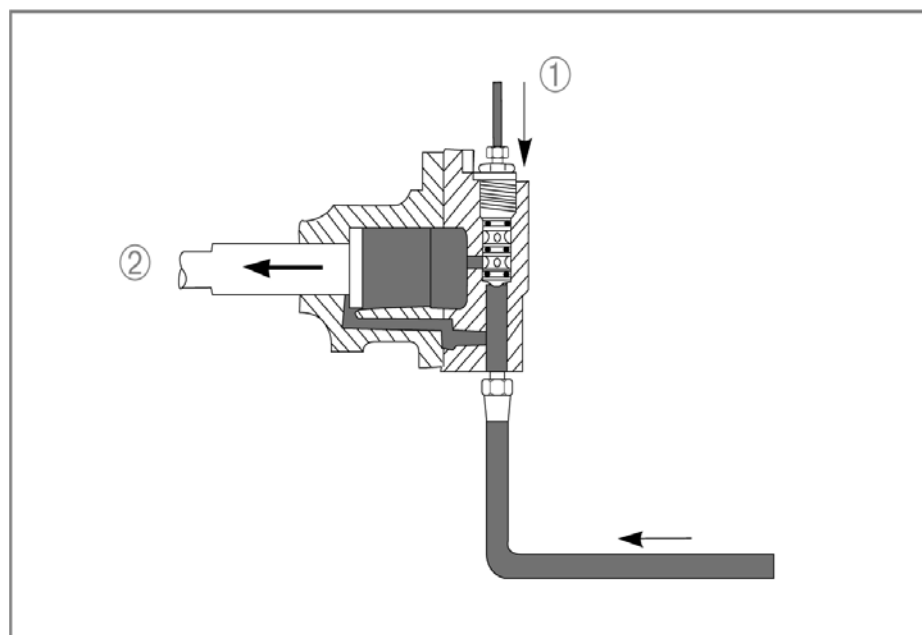
**Even Numbered Gear Positions (2, 4, 6, 8, 10)** With the Roadranger valve button in the forward position, air is supplied to the splitter cylinder cover port (1), moving the piston forward, engaging splitter gearing (2).

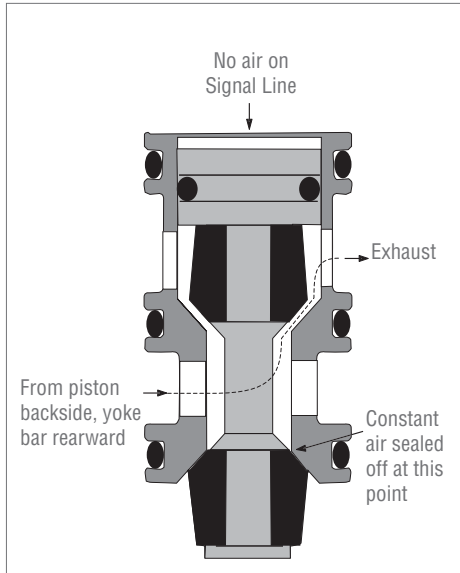
The insert valve is a self-contained 1-13/16" valve assembly located in the splitter cylinder cover. It cannot be disassembled except for the three (3) O-rings on the outer diameter. The O-rings provide a stationary seal and do not move in the cylinder.

Insert valve piston travel is only 1/32". When no air is applied to the valve piston top side through the signal line, constant air supplied from the air filter/regulator moves the yoke bar rearward to engage the rear auxiliary drive gear (LO and HI range direct), while air is exhausted out the insert valve.

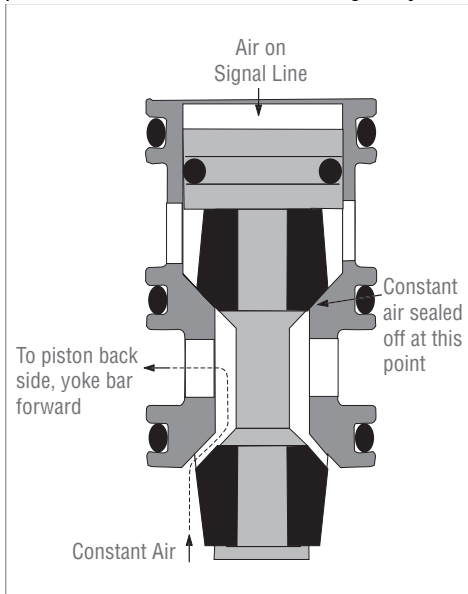
When air is applied to the valve piston top side, the piston moves down passing air through the insert valve bottom to the cylinder piston front and backside, moving the yoke bar forward to engage the front auxiliary drive gear (LO and HI range overdrive).

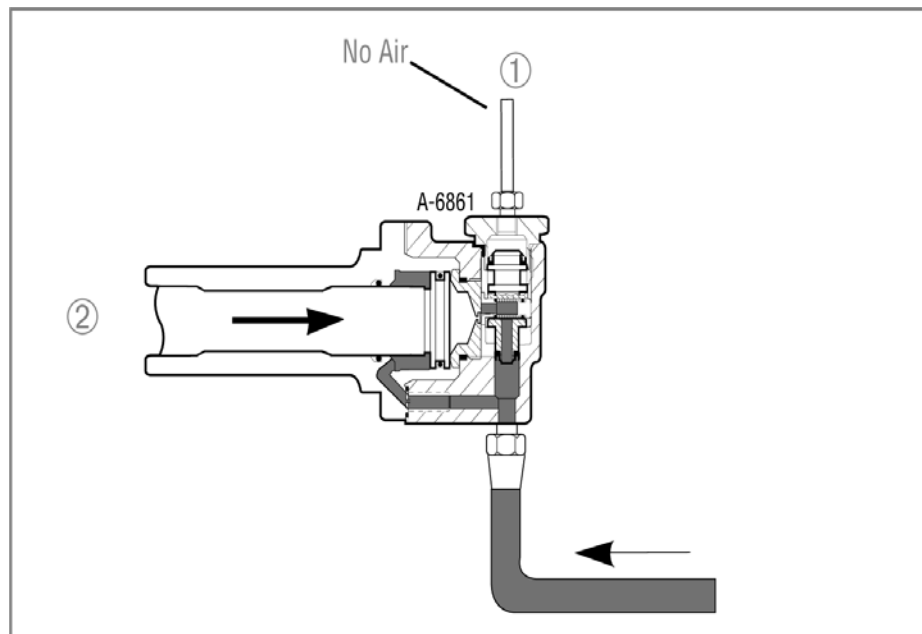
**Odd Numbered Gear Positions (1, 3, 5, 7, 9)** With the Roadranger valve button in the rearward position, no air is supplied to the splitter cylinder cover port (1), moving the piston rearward, disengaging splitter gearing (2).

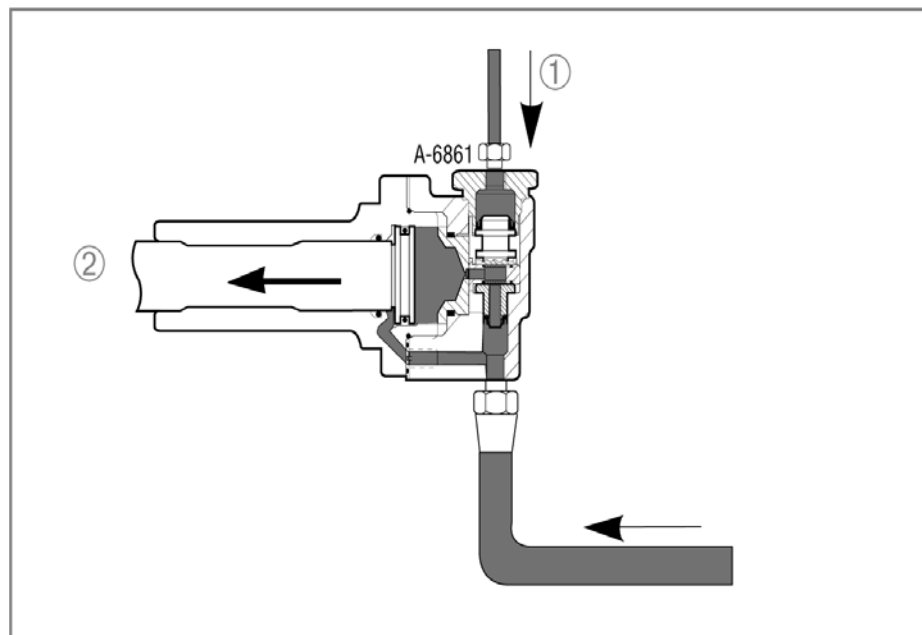
**Even Numbered Gear Positions (2, 4, 6, 8, 10)** With the Roadranger valve button in the forward position, air is supplied to the splitter cylinder cover port (1), moving the piston forward, engaging splitter gearing (2).

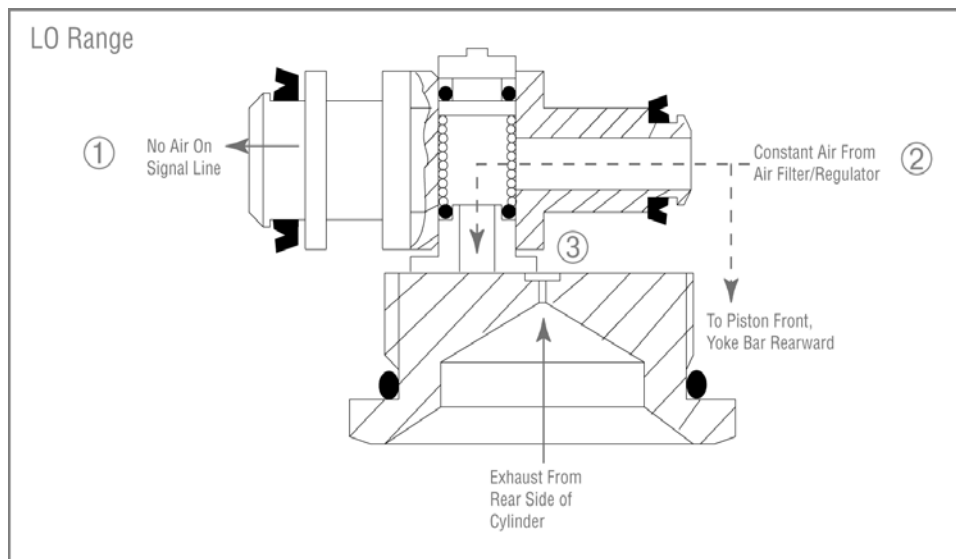
The spool valve components shown are part of a self-contained valve assembly, part number A-6861.

The spool valve piston travel is approximately 1/2". When no air is supplied from the Roadranger valve to the valve spool left side (1), constant air from the filter/regulator (2) is supplied to the splitter cylinder piston front side moving the yoke bar rearward. Air is exhausted from the splitter cylinder rear (3) and from the breather situated on the valve assembly rear.

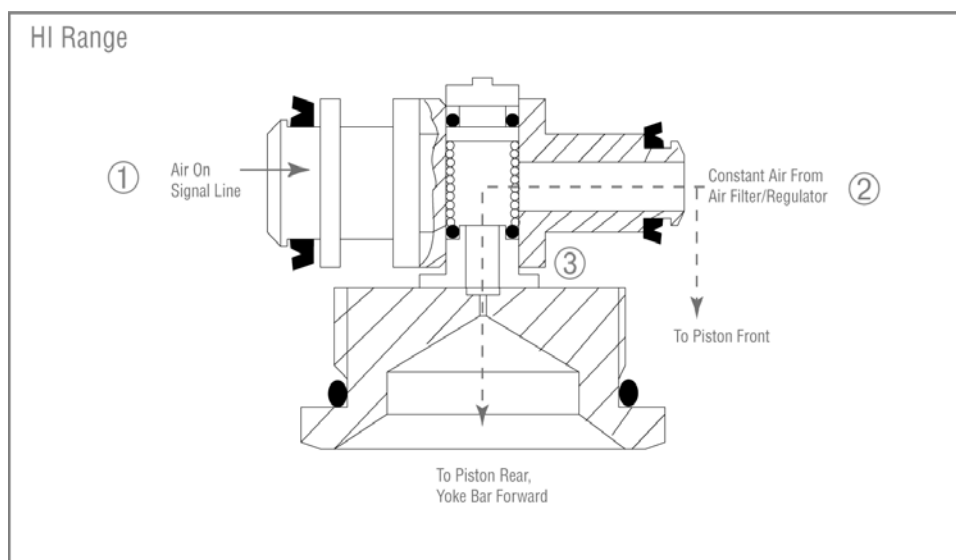
When air is supplied from the Roadranger valve to the valve spool left side (1), constant air from the filter/regulator (2) is supplied to the splitter cylinder piston rear side moving the yoke bar forward. Air is exhausted from the splitter cylinder front (3) and from the breather situated on the valve assembly rear.

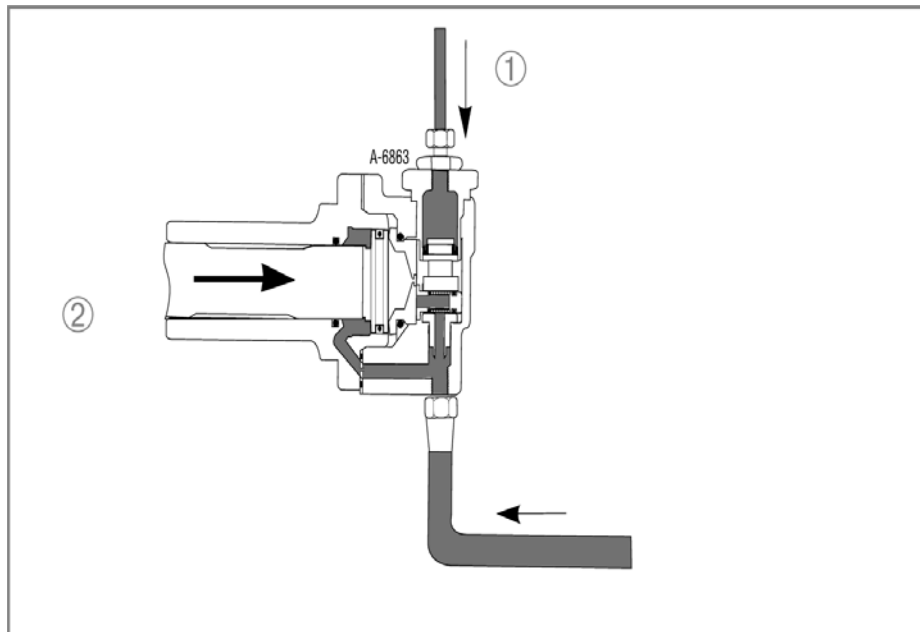
**Odd Numbered Gear Positions (1, 3, 5, 7, 9)** With the Roadranger valve button in the forward position, air is supplied to the splitter cylinder cover port (1), moving the piston rearward, disengaging splitter gearing (2).

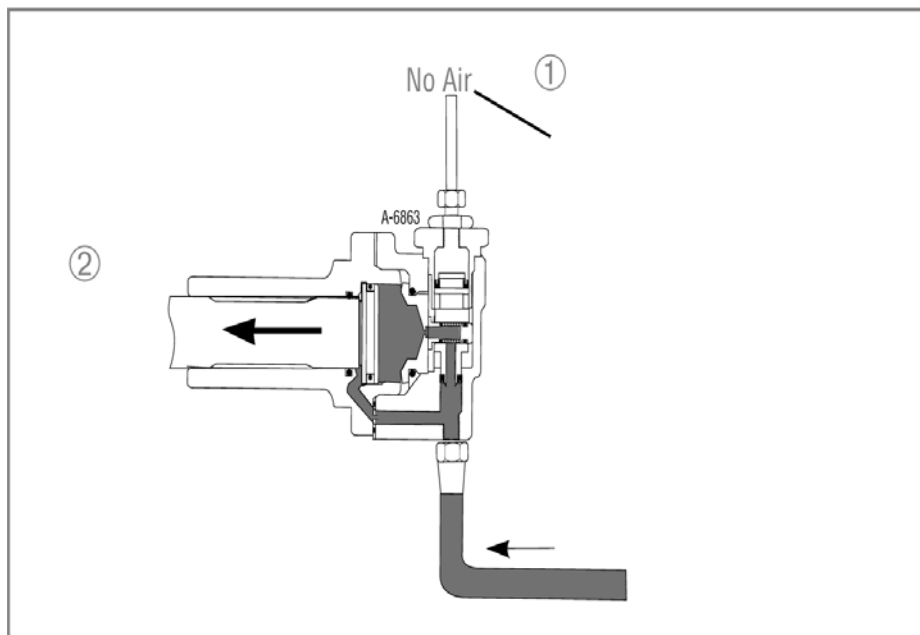
**Even Numbered Gear Positions (2, 4, 6, 8, 10)** With the Roadranger valve button in the rearward position, no air is supplied to the splitter cylinder cover port (1), moving the piston forward, engaging splitter gearing (2).

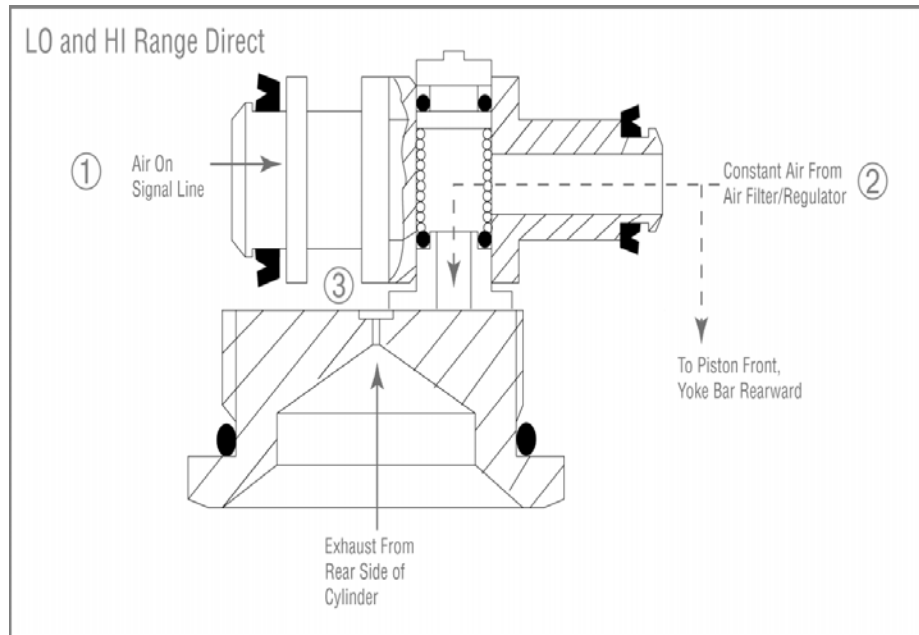
The spool valve components shown are part of a self-contained valve assembly, part number A-6863.

The spool valve piston travel is approximately 1/2". When air is supplied from the Roadranger valve to the valve spool left side (1), constant air from the filter/regulator (2) is supplied to the splitter cylinder piston front side moving the yoke bar rearward. Air is exhausted from the splitter cylinder rear (3) and from the breather situated on the valve assembly rear.

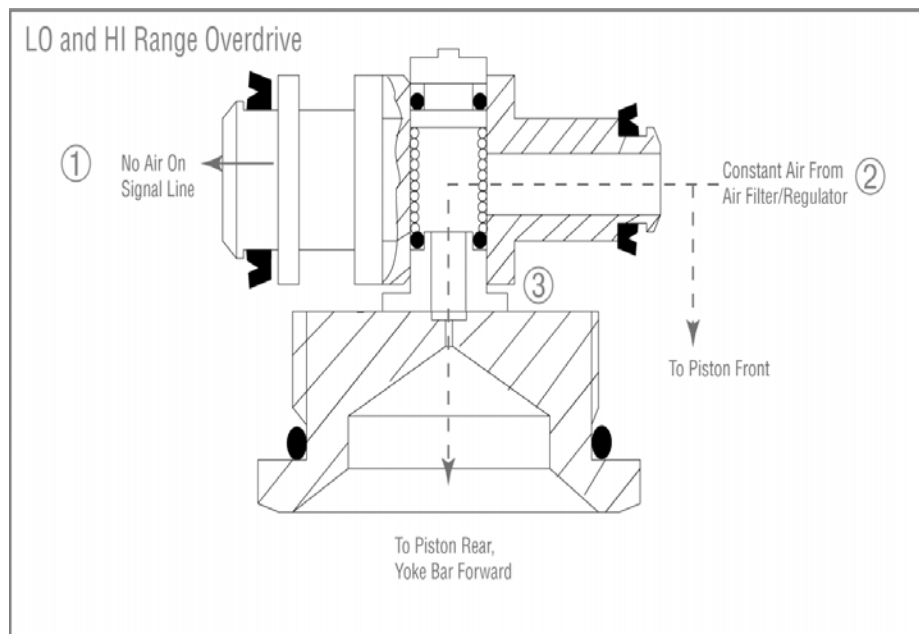
When no air is supplied from the Roadranger valve to the valve spool left side (1), constant air from the filter/regulator (2) is supplied to the splitter cylinder piston rear side moving the yoke bar forward. Air is exhausted from the splitter cylinder front (3) and from the breather situated on the valve assembly rear.

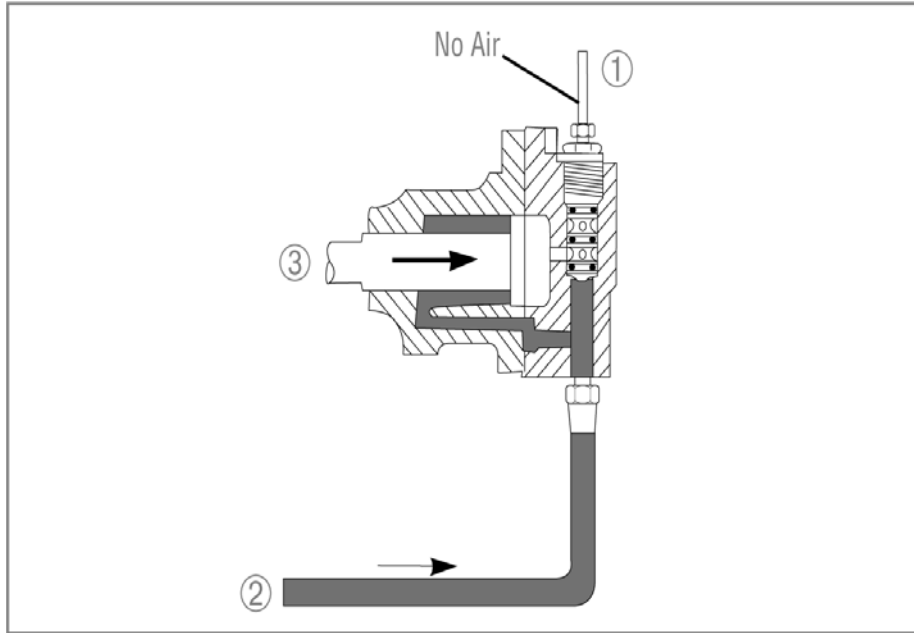
**LO Range or HI Range L** - With the splitter control button in the "rearward" position, no air is supplied to the splitter cylinder cover left port (1). The constant air from the air filter/regulator assembly (2) moves the splitter piston rearward, disengaging the front auxiliary gear (3).

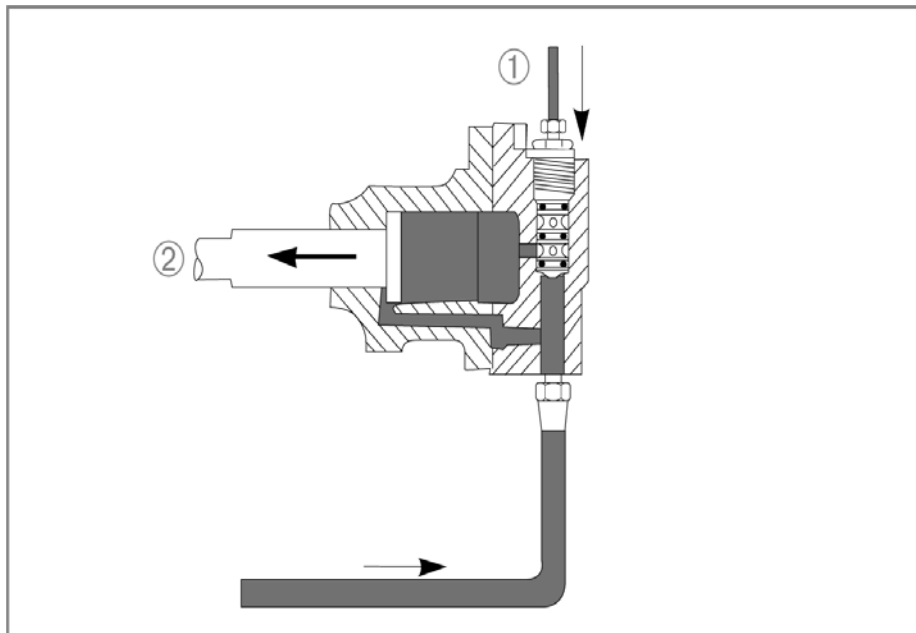
**HI Range H** - With the splitter control button in the "forward" position, air is supplied to the splitter cylinder cover left port (1), moving the splitter piston forward, engaging the front auxiliary drive gear (2).

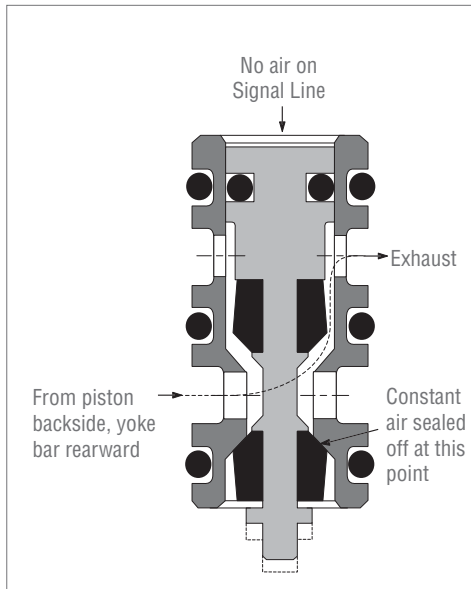
The insert valve is a self-contained 1-13/16" valve assembly located in the intermediate shift cylinder cover. It cannot be disassembled except for the three (3) O-rings on the outer diameter. The O-rings provide a stationary seal and do not move in the cylinder.

Insert valve piston travel is only 1/32". When no air is applied to the valve piston top side through the signal line, constant air supplied from the air filter/regulator moves the yoke bar rearward to engage the rear auxiliary drive gear (LO and HI range L), while air is exhausted out the insert valve.

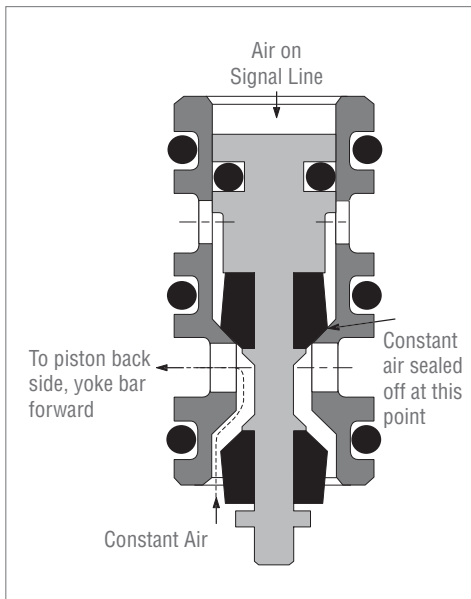
When air is applied to the valve piston top side, the piston moves down passing air through the insert valve bottom to the cylinder piston front and backside, moving the yoke bar forward to engage the front auxiliary drive gear (HI range H).
