## Troubleshooting Guide

# Fuller Transmissions TRTS0920

July 2011

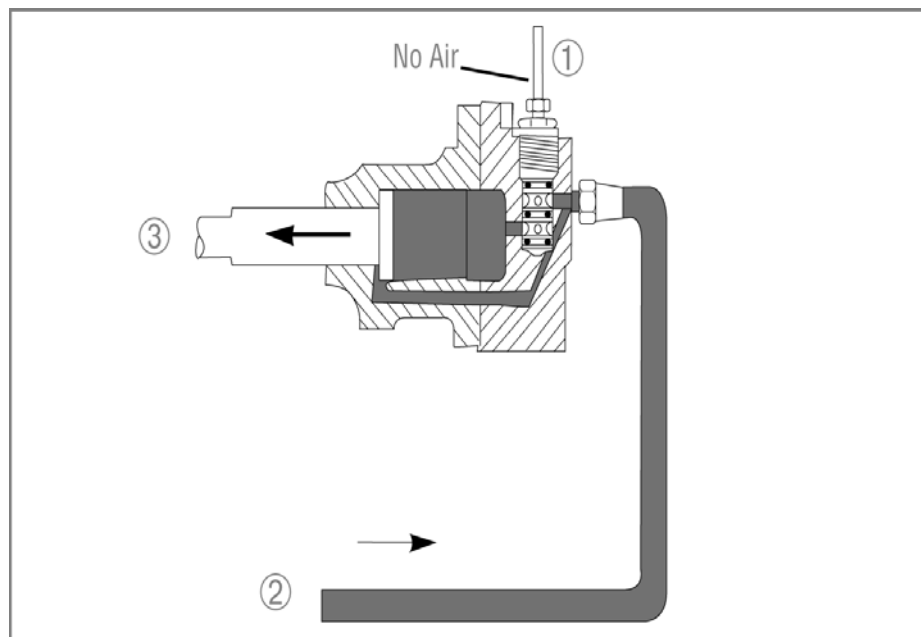
**LO Range or HI Range L** - With the splitter control button in the "rearward" position, no air is supplied to the splitter cylinder cover top port (1). The constant air from the air filter/regulator assembly (2) moves the splitter piston forward, disengaging the rear auxiliary drive gear (3).

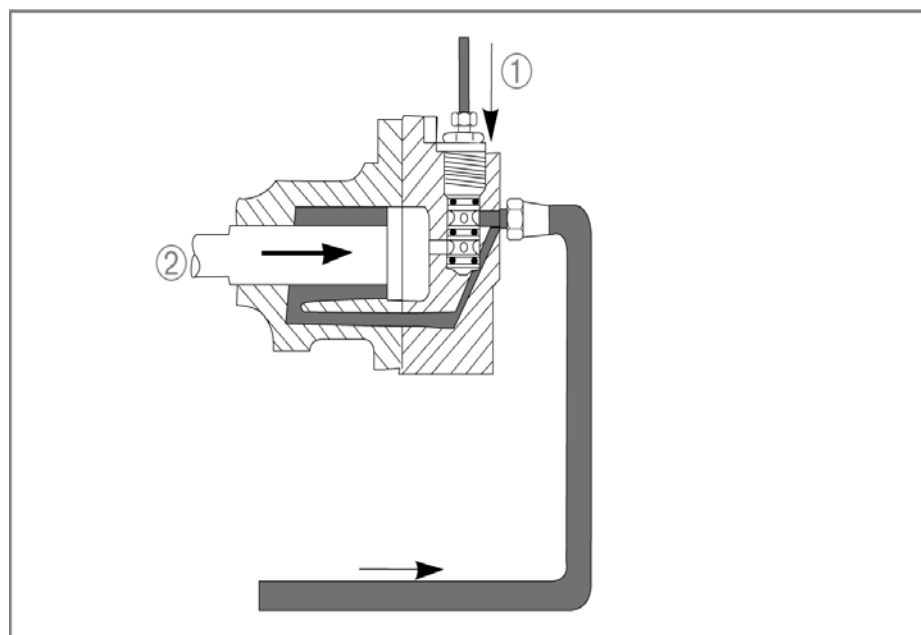
**HI Range H** - With the splitter control button in the "forward" position, air is supplied to the splitter cylinder cover top port (1), moving the splitter piston rearward, engaging the rear auxiliary drive gear (2).

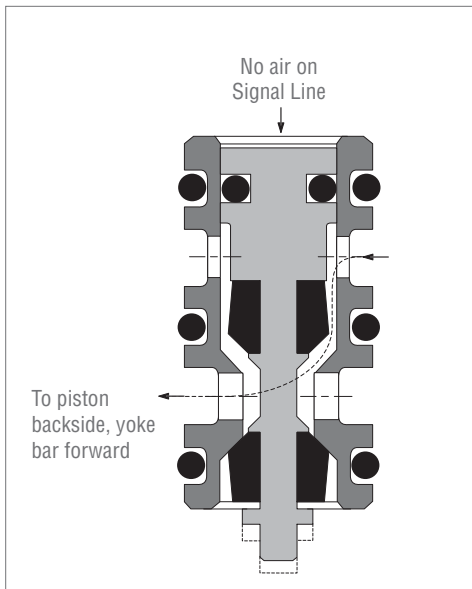
Insert valve piston travel is only 1/32". When no air is applied to the valve piston top side, constant air supplied from the air filter/regulator passes freely through the insert valve and to the cylinder piston backside, moving the yoke bar forward to disengage the rear auxiliary drive gear (LO range and HI range L).

The insert valve is a self-contained 1-13/16" valve assembly located in the intermediate shift cylinder cover. It cannot be disassembled except for the three (3) O-rings on the outer diameter. The O-rings provide a stationary seal and do not move in the cylinder.

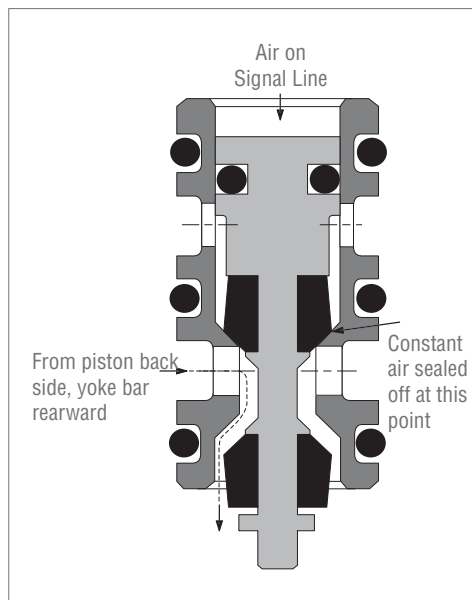
When air is applied to the valve piston top side through the signal line, the piston moves down to cut off air supplied to the cylinder piston backside. This air is exhausted out the cover bottom port as constant air supplied from the regulator is directed to the cylinder piston front side, moving the yoke bar rearward to engage the rear auxiliary drive gear (HI range H).

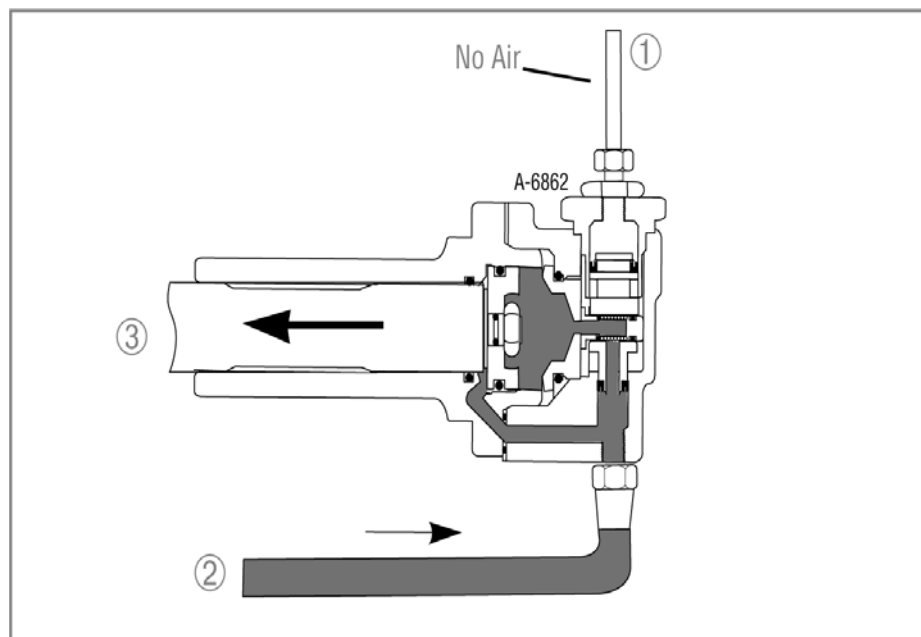
**LO Range or HI Range Low Split** - With the splitter control button in the "rearward" position, no air is supplied to the splitter cylinder cover top port (1). The constant air from the air filter/regulator assembly (2) moves the splitter piston rearward, disengaging the rear auxiliary drive gear (3).

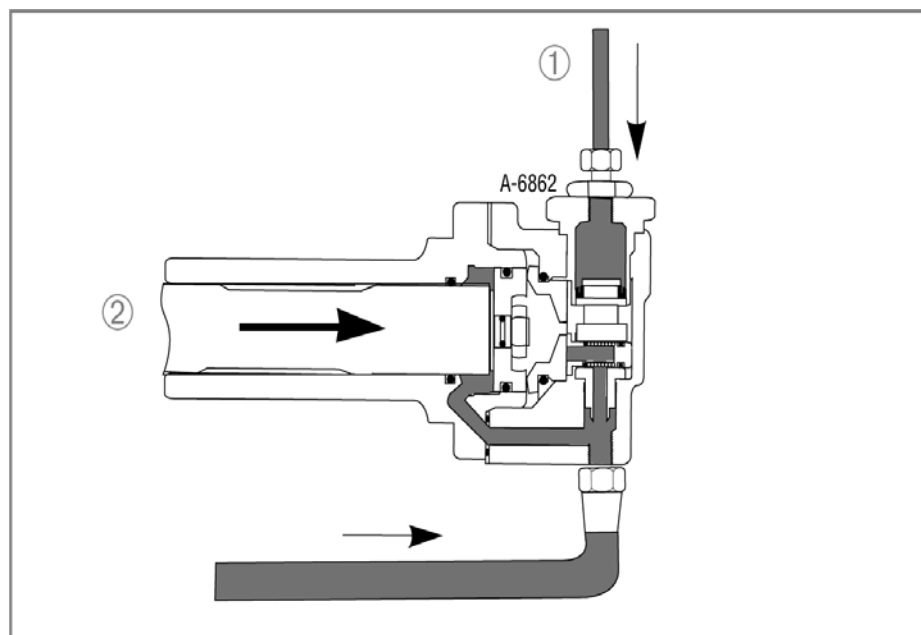
**HI Range High Split** - With the splitter control button in the "forward" position, air is supplied to the splitter cylinder cover top port (1), moving the splitter piston forward, engaging the rear auxiliary drive gear (2).

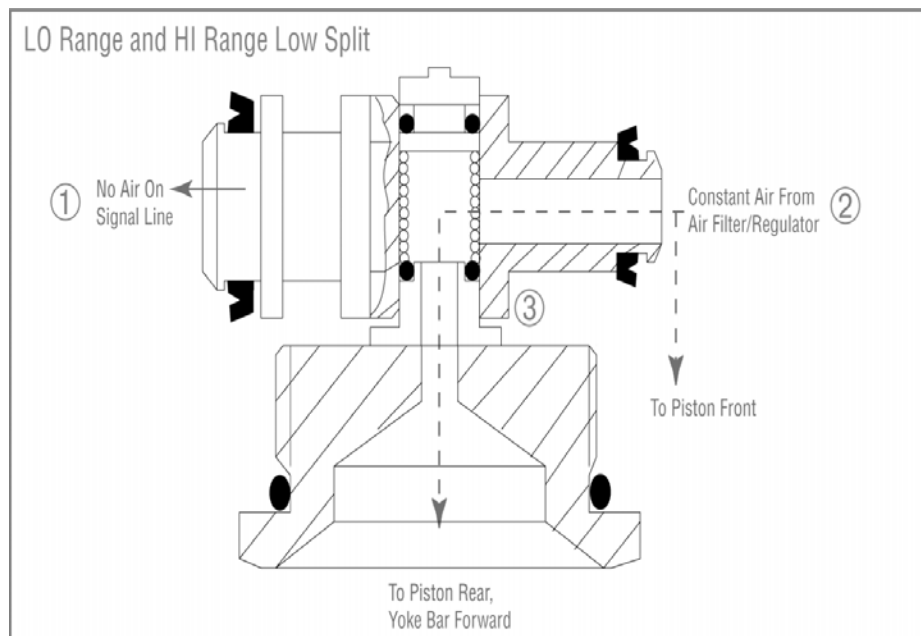
The spool valve piston travel is approximately 1/2". When no air is supplied from the Roadranger valve to the valve spool left side (1), constant air from the filter/regulator (2) is supplied to the splitter cylinder piston rear side moving the yoke bar forward.

The spool valve components shown are part of a self-contained valve assembly, part number A-6862.

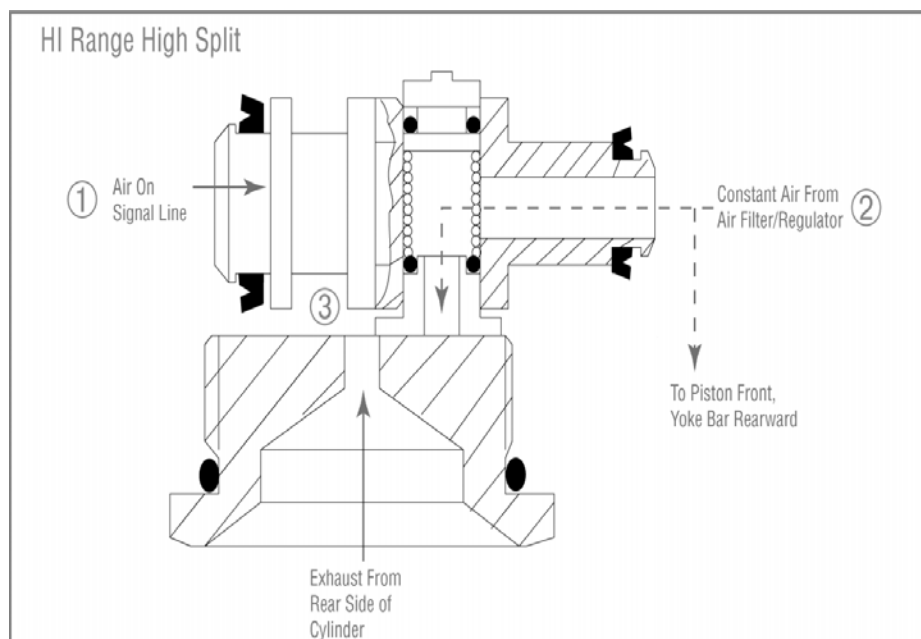
When air is supplied from the Roadranger valve to the valve spool left side (1), constant air from the filter/regulator (2) is supplied to the splitter cylinder piston front side moving the yoke bar rearward. Air is exhausted from the splitter cylinder rear (3) and from the breather situated on the valve assembly rear.

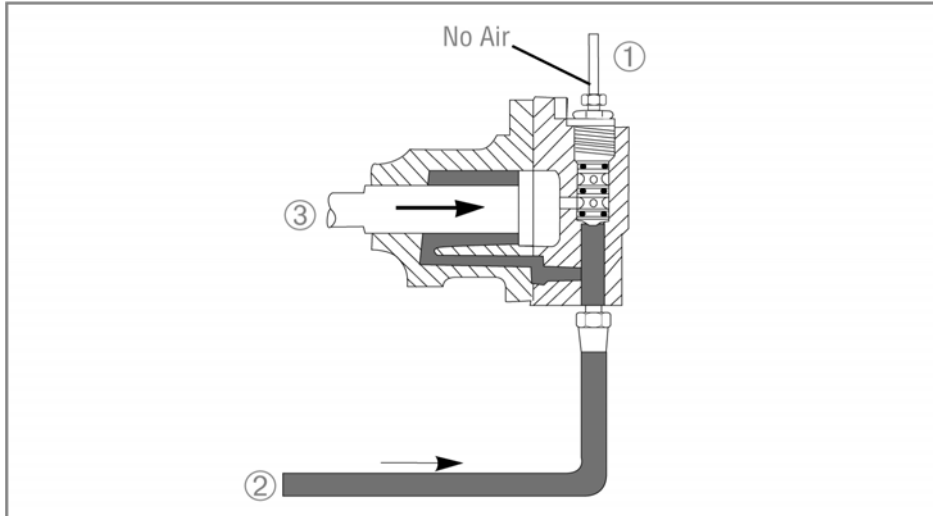
**LO or HI Range L** - With the splitter control button in the "rearward" position, no air is supplied to the splitter cylinder cover left port (1). The constant air from the air filter/regulator assembly (2) moves the splitter piston rearward, disengaging the front auxiliary drive gear (3).

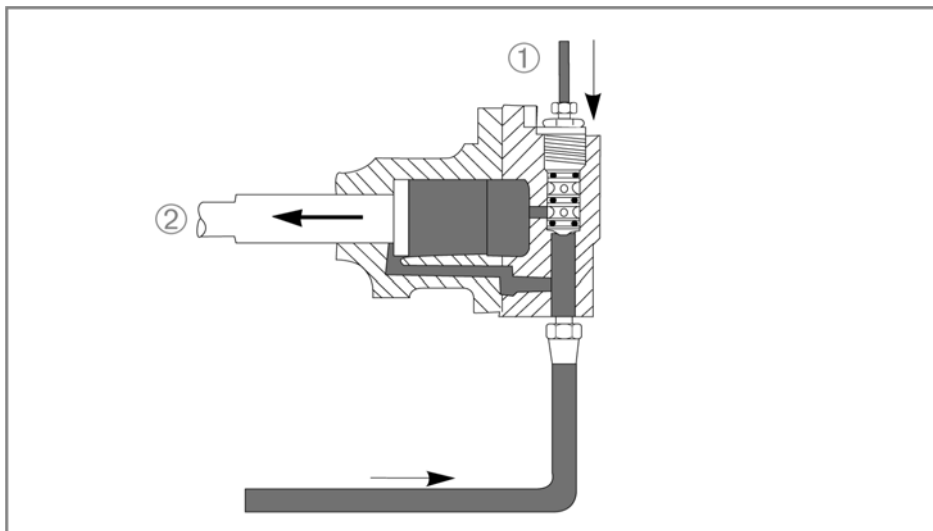
**LO or HI Range H** - With the splitter control button in the "forward" position, air is supplied to the splitter cylinder cover left port (1), moving the splitter piston forward, engaging the front auxiliary drive gear (2).

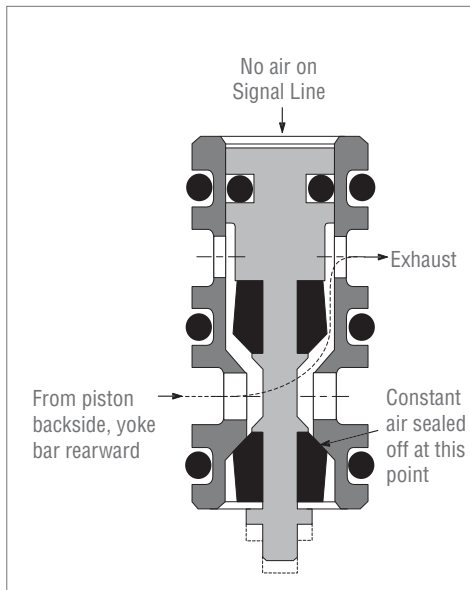
Insert valve piston travel is only 1/32". When no air is applied to the valve piston top side through the signal line, constant air supplied from the air filter/regulator moves the yoke bar rearward to engage the rear auxiliary drive gear (LO and HI range L), while air is exhausted out the insert valve.

The insert valve is a self-contained 1-13/16" valve assembly located in the intermediate shift cylinder cover. It cannot be disassembled except for the three (3) O-rings on the outer diameter. The O-rings provide a stationary seal and do not move in the cylinder.

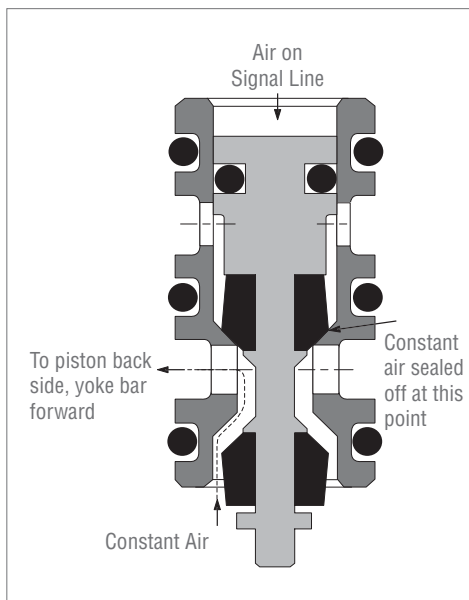
When air is applied to the valve piston top side, the piston moves down passing air through the insert valve bottom to the cylinder piston front and backside, moving the yoke bar forward to engage the front auxiliary drive gear (LO range and HI range H).

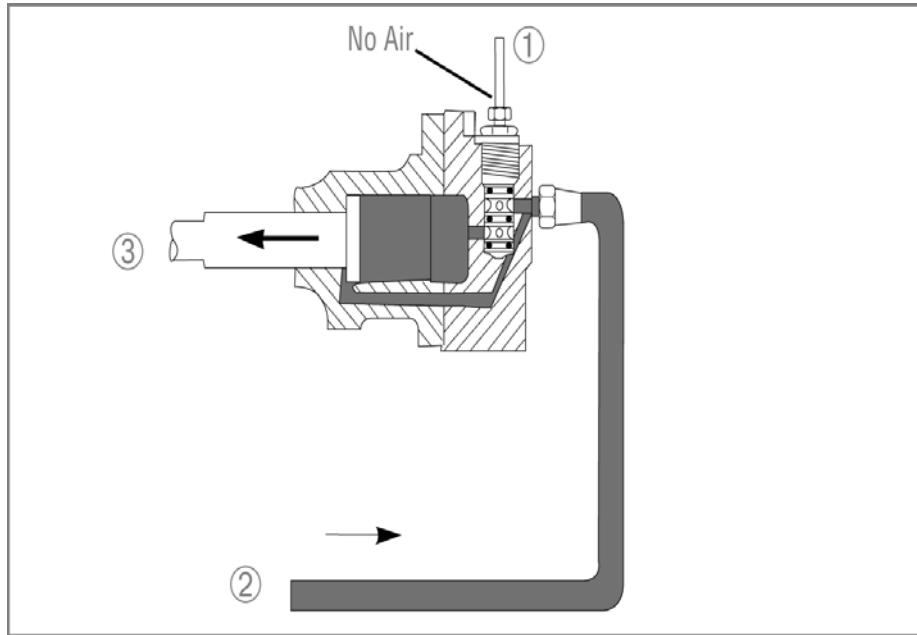
**LO Range or HI Range L** - With the splitter control button in the "rearward" position, no air is supplied to the splitter cylinder cover top port (1). The constant air from the air filter/regulator assembly (2) moves the splitter piston forward, disengaging the rear auxiliary drive gear (3).

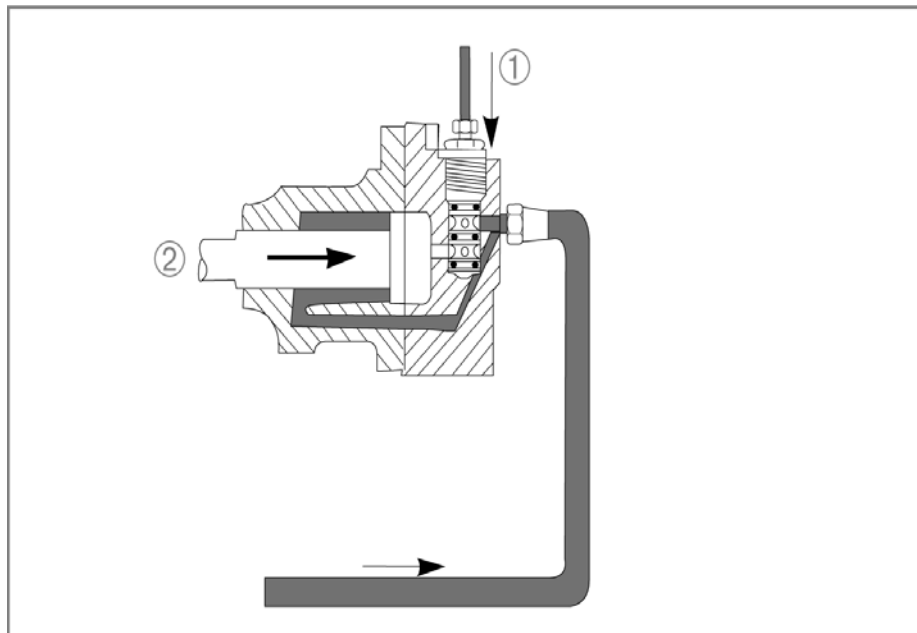
**LO Range or HI Range H** - With the splitter control button in the "forward" position, air is supplied to the splitter cylinder cover top port (1), moving the splitter piston rearward, engaging the rear auxiliary drive gear (2).

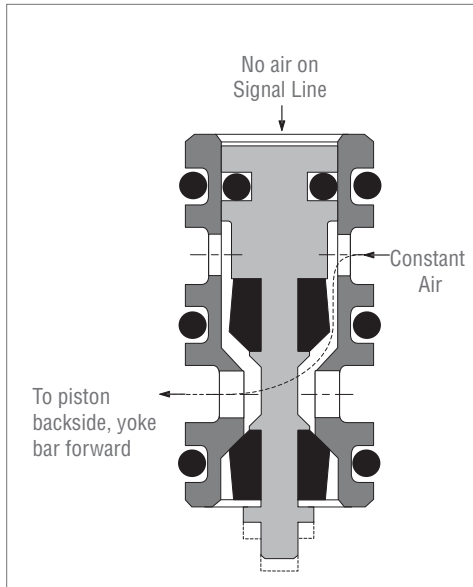
Insert valve piston travel is only 1/32". When no air is applied to the valve piston top side, constant air supplied from the air filter/regulator passes freely through the insert valve and to the cylinder piston backside, moving the yoke bar forward to disengage the rear auxiliary drive gear (LO range and HI range L).

The insert valve is a self-contained 1-13/16" valve assembly located in the intermediate shift cylinder cover. It cannot be disassembled except for the three (3) O-rings on the outer diameter. The O-rings provide a stationary seal and do not move in the cylinder.

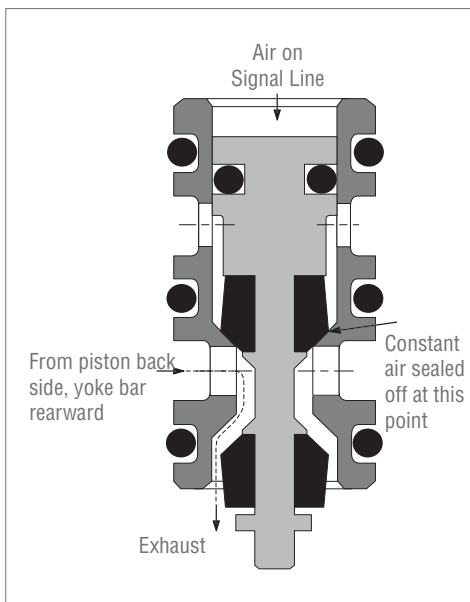
When air is applied to the valve piston top side through the signal line, the piston moves down to cut off air supplied to the cylinder piston backside. This air is exhausted out the cover bottom port as constant air supplied from the regulator is directed to the cylinder piston front side, moving the yoke bar rearward to engage the rear auxiliary drive gear (LO range and HI range H).

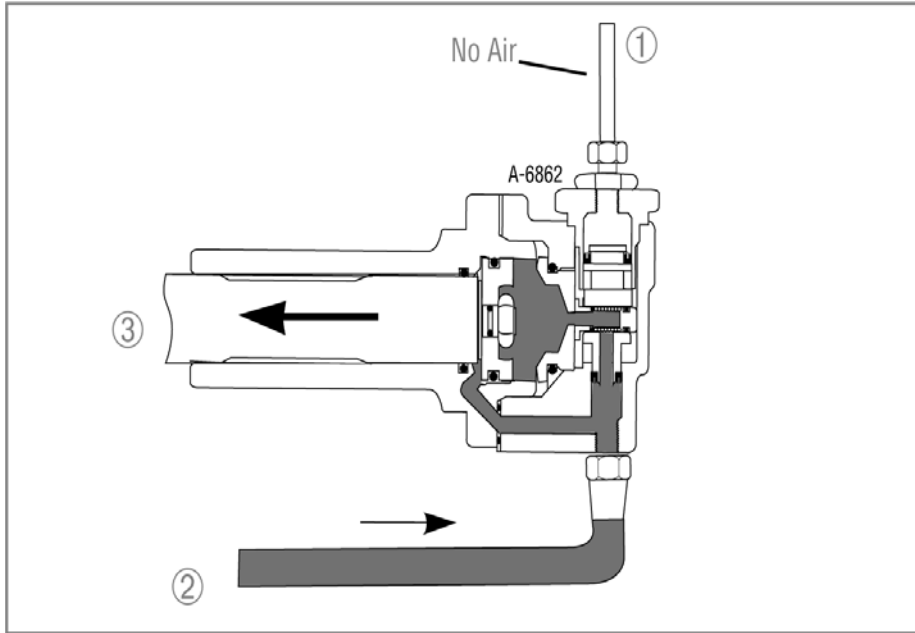
**LO Range or HI Range Low Split** - With the splitter control button in the "rearward" position, no air is supplied to the splitter cylinder cover top port (1). The constant air from the air filter/regulator assembly (2) moves the splitter piston forward, disengaging the rear auxiliary drive gear (3).

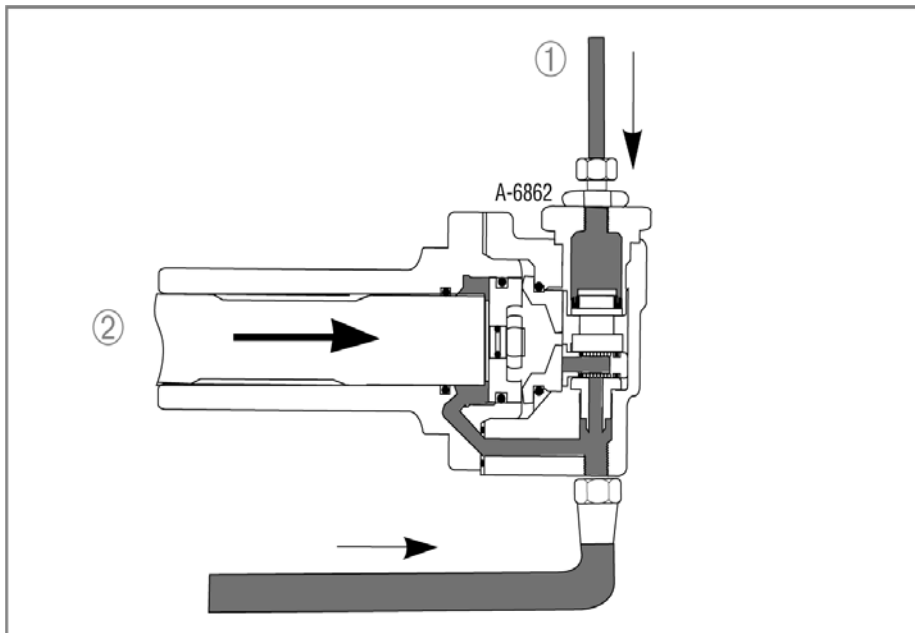
**LO Range or HI Range High Split** - With the splitter control button in the "forward" position, air is supplied to the splitter cylinder cover top port (1), moving the splitter piston rearward, engaging the rear auxiliary drive gear (2).

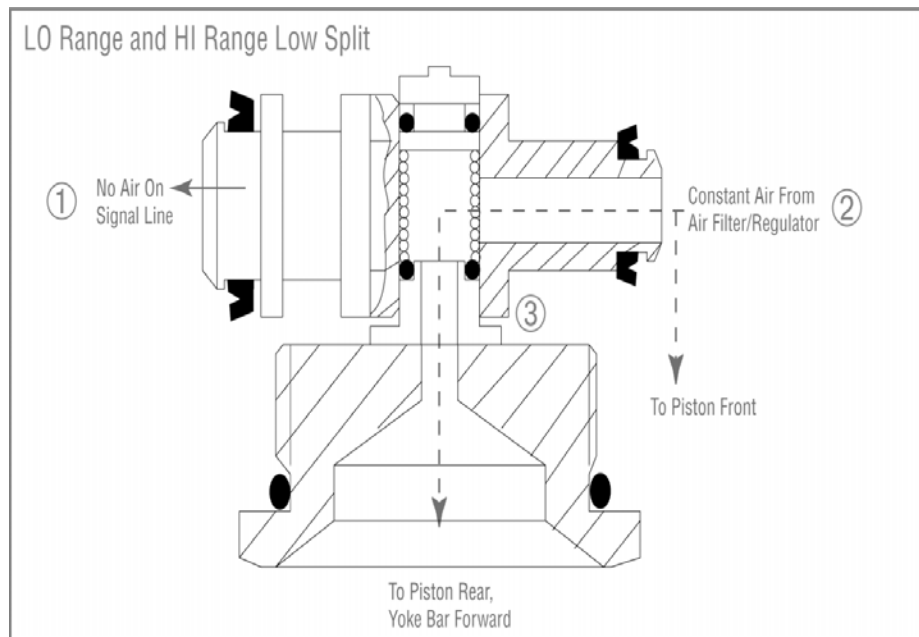
The spool valve piston travel is approximately 1/2". When no air is supplied from the Roadranger valve to the valve spool left side (1), constant air from the filter/regulator (2) is supplied to the splitter cylinder piston rear side moving the yoke bar forward. Air is exhausted from the splitter cylinder front (3) and from the breather situated on the valve assembly rear.

The spool valve components shown are part of a self-contained valve assembly, part number A-6862.

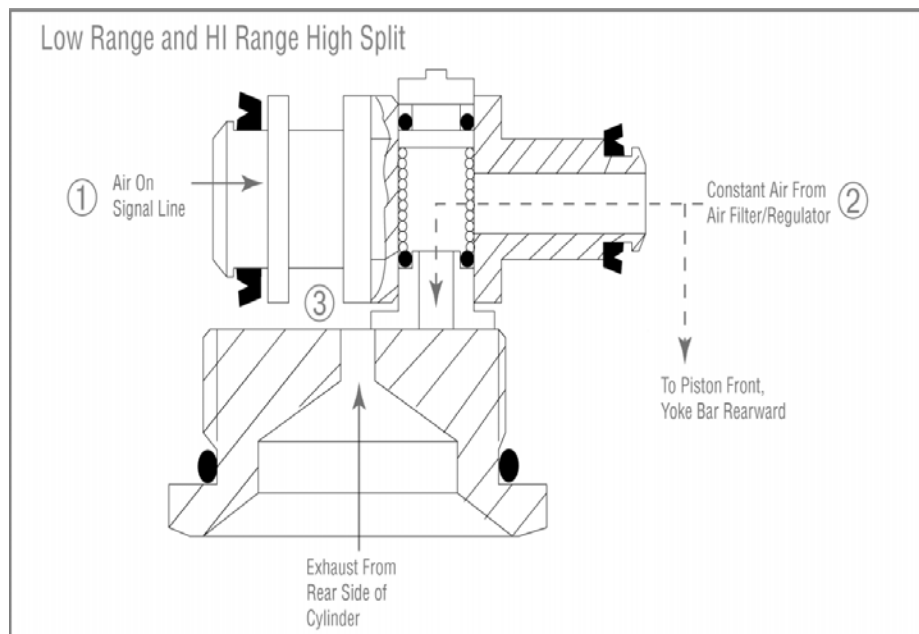
When air is supplied from the Roadranger valve to the valve spool left side (1), constant air from the filter/regulator (2) is supplied to the splitter cylinder piston front side moving the yoke bar rearward. Air is exhausted from the splitter cylinder rear (3) and from the breather situated on the valve assembly rear.
