# TECHNICIANS' GUIDE

# INSPECTION AND ANALYSIS OF THE ALLISON 4000/B 500 PRODUCT FAMILIES

**NOTICE:** This guide is intended for use by technicians skilled in diagnosis and repair of automatic transmissions. Contact an authorized Allison Transmission service outlet for further information or clarification if required. All specifications provided in this manual are subject to change without notice.

The Technicians' Guide is intended to provide additional guidance with the inspection and analysis of transmission parts. This guide should be used by technicians who overhaul Allison 4000/B 500 automatic transmissions in conjunction with the 4000/B 500 Service Manual (SM2457EN) when inspecting parts to determine their serviceability and reuse.

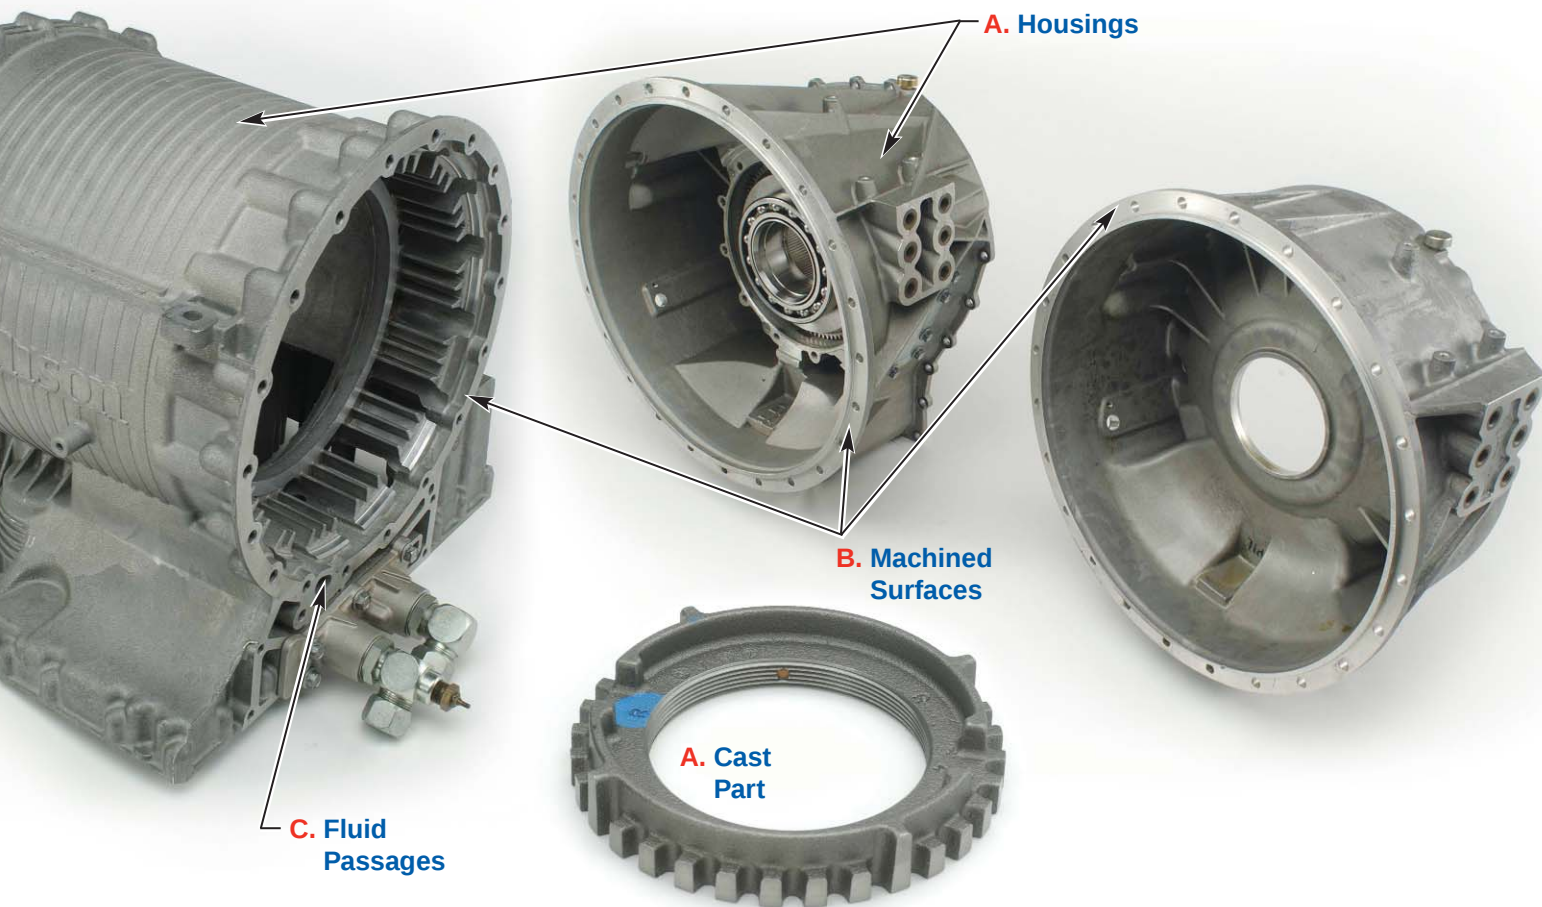
**A.** Replace housings or other cast parts that are cracked or broken. Inspect clutch housing sealing surfaces for imperfections that could damage the piston seals or interfere with mating parts. Inspect threaded holes for bad threads. Clean damaged threads with the correct size tap.

**B.** Inspect all machined surfaces for damage that could cause fluid leakage. Inspect mounting faces and bores for damage.

**C.** Inspect all fluid passages for obstructions, porosity, broken lands, cracks and land surface imperfections.

**D.** Replace housings that have splines worn beyond wear limits. Refer to the Wear Limits Table (7-1) in Service Manual SM2457EN.

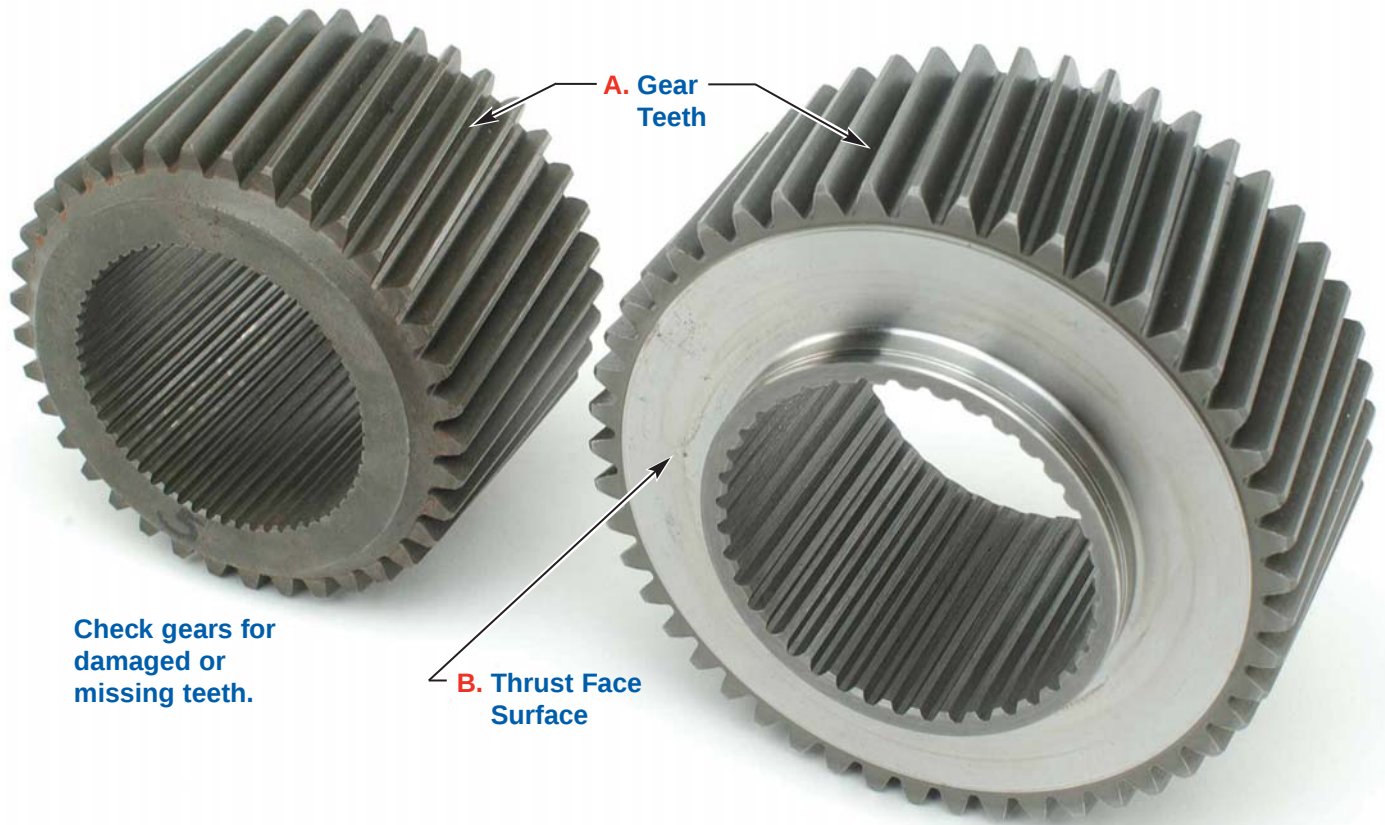
Check gears for damaged or missing teeth.

**A. Gear Teeth**

**B. Thrust Face Surface**

**A.** Inspect gears for damaged or broken teeth. Inspect gear teeth for wear that has changed the original tooth shape. If this condition is noted, replace the gear. Inspect gears for load pattern and signs of distress. Any signs of distress indicate the gear may fail during operation. Reusing distressed gears is an individual customer decision based on experience. Backlash cannot be used to establish critical gear wear. Pits, scuffs, scores or galling are typically evident long before backlash exceeds specification.

**B.** Inspect the thrust face of gears for damage. If these defects cannot be removed with a soft stone, replace the gear.

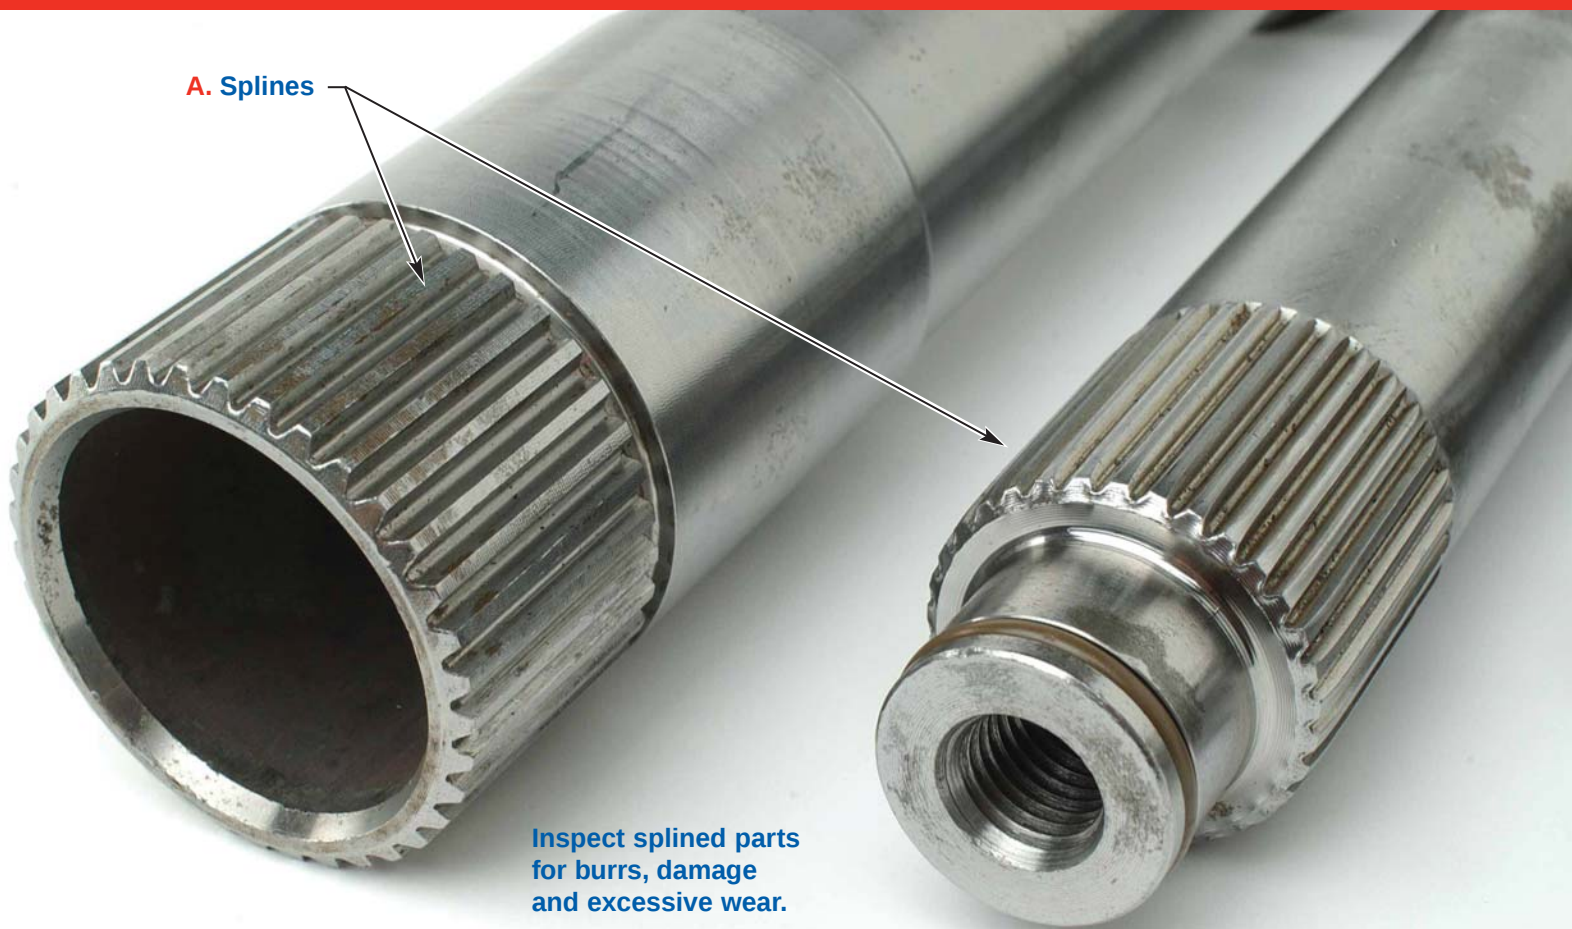
**A.** Inspect splined parts for damage. Remove burrs with a soft stone. Spline wear is not considered harmful except where it affects the fit of the splined parts. Spline wear is determined by comparing feeler gauge thickness with the thickness of the worn area on the spline. Replace parts having excessive spline wear. The maximum movement allowed at the splines is

0.38 mm (0.015 inches) if not otherwise listed in Wear Limits Table 7-1 in Service Manual SM2457EN. Do not reuse a splined part that exceeds the published maximum spline wear. Backlash cannot be used to establish critical spline wear. Accurate backlash measurement requires the mating parts to be concentrically located.

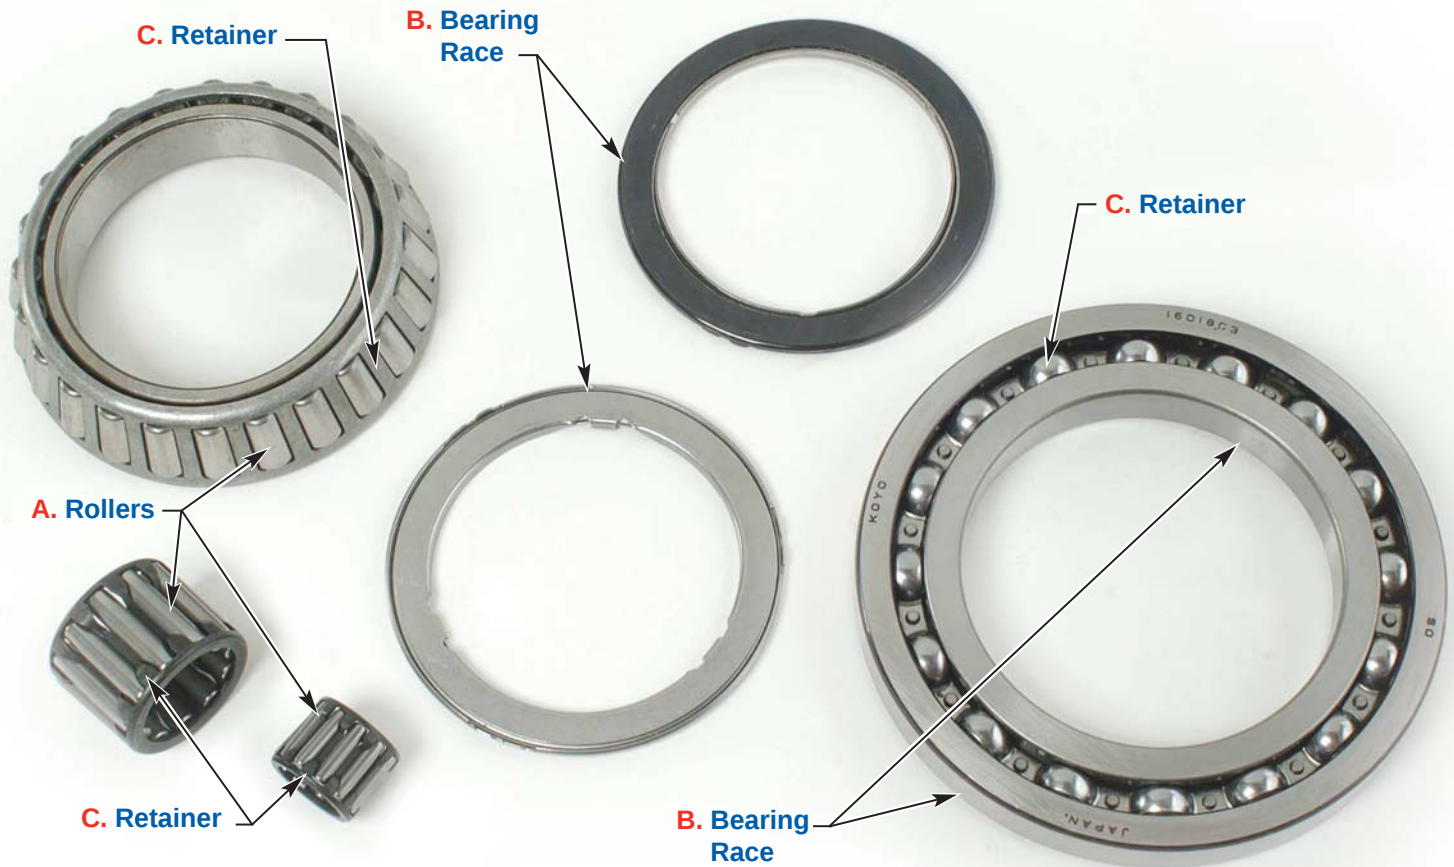
**A.** Replace the bearing if any rollers/balls are rusted. Replace the bearing if balls/rollers have a feeling of looseness in the retainer or race compared to a new bearing. Replace the bearing if balls/rollers are discolored from heat, lack of lubrication or debris lapping in the balls/rollers. Replace the bearing if the balls/rollers are worn, galled or abraded. Replace the bearing if it catches or feels rough after being thoroughly cleaned.

**B.** Replace the bearing if any races are rusted. Replace the bearing if the bearing balls/rollers have a feeling of looseness in the raceway compared to a new

bearing. Replace the bearing if races are discolored from heat, lack of lubrication or debris lapping in the race. Replace the bearing if the races are worn, galled or abraded. Replace the bearing if it catches or feels rough after being thoroughly cleaned.

**C.** Replace the bearing if any retainer or retainer clip is fractured, bent, dented or missing. Replace the bearing if any retainer is rusted. Replace the bearing if there is a feeling of looseness between the retainer and ball/roller compared to a new bearing. Replace the bearing if it catches or feels rough after being thoroughly cleaned.

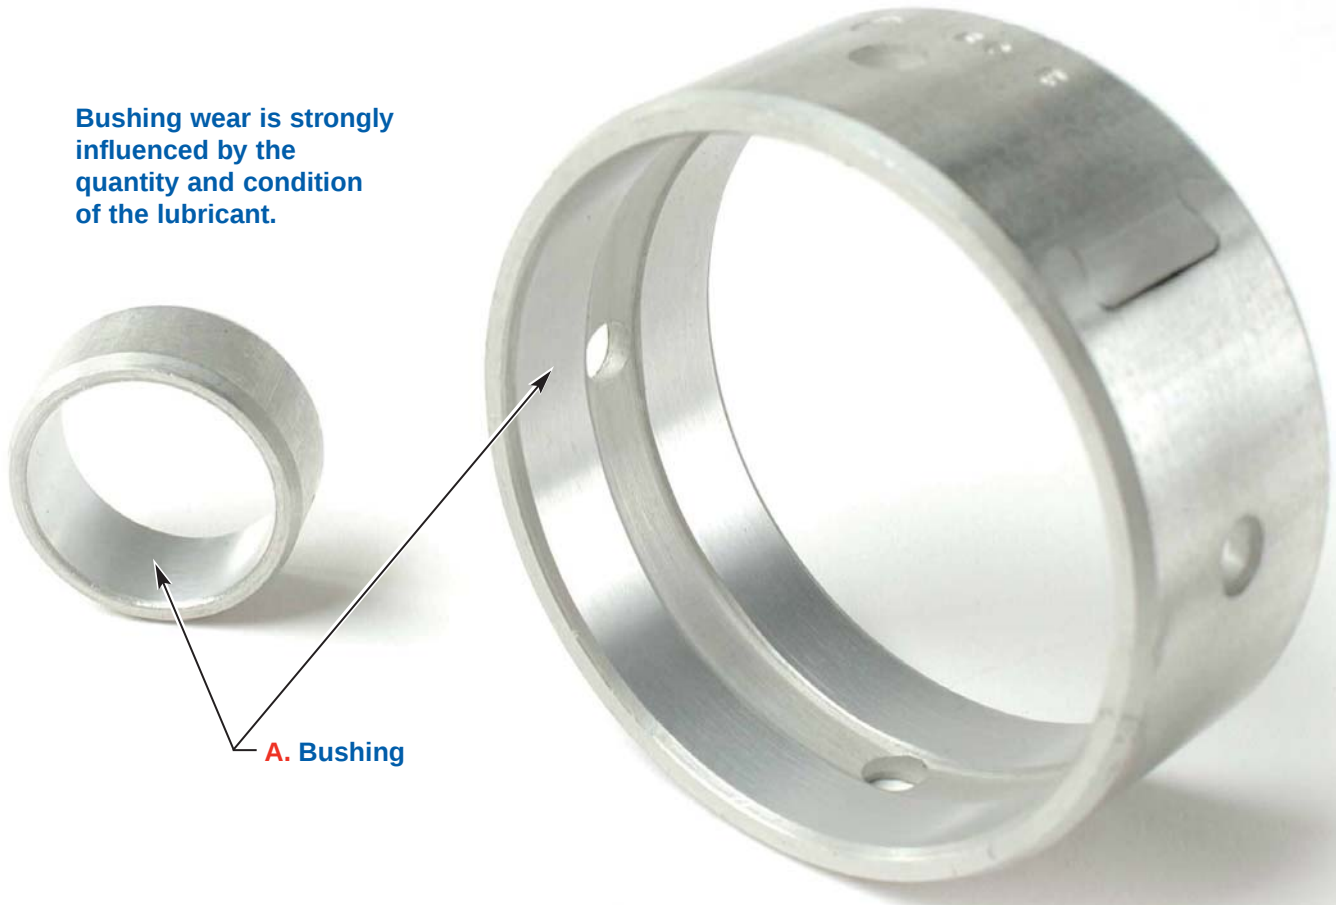
**A. Bushing**

**A.** Inspect bushings for wear beyond service limits. Replace any bushing which is excessively worn. Inspect bushings for discoloration and surface damage due to lack of lubrication. Replace any bushing which is damaged.

Mechanically, bushings are the simplest type of journal bearing and are often referred to as “plain” bearings. A bushing is simply a sleeve of bearing material, such as bronze or aluminum, in which a component rides. Bushing wear is strongly influenced by the quantity and condition of the lubricant. Bushing bearing surfaces are sometimes grooved to better distribute lubrication across the bearing surface.

Some bushings are susceptible to material leaching. This can be caused by oxidized oil that has turned acidic combined with heat and mechanical loading. The TAN (Total Acid Number) of the transmission oil should not change by more than 3 from the baseline (new fluid) TAN. Changing transmission oil per recommended change intervals or based on a successful oil sampling program will help prevent material leaching.

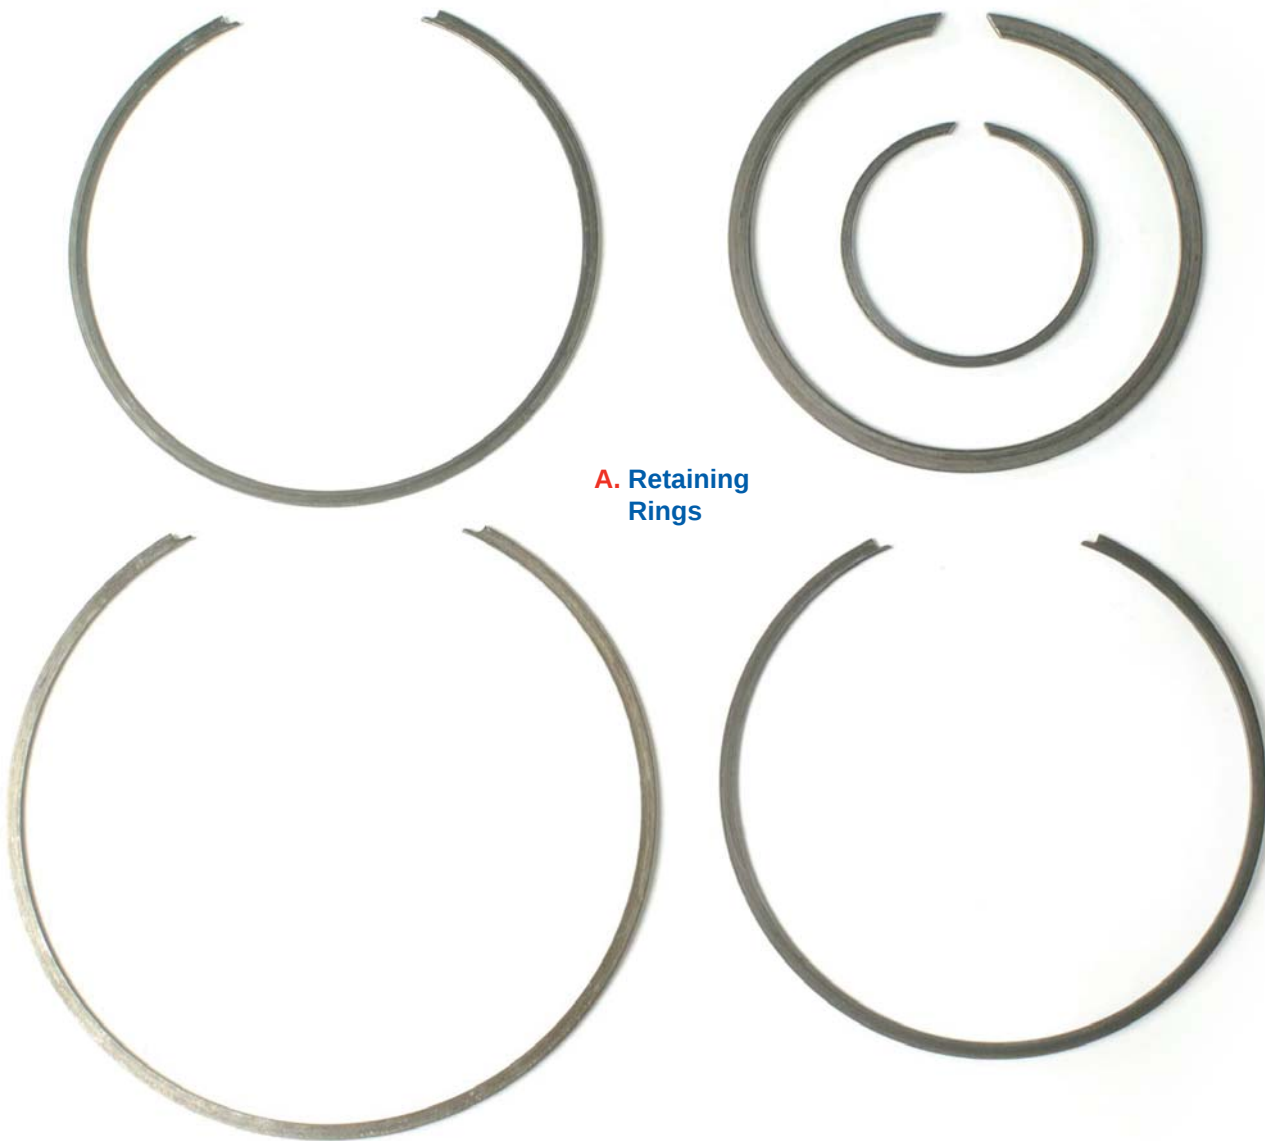
**A. Retaining  
Rings**

**A.** Inspect retaining rings for damage, distortion and excessive wear. Replace retaining rings if damage cannot be repaired using a soft stone or crocus cloth.

**Examine retaining  
rings for damage,  
distortion or  
excessive wear.**

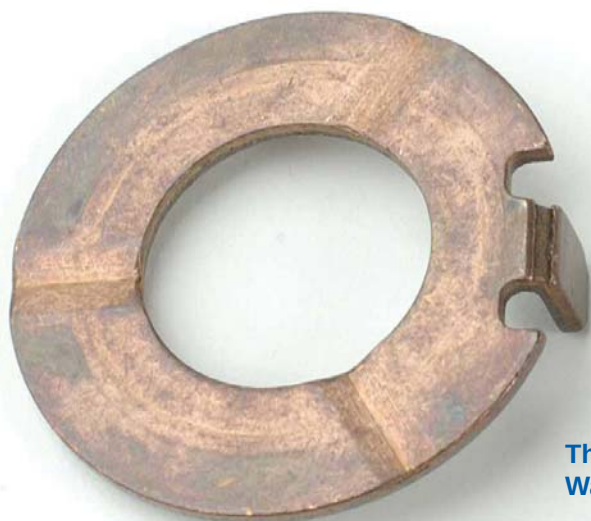
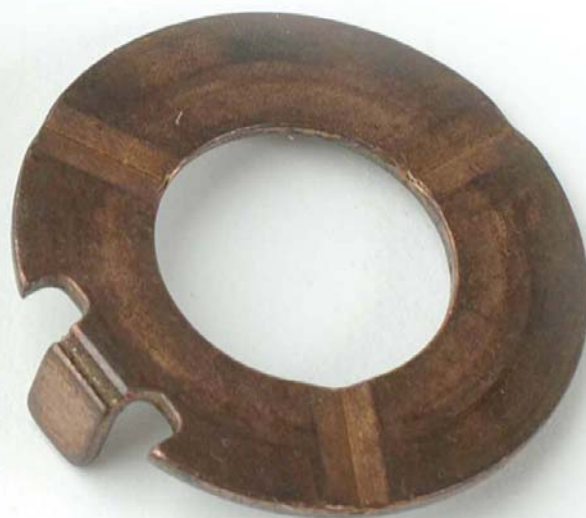
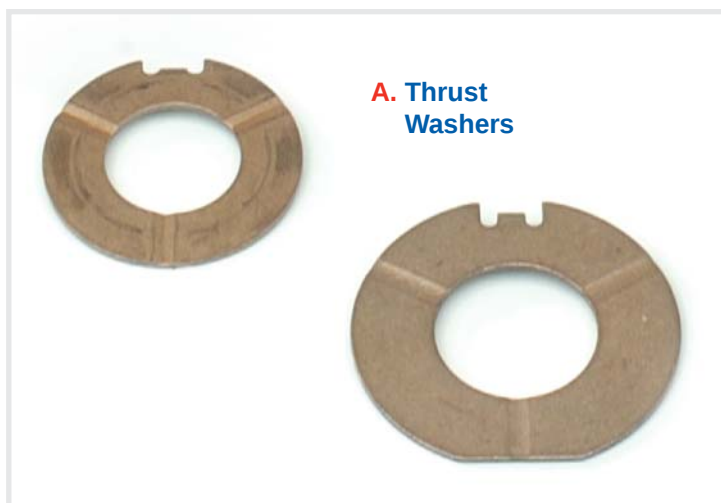
A. Thrust Washers

Thrust Washers

**A.** Replace thrust washers if they are worn beyond service limits. Replace thrust washers if they are galled, abraded or distorted. Replace thrust washers if they are damaged due to a lack of lubrication.

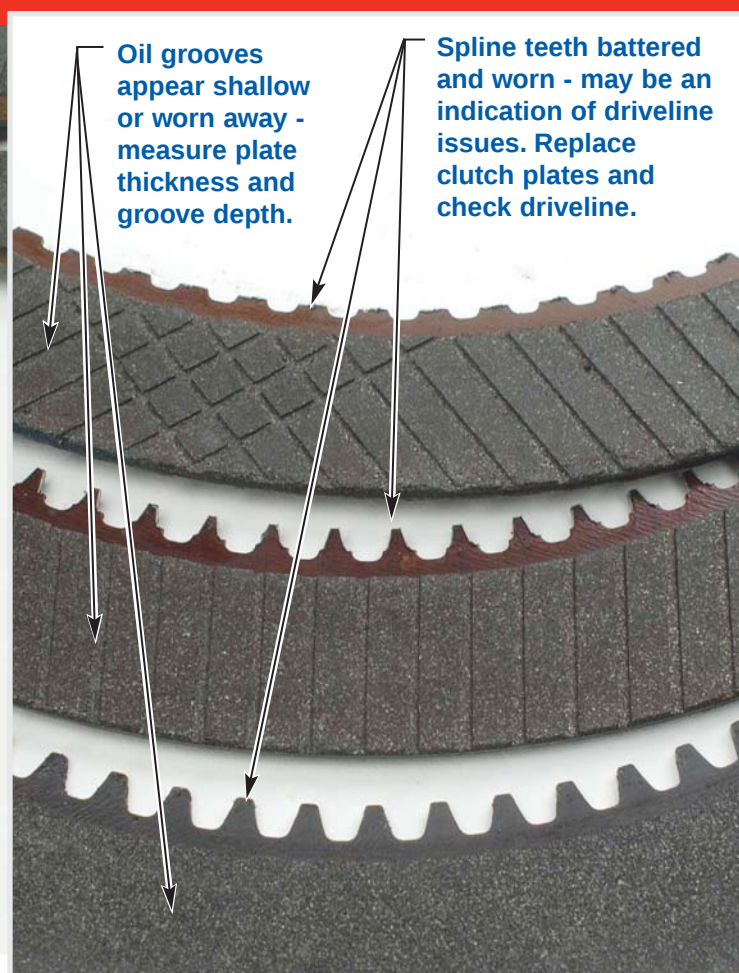
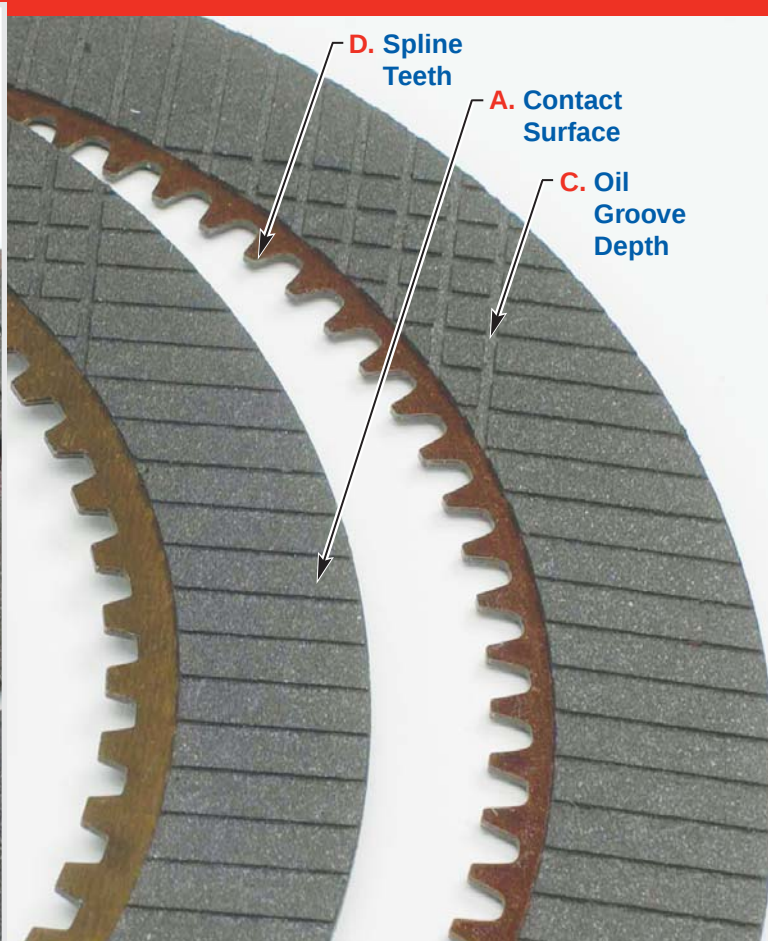
**A.** Inspect friction plate contact faces and splines for excessive wear, damage and coning. Inspect the plates for burrs, pitted faces, cracks, distortion and damaged spline teeth.

**B.** Measure friction plate thickness and coning. Reference the Service Manual for minimum thickness and maximum coning specifications. Do not reuse friction plates that do not meet published specifications. If reused plates are slightly coned (within specification), make sure each plate is stacked with the cone facing the same direction.

**C.** Measure friction plate oil groove depth. Replace any plates that are not within Service Manual minimum groove depth specification.

**D.** Inspect spline teeth for excessive wear and battering. Replace the clutch plate if damage cannot be repaired using a soft

stone or crocus cloth. Replace the clutch plate if spline teeth are broken or missing.

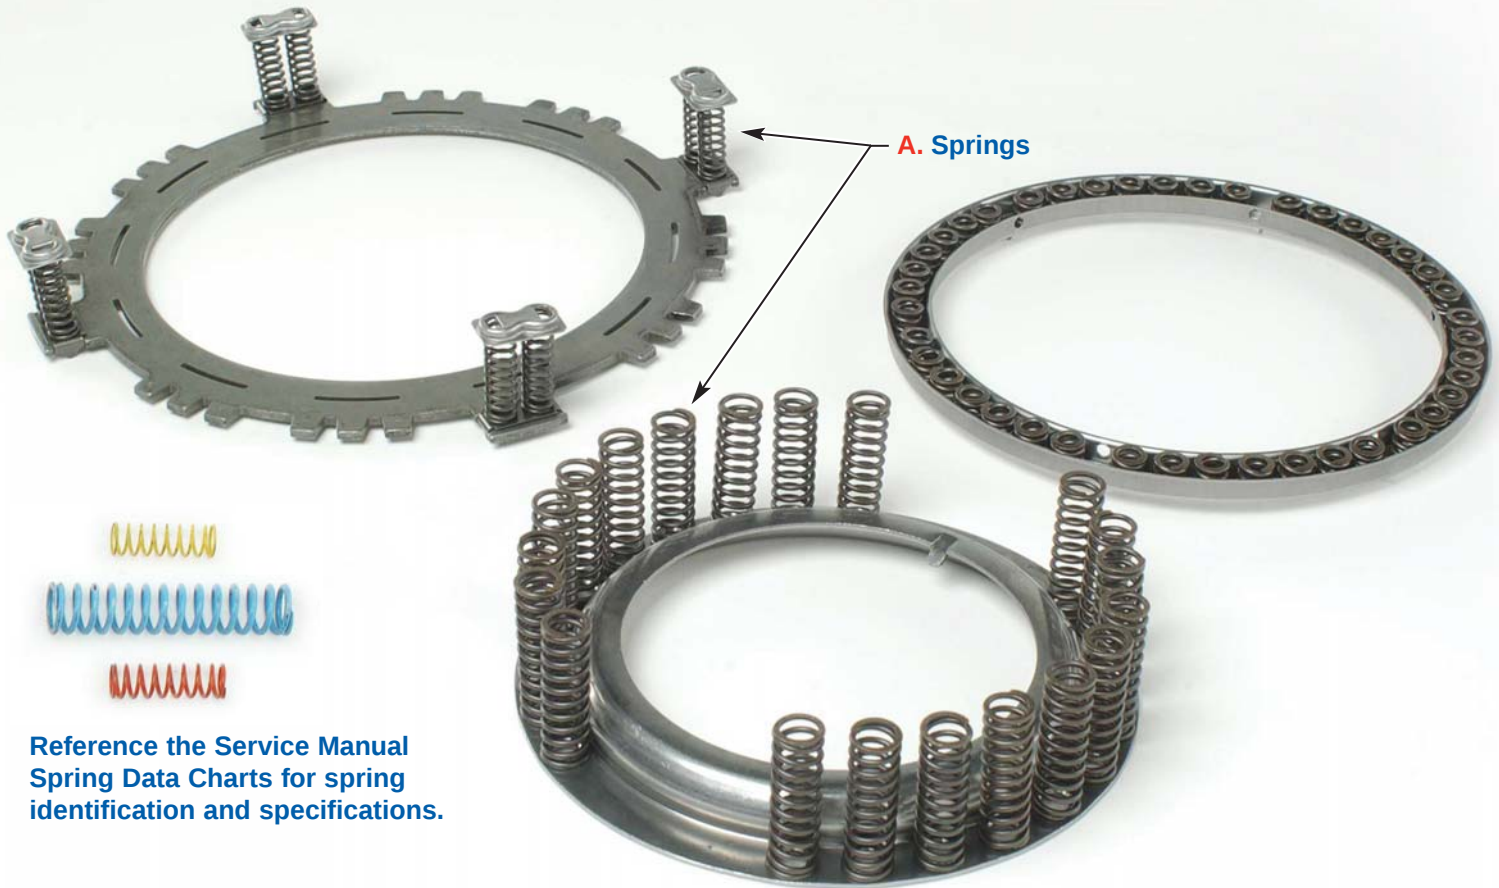
**A.** Inspect springs for permanent set and wear due to rubbing adjacent parts. Replace the spring if any of these defects are identified or if the spring fails to meet published service limits. Reference the Spring Data Charts in Service Manual SM2457EN for spring identification and service limit specifications.

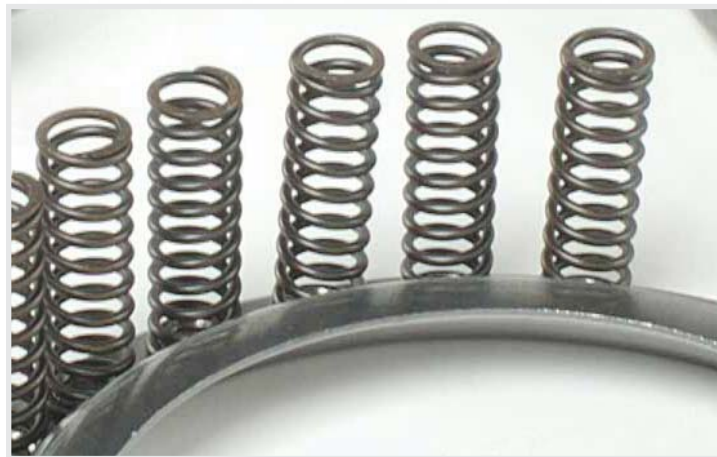
Inspect springs for signs of overheating, permanent set or wear due to rubbing adjacent parts.

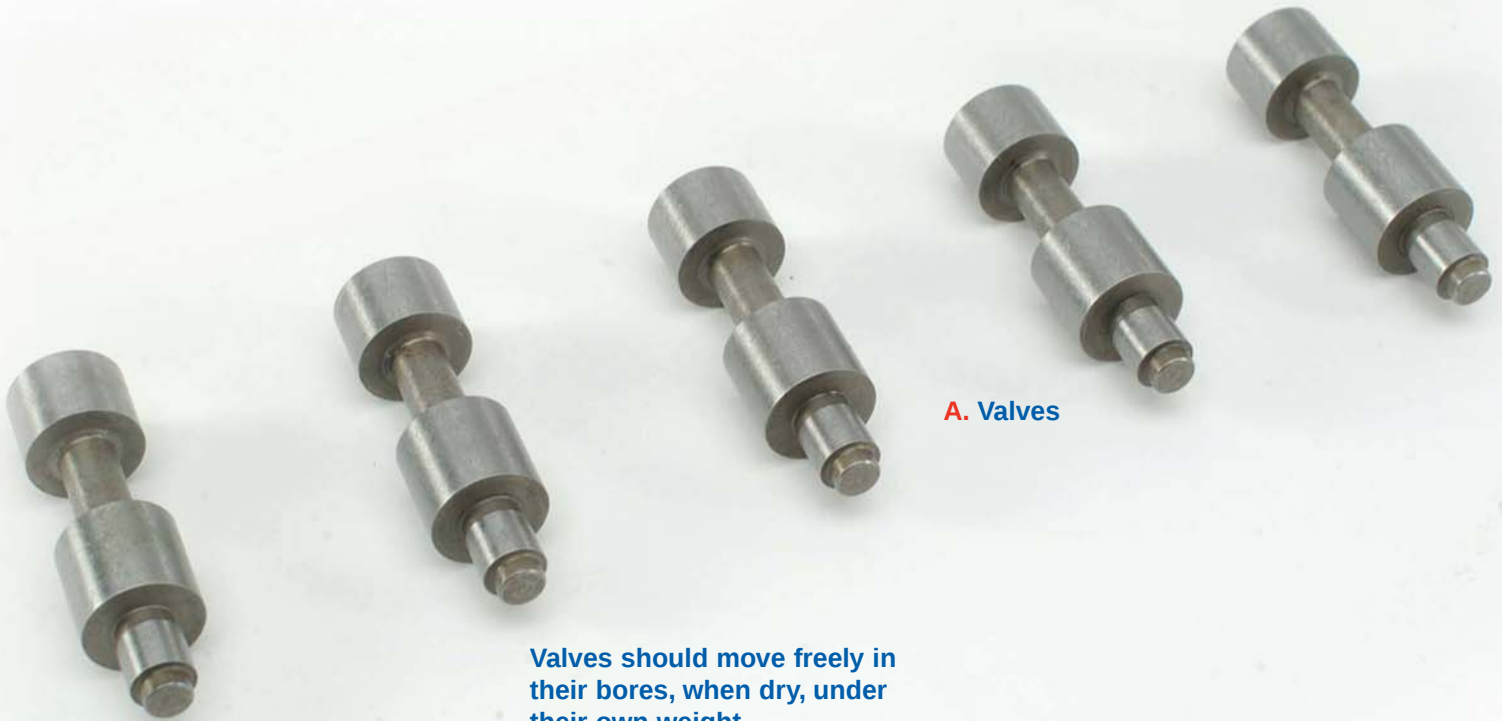
A. Valves

Valves should move freely in their bores, when dry, under their own weight.

**A.** Valves must be free of nicks, burrs and scoring and operate smoothly in their bores without sticking. Dry valves must move freely in their bores by their own weight. Replace damaged valves. A soft stone or crocus cloth can be used in an attempt to repair slight irregularities.

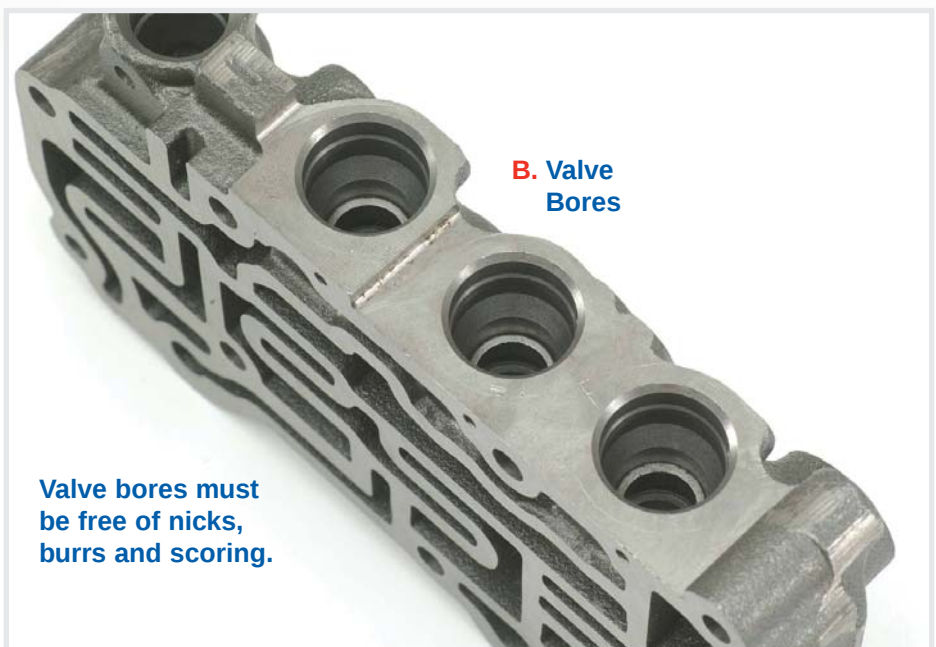
B. Valve Bores

**B.** Valve bores must be free of nicks, burrs and scoring. No honing of any kind is allowed. A soft stone or crocus cloth can be used in an attempt to repair slight irregularities.

Valve bores must be free of nicks, burrs and scoring.

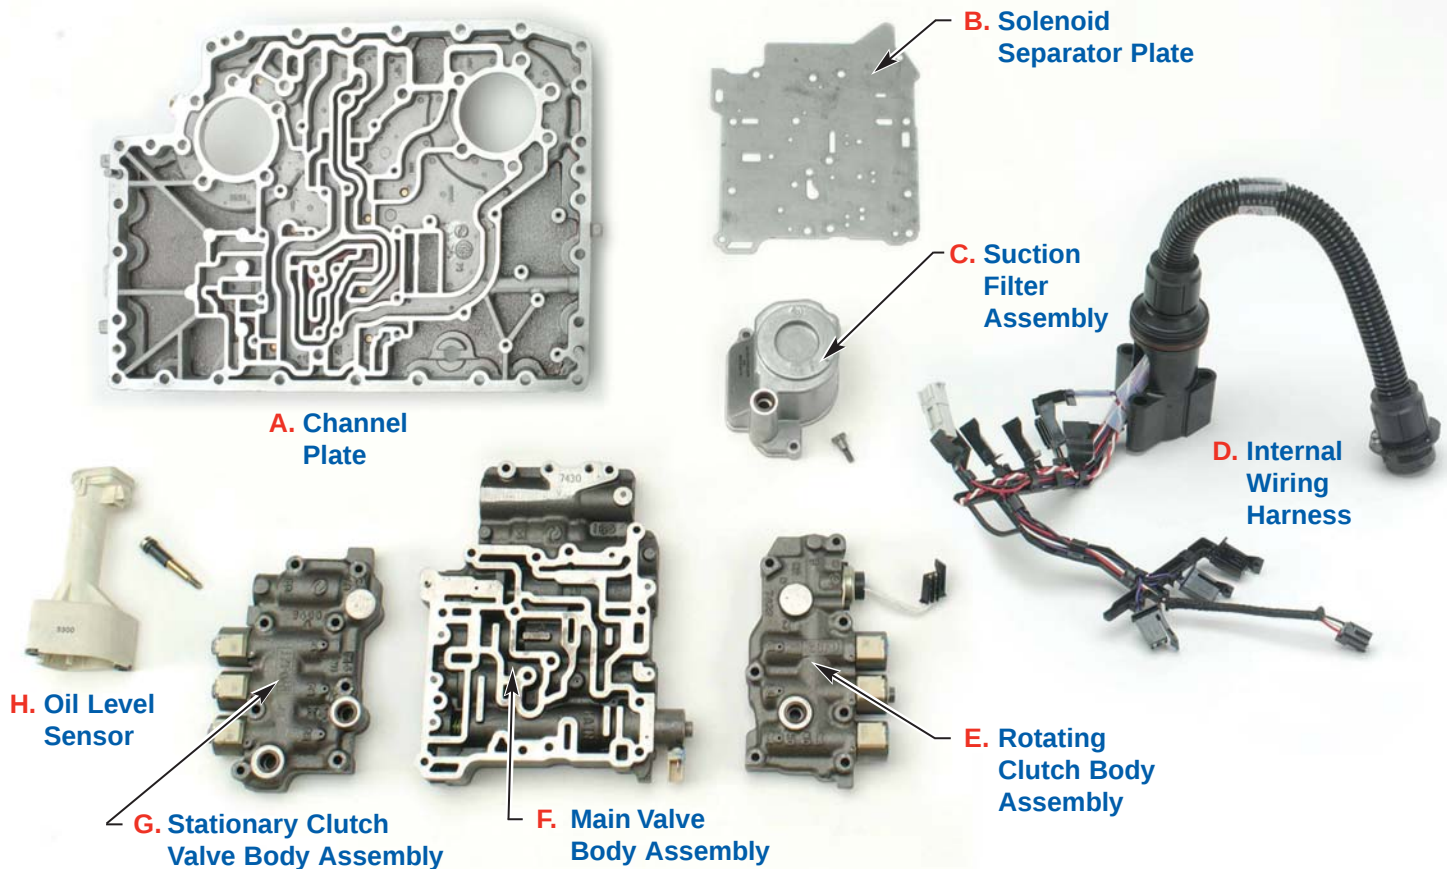
**A.** Inspect the channel plate for damage. All passages must be clear of debris. Inspect all machined surfaces for burrs, nicks or scoring. Light stoning and crocus cloth may be used to eliminate minor high spots. If a channel plate cannot be repaired so that all machined surfaces can seal correctly to their mating parts, or if thread damage cannot be repaired, replace the channel plate.

**B.** Inspect both separator plates for dents, nicks, burrs and other damage or distortion. Replace the plate if it has damage which cannot be repaired using a soft stone or crocus cloth. All passages must be clean and debris free.  
(continued)

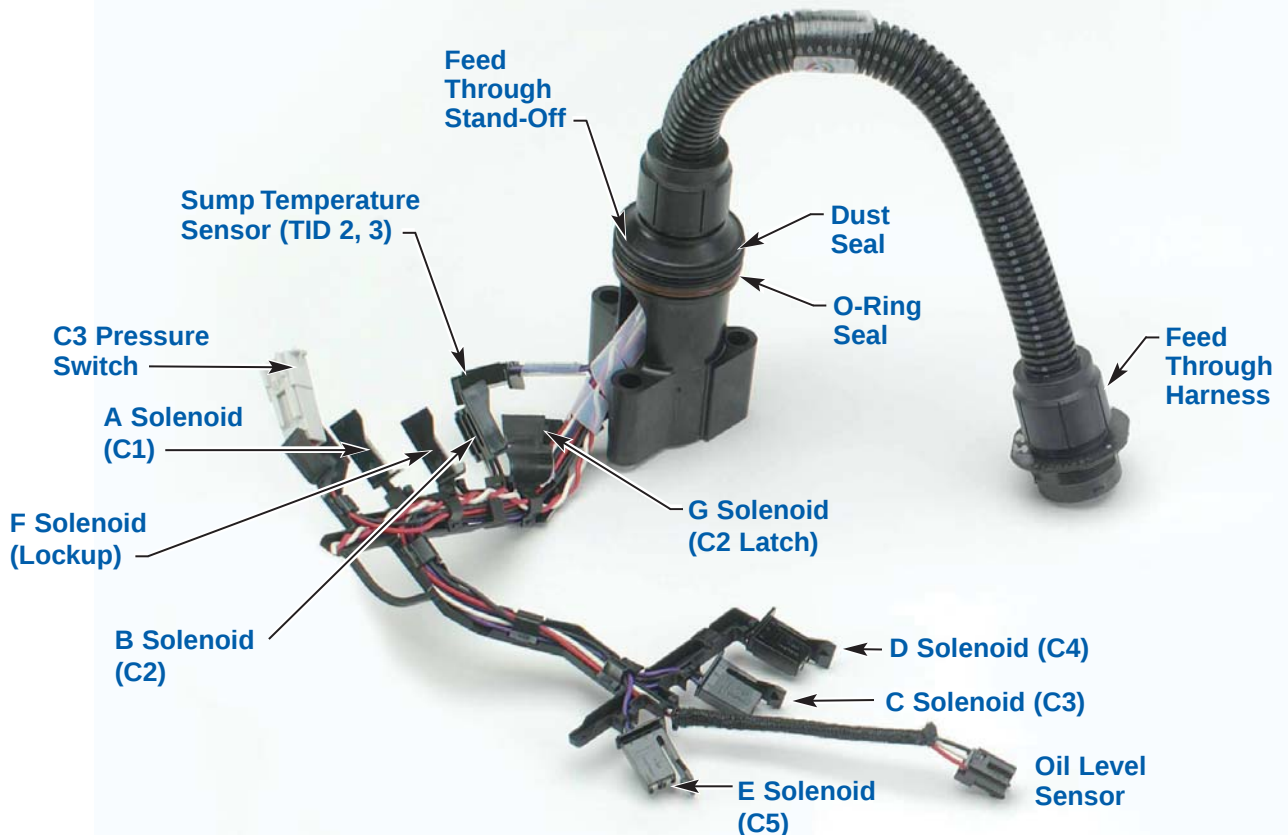
## Identification Detail: Internal Wiring Harness

**C.** Replace the suction filter assembly during overhaul.

**D.** Replace or repair the control module wiring harness if the wires, terminals or connectors are visibly damaged. Inspect the molded harness channel for cracks or breaks. Replace the harness if the molded channel is damaged. Check sump temperature resistance following the guidelines and specifications listed in the Service Manual and Troubleshooting Manual.

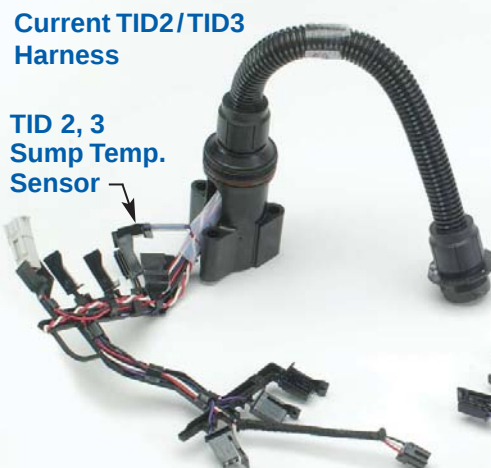
### Current TID2/TID3 Harness

#### TID 2, 3 Sump Temp. Sensor

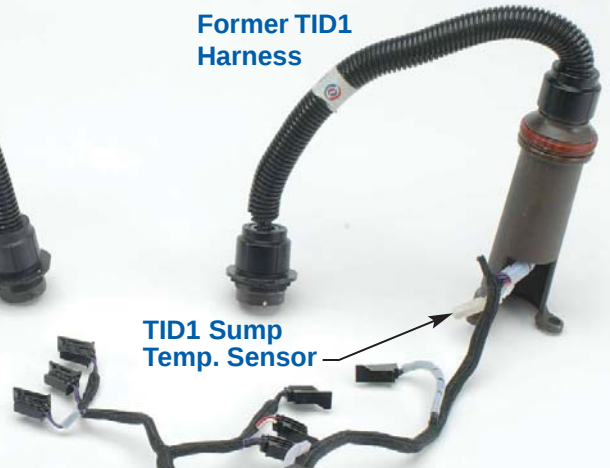
### Former TID1 Harness

#### TID1 Sump Temp. Sensor

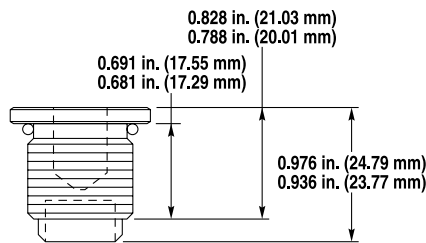
#### CURRENT OIL DRAIN PLUG ASSEMBLY – 29534362

**Current plug is backward compatible with all control modules.**

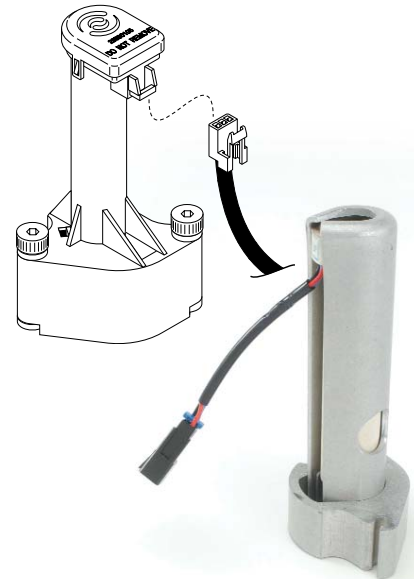
#### Oil Level Sensor Redesign - SIL 19-WT-99

**Kit must be used when replacing former sensor with current sensor.**

**H.** Replace the optional oil level sensor if it is determined it is not functioning correctly.

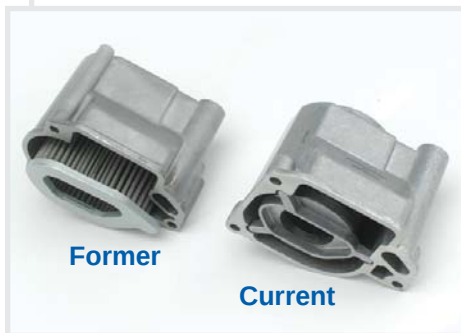
### Suction Filter Redesign - SIL 1-WT-00

**Former**

**Current**

**Replace the assembly during overhaul.**

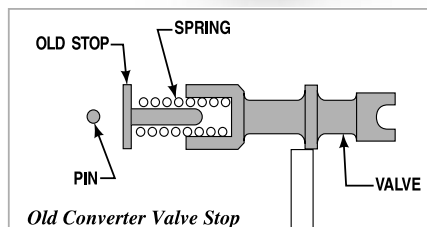
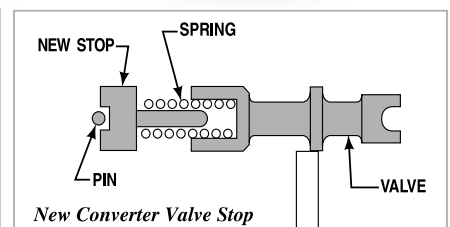
### Converter Regulator Valve Stop Redesign - SIL 12-WT-99

Former Stop

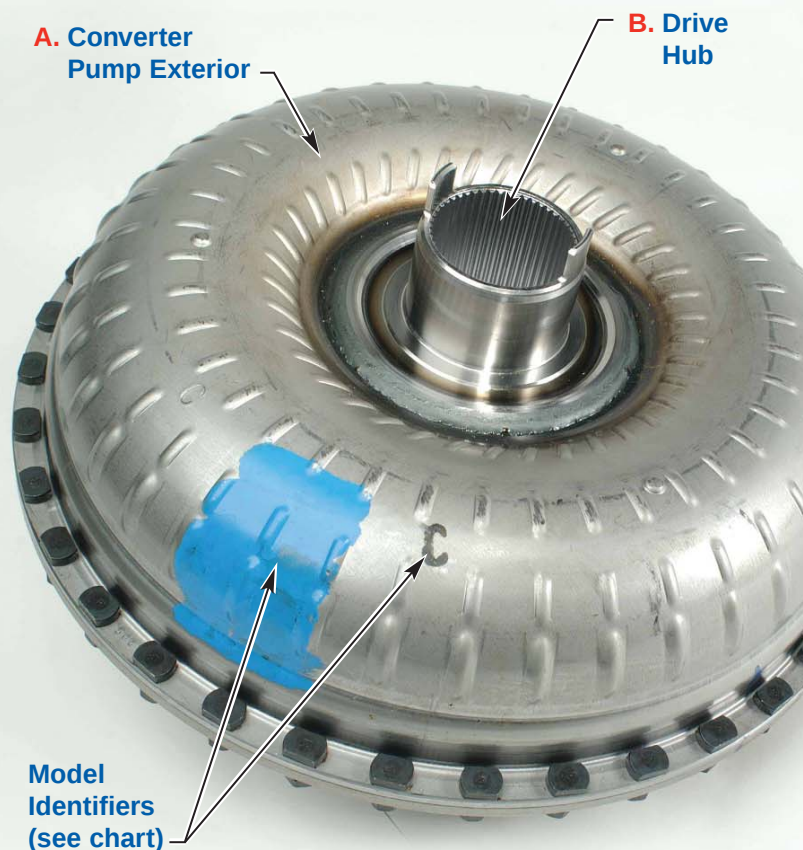
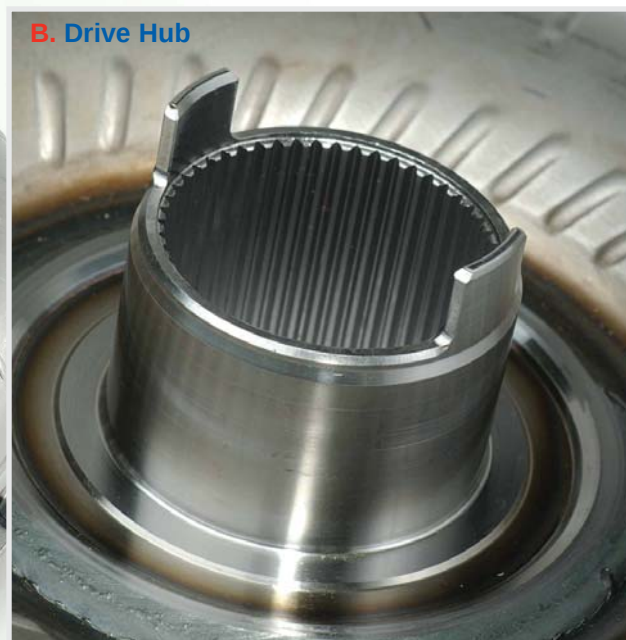
## TORQUE CONVERTER MODULE

Inspect the pump hub tangs for cracks, impact damage and broken tangs.

**A.** Inspect the converter pump exterior for dents and sealing surface damage. Replace the converter pump if damage cannot be removed with a soft stone or crocus cloth.

**B.** Inspect the converter pump hub for damage and excessive wear. Minimum pump hub diameter is 88.99 mm (3.504 inch). Inspect the pump hub tangs for cracks, impact damage or broken tangs. Maximum allowable tang step wear is 0.31 mm (0.012 inch). On PTO-equipped models, check the splines inside the hub for wear and damage. Maximum spline wear is 0.38 mm (0.015 inch).

**NOTE:** Do not use crocus cloth on the converter pump hub. Polishing the hub with crocus cloth can cause improper input seal performance resulting in fluid leakage.

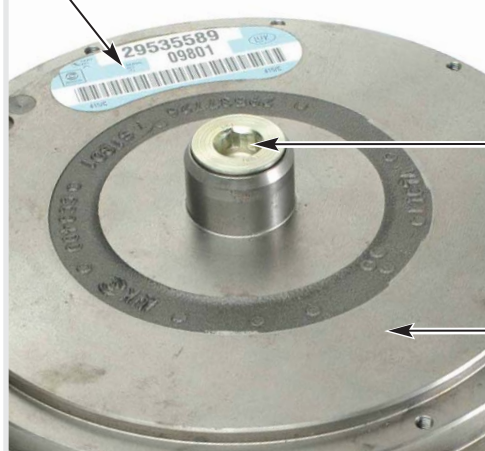
The current front cover has a threaded pilot to accept the current converter plug. Plugs are not interchangeable

Model Identifiers (see chart previous page)

**D. Pilot**

**C. Front Cover Mounting Face**

**C.** Inspect the torque converter front cover mounting faces for damage. Inspect the flexplate adapter bolt holes for stripped or damaged threads.

**D.** Inspect the front cover pilot for damage and wear. Maximum pilot diameter is 61.77 mm (2.432 inches). Inspect the torque converter end plug and the retaining bolt for stripped or damaged threads. Verify that the correct turbine shaft selective shim is installed following the Service Manual procedures.

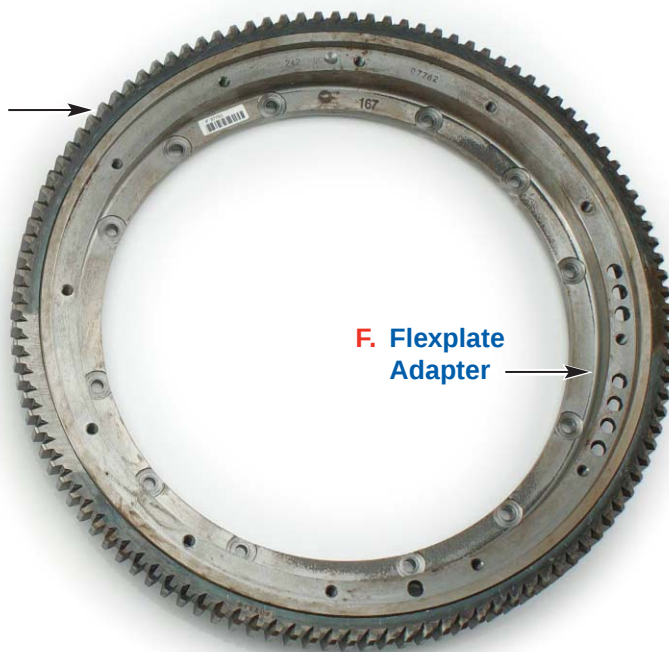
**Turbine Shaft Selective Shim**

**E. Ring Gear**

**F. Flexplate Adapter**

**E.** Inspect the engine starter ring gear for chipped, worn or broken teeth.

**F.** Inspect the flexplate adapter mounting faces for surface damage. Replace the adapter if damage cannot be repaired using a soft stone or crocus cloth. Inspect the flexplate adapter bolt holes for stripped or damaged threads. Clean damaged threads using the correct size tap. Replace the adapter if damage cannot be repaired.

**NOTE:** The flexplate adapter bolt holes use Spiralock® threads. A Spiralock® tap must be used when repairing damaged threads. Using a standard tap will destroy the locking feature. If this occurs, the torque converter front cover must be replaced.
