# TECHNICIANS' GUIDE

# INSPECTION AND ANALYSIS OF THE ALLISON 4000/B 500 PRODUCT FAMILIES

**NOTICE:** This guide is intended for use by technicians skilled in diagnosis and repair of automatic transmissions. Contact an authorized Allison Transmission service outlet for further information or clarification if required. All specifications provided in this manual are subject to change without notice.

The Technicians' Guide is intended to provide additional guidance with the inspection and analysis of transmission parts. This guide should be used by technicians who overhaul Allison 4000/B 500 automatic transmissions in conjunction with the 4000/B 500 Service Manual (SM2457EN) when inspecting parts to determine their serviceability and reuse.

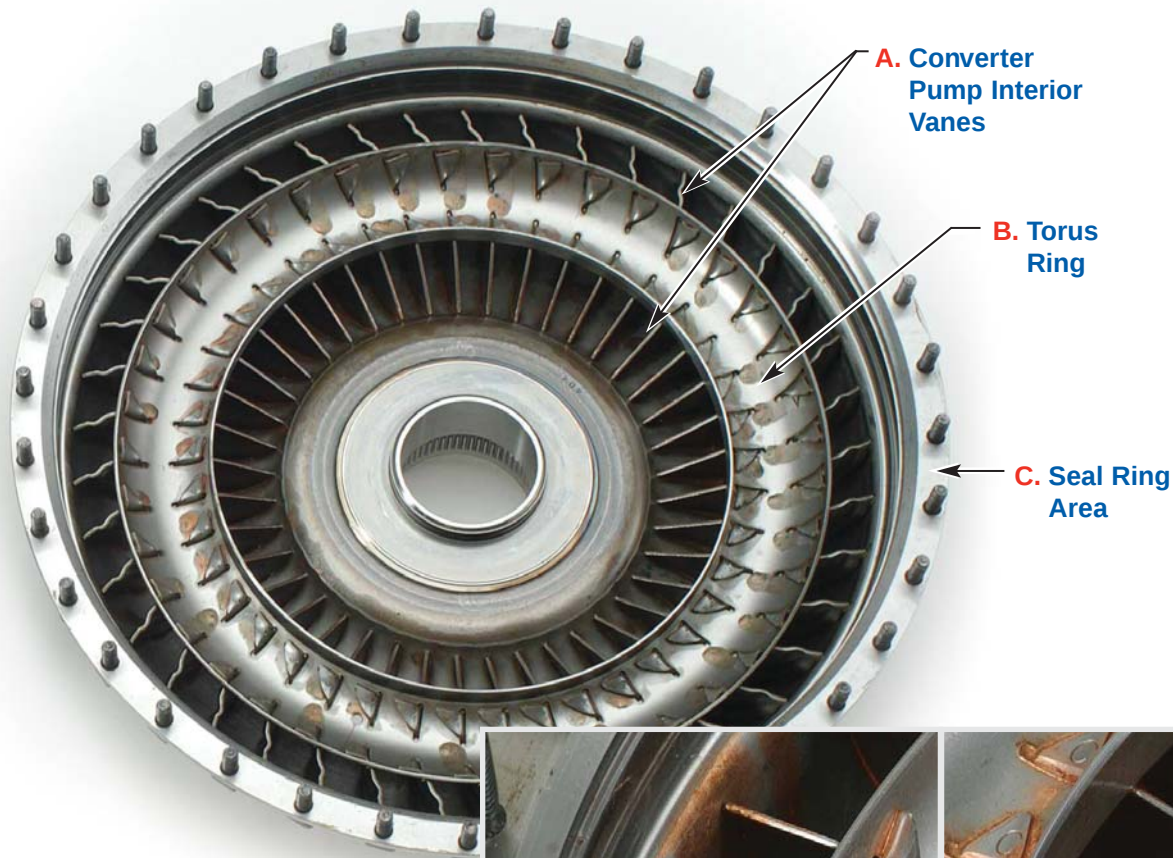
**A.** Inspect the converter pump interior. Replace the assembly if the vanes are damaged, cracked or loose.

**B.** Replace the converter pump assembly if the torus ring is loose or cracked.

**C.** Inspect the seal surface between the converter pump assembly and the front cover. Light stoning is permitted to remove slight irregularities.

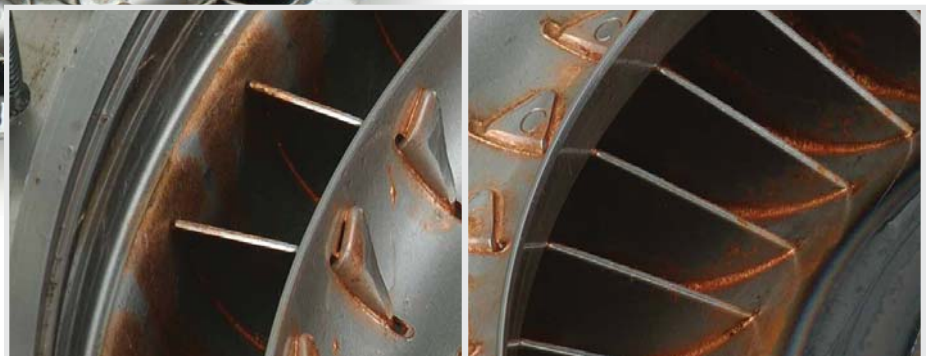
Replace the assembly if the vanes are damaged, cracked or loose.

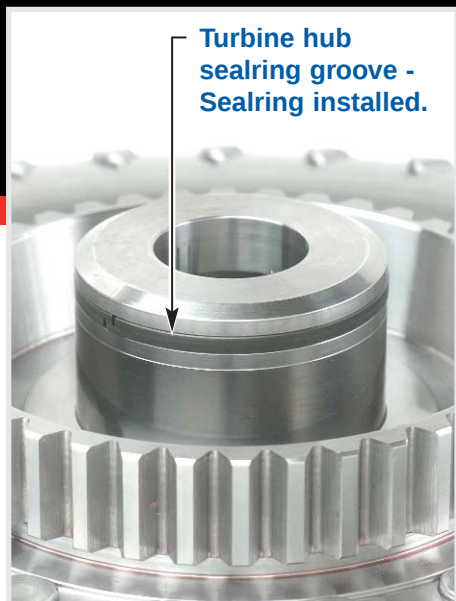
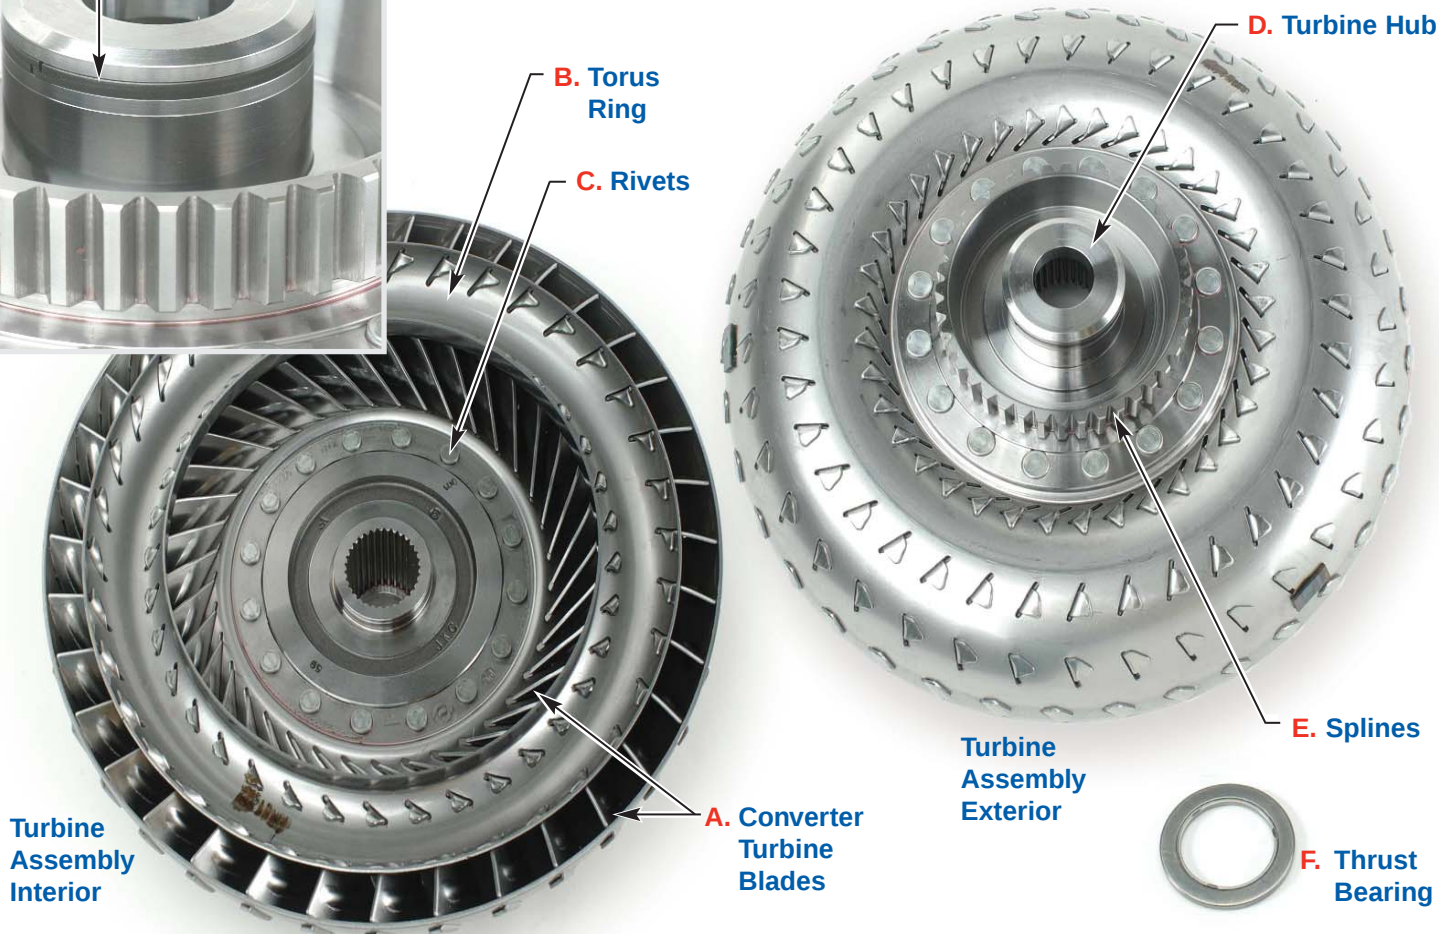
**A.** Inspect the converter turbine assembly. Replace the assembly if the blades are cracked, broken or loose.

**B.** Inspect the torus ring. Replace the turbine assembly if the torus ring is loose or cracked.

**C.** Inspect the rivets. Replace the turbine assembly if the rivets are loose or cracked.

**D.** Inspect the converter turbine hub. Replace the converter turbine assembly if the hub is worn beyond limits. Minimum allowable hub diameter is 66.69 mm (2.626 inches). Inspect the sealring groove for damage.

**E.** Inspect the hub splines for damage and wear. Spline movement between the lockup damper and turbine hub cannot exceed 0.38 mm (0.015 inch). Replace the turbine assembly if splines are excessively worn.

**F.** Inspect the thrust bearing following the “General Inspection Guidelines for Bearings” section of this manual. Replace any thrust bearing failing these inspection procedures.

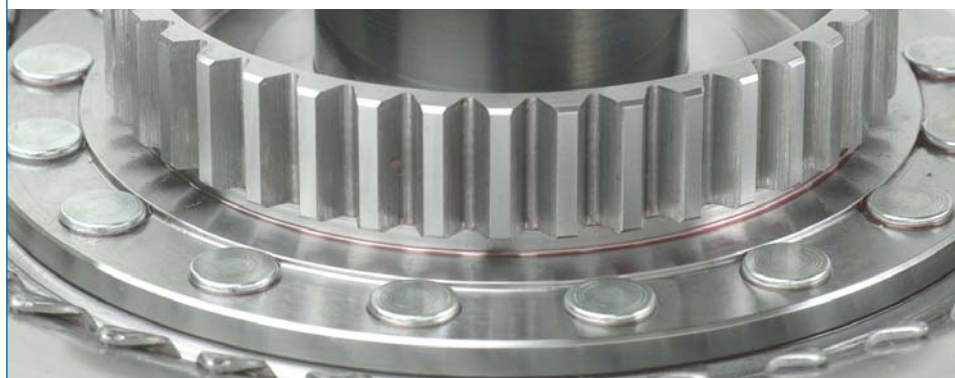
Inspect the hub splines and rivets for damage and wear.

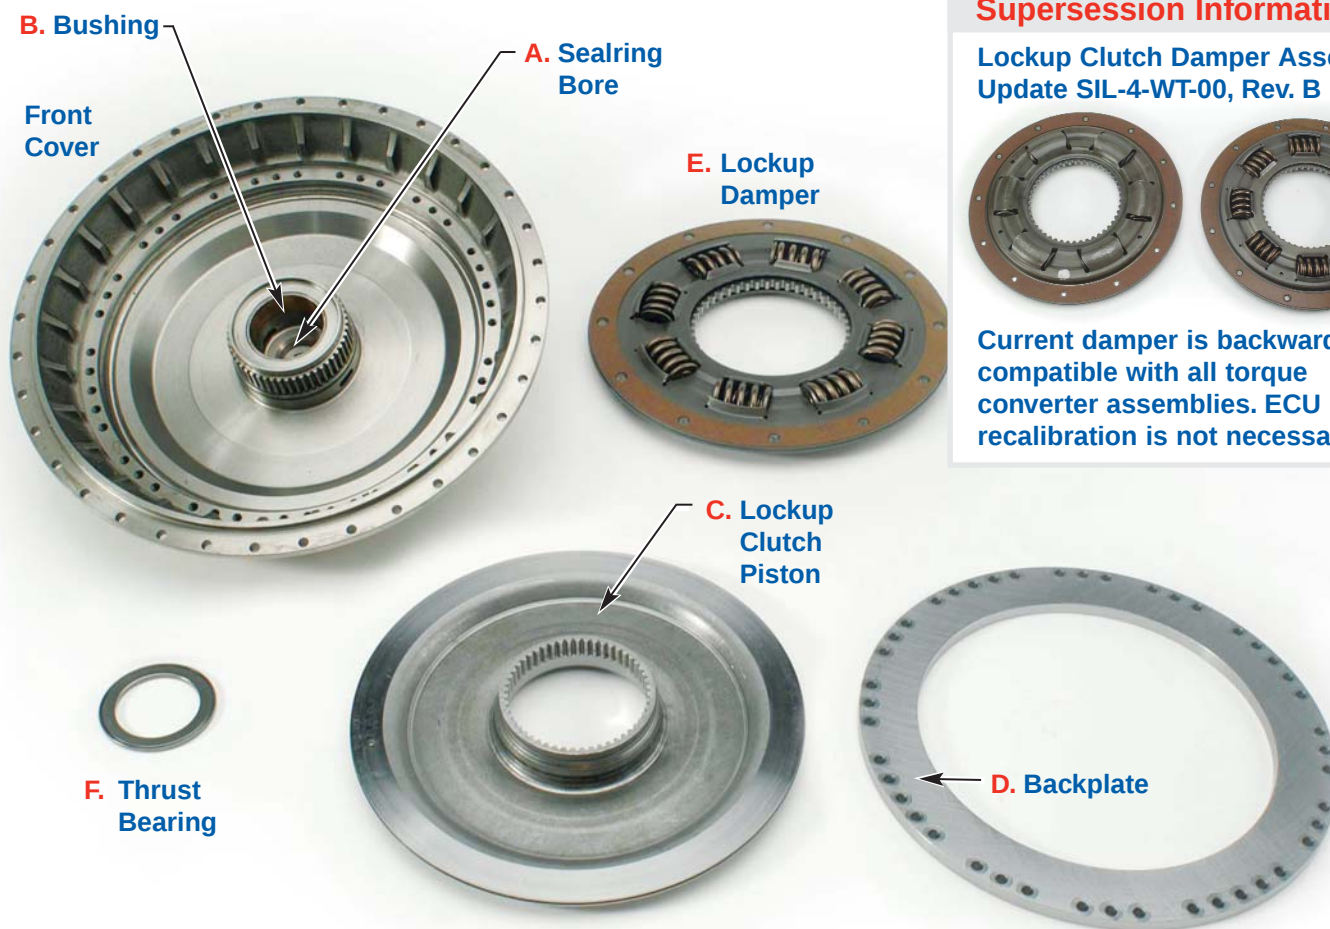
**A.** Torque converter lockup clutch components fit inside the front cover. Install a new turbine sealing in the converter cover bore then measure the sealing inside diameter. Replace the cover assembly if diameter exceeds 61.77 mm (2.432 inch).

**B.** Inspect the converter cover bushing for damage. Replace the bushing if damage cannot be removed with crocus cloth. Maximum allowable bushing inside diameter is 66.91 mm (2.634 inch).

**C.** Inspect the lockup clutch piston for damage. Minimum allowable piston thickness is 6.53 mm (0.257 inch).

**D.** Inspect the lockup clutch backplate for damage, scoring and overheating. Minimum allowable plate thickness is 11.79 mm (0.464 inch).

**NOTE:** If the backplate is within thickness limits but has surface damage due to metal transfer between the backplate and lockup damper, the plate may be reused by turning it over so that the lockup damper has a new contact surface.

**E.** Replace the lockup clutch damper if the friction surfaces are worn beyond service limits. Minimum allowable friction surface thickness is 8.51 mm (0.335 inch). Maximum allowable damper distortion is 0.51 mm (0.020 inch). Maximum allowable movement between the damper and converter turbine splines is 0.38 mm (0.015 inch). Replace the damper if any of these measurements are beyond allowable limits.

**F.** Inspect thrust bearing following the "General Inspection Guidelines for Bearings" section of this manual. Replace any thrust bearing failing these inspection procedures.

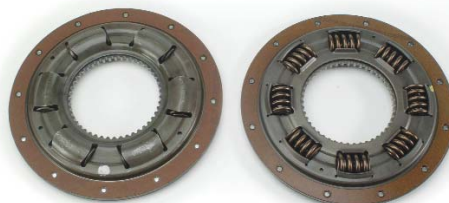
Lockup Clutch Damper Assembly  
Update SIL-4-WT-00, Rev. B

Current damper is backward compatible with all torque converter assemblies. ECU recalibration is not necessary.

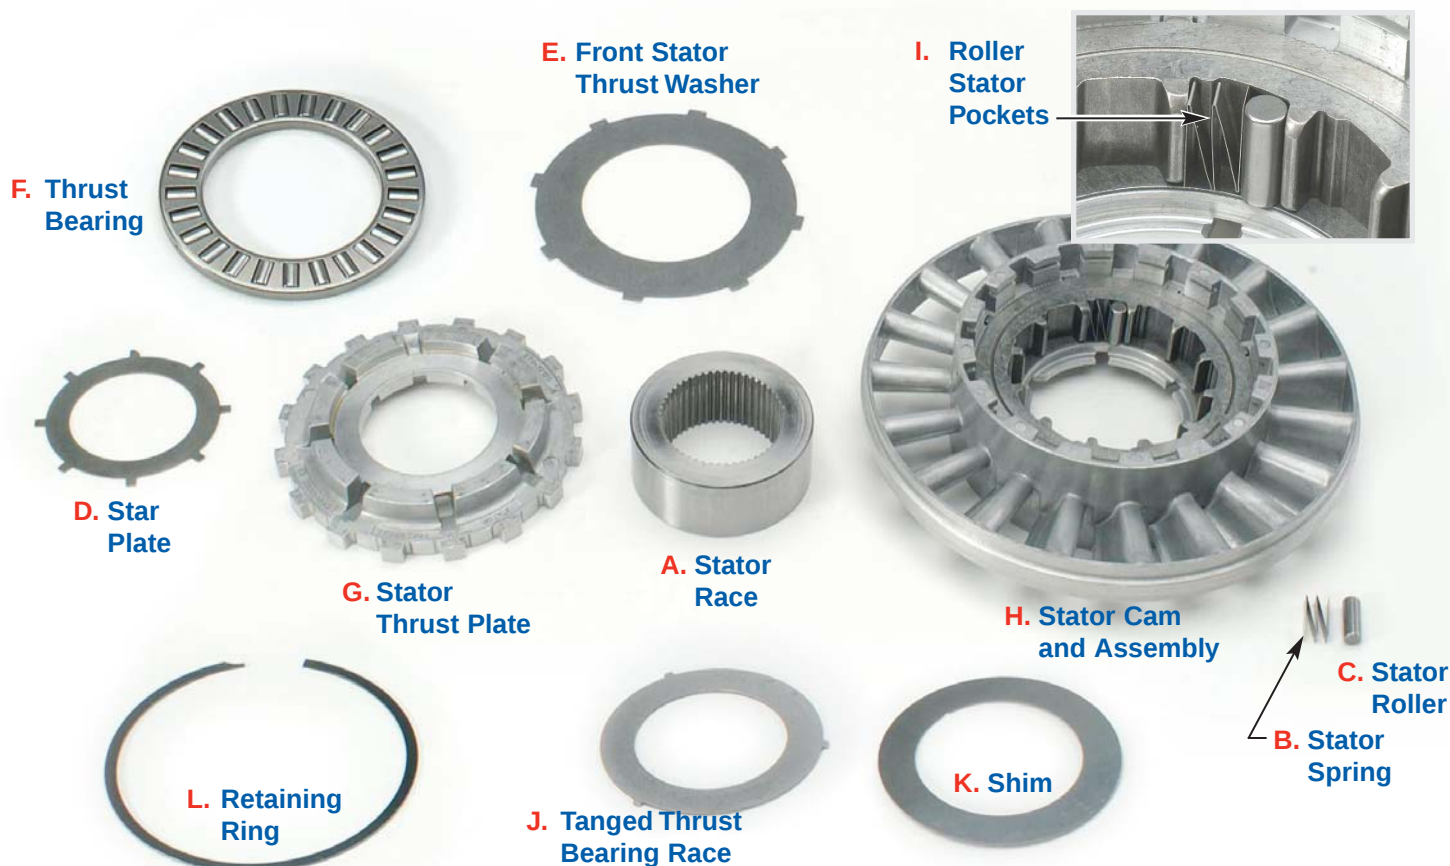
**A.** Inspect the **stator race** for damage. Replace the race if damage cannot be repaired using a soft stone or crocus cloth.

**B.** Inspect the **stator springs** for correct spring height following per the Service Manual. Replace any spring which has a free length below 17.8 mm (0.700 inch).

**C.** Inspect the **stator rollers** for damage. Rollers should be smooth, round and defect-free. Replace damage or worn rollers.

**D.** Inspect the **star plate** for excessive wear. Replace the star plate if damage cannot be repaired using a soft stone or crocus cloth.

**E.** Inspect the **front stator thrust washer** for wear beyond service limits. Replace the stator thrust washer if it is worn 0.40 mm (0.010

inch) or more. If it is within service limits, the thrust washer can be turned over and the un-worn surface can be used.

**F.** Inspect the **thrust bearings** following the "General Inspection Guidelines for Bearings" section of this manual. Replace any thrust bearings failing these inspection procedures.

**G.** Inspect the **stator thrust plate** for damage and wear. Replace the plate if damage cannot be removed using a soft stone or crocus cloth. Minimum allowable plate thickness is 9.45 mm (0.372 inch).

**H.** Inspect the **stator and cam assembly** for damage. Replace the stator and cam assembly if damaged.

**I.** Inspect the **stator roller pockets** for wear and damage. Verify correct spring-to-roller orientation. Inspect the bottom of the cam pocket for wear. Replace the stator and cam assembly if it is worn 0.40 mm (0.010 inch) or more in the bottom of the pocket.

**J.** Inspect **tanged thrust bearing race** for damage. Replace any damaged race.

**K.** Inspect **shim** for damage. Replace any damaged shims. Use procedure for shim selection in 4000 Series Service Manual.

**L.** Inspect the **retaining ring** for damage and distortion. Replace any distorted or damaged retaining rings.

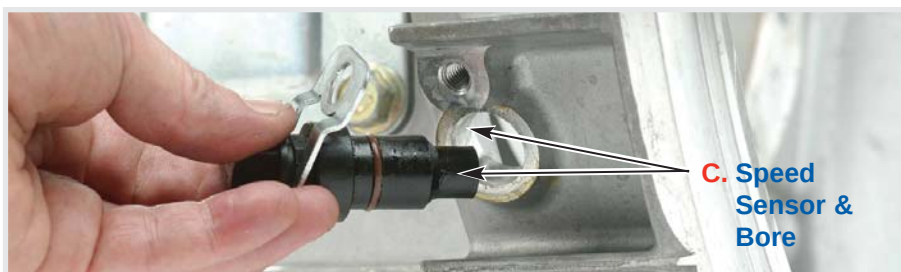
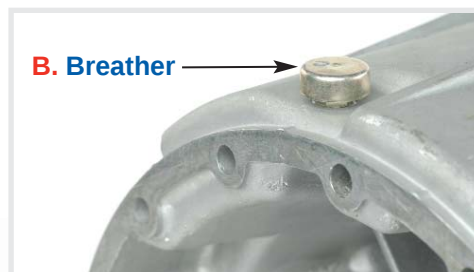
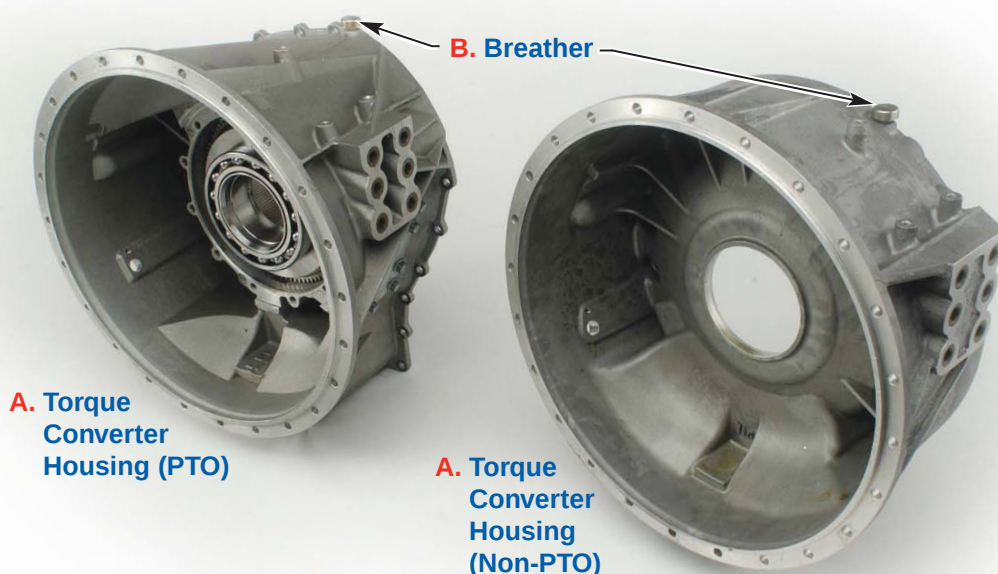
## TORQUE CONVERTER HOUSING MODULE

**A.** Inspect for torque converter housing damage. High spots may be removed with crocus cloth or a soft stone. Inspect threaded holes for debris and thread damage. Replace the torque converter housing if it is cracked, if it leaks from a damaged machined surface, or if it has thread damage which cannot be repaired.

**B.** Inspect the breather for damage and obstructions. Replace the breather if it is damaged. Clean the breather if it is blocked with debris.

**C.** Replace the input speed sensor if the sensor body or electrical terminals are damaged. Speed sensor resistance is 300 ohms (plus or minus 30 ohms). Replace the

**D.** On PTO-equipped models, inspect the converter housing bearing bore for wear. Maximum allowable bearing bore inside diameter is 180.05 mm (7.088 inches). Replace the housing if damage cannot be repaired using a soft stone or crocus cloth.

**E.** Inspect the PTO bearing retainer mounting face surface and threads for damage. Replace the housing if surface damage cannot be repaired using a soft stone or crocus cloth. Replace the housing if thread damage cannot be repaired.

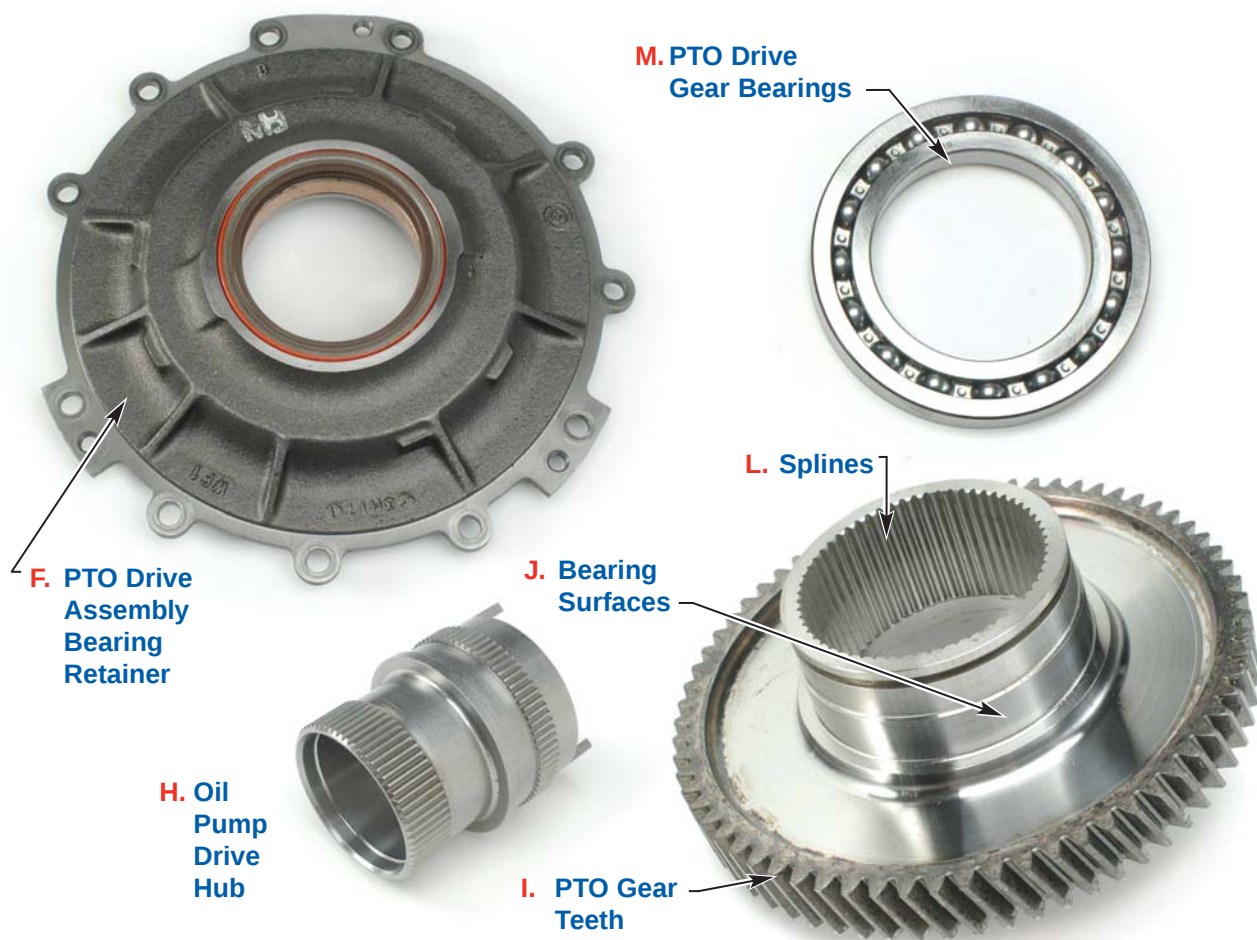
**F.** On PTO-equipped models, inspect the PTO drive bearing retainer housing bore for damage. Replace the retainer if damage cannot be repaired using a soft stone or crocus cloth. Replace the retainer housing if the bushing has spun in the bushing bore.

**G.** Inspect the retainer housing bushing for damage and wear. Replace the bushing if damaged. Maximum allowable bushing inside diameter is 89.19 mm (3.511 inches). Replace the bushing if it is worn beyond service limits.

**I.** Inspect the PTO drive gear teeth for chips, pitting and excessive wear. Replace the gear if damage cannot be repaired using a soft stone or crocus cloth.

**NOTE:** Some axial movement of the gear is normal, but movement should not exceed 3.175 mm (0.125 inch). Replace the PTO bearings if axial movement exceeds service limit.

**NOTE:** Normal operating backlash after PTO is installed is 0.1 mm to 0.66 mm (0.004 to 0.026 inch).

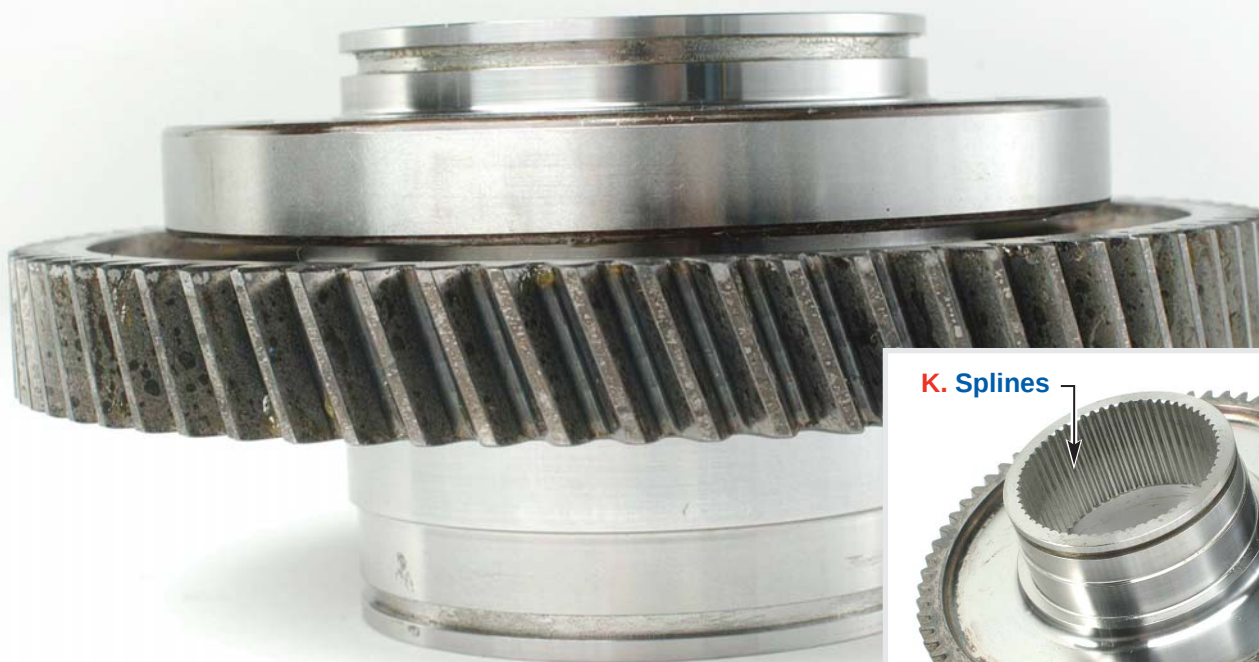
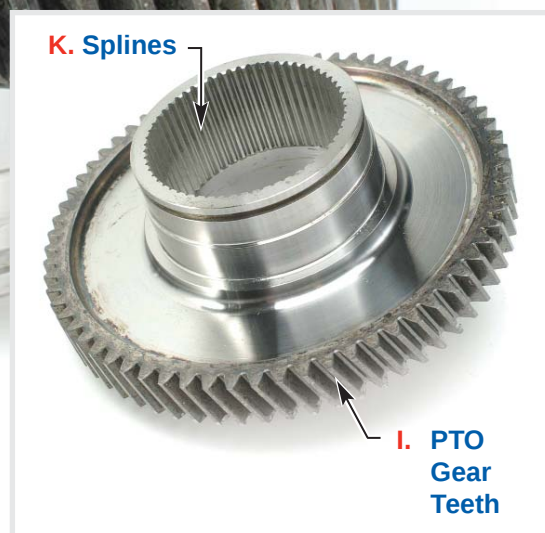
**J.** Inspect the PTO drive hub tangs for step wear, deformation and cracks. Replace the drive hub if tang step wear exceeds 0.38 mm (0.015 inch) or if either tang is deformed or cracked.

**NOTE:** Drive hub tang breakage or deformity accompanied by charging pump bushing failure and ground sleeve wear is often caused by poor transmission fluid condition due to improper maintenance intervals. Observation of proper fluid change intervals is key to optimum transmission life.

**K.** Inspect the drive hub splines for wear. Replace the drive hub if spline wear exceeds 0.38 mm (0.015 inch).

**L.** Inspect the PTO drive gear bearings following the “General Inspection Guidelines for Bearings” section of this manual. Replace either bearing as needed.

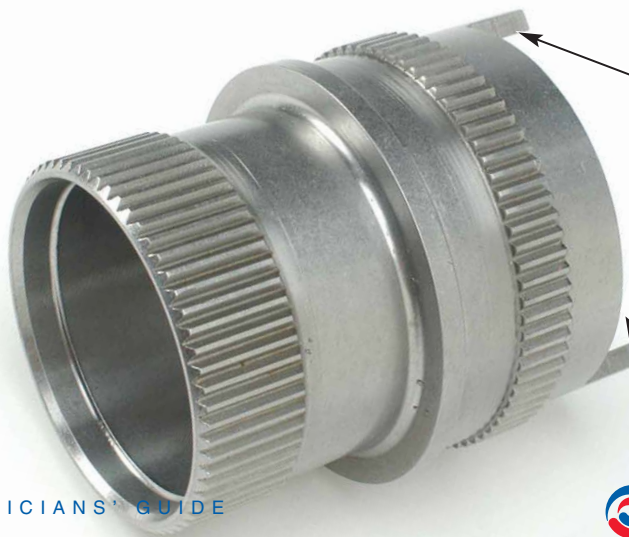
Examine the oil pump drive tangs for excessive battering.

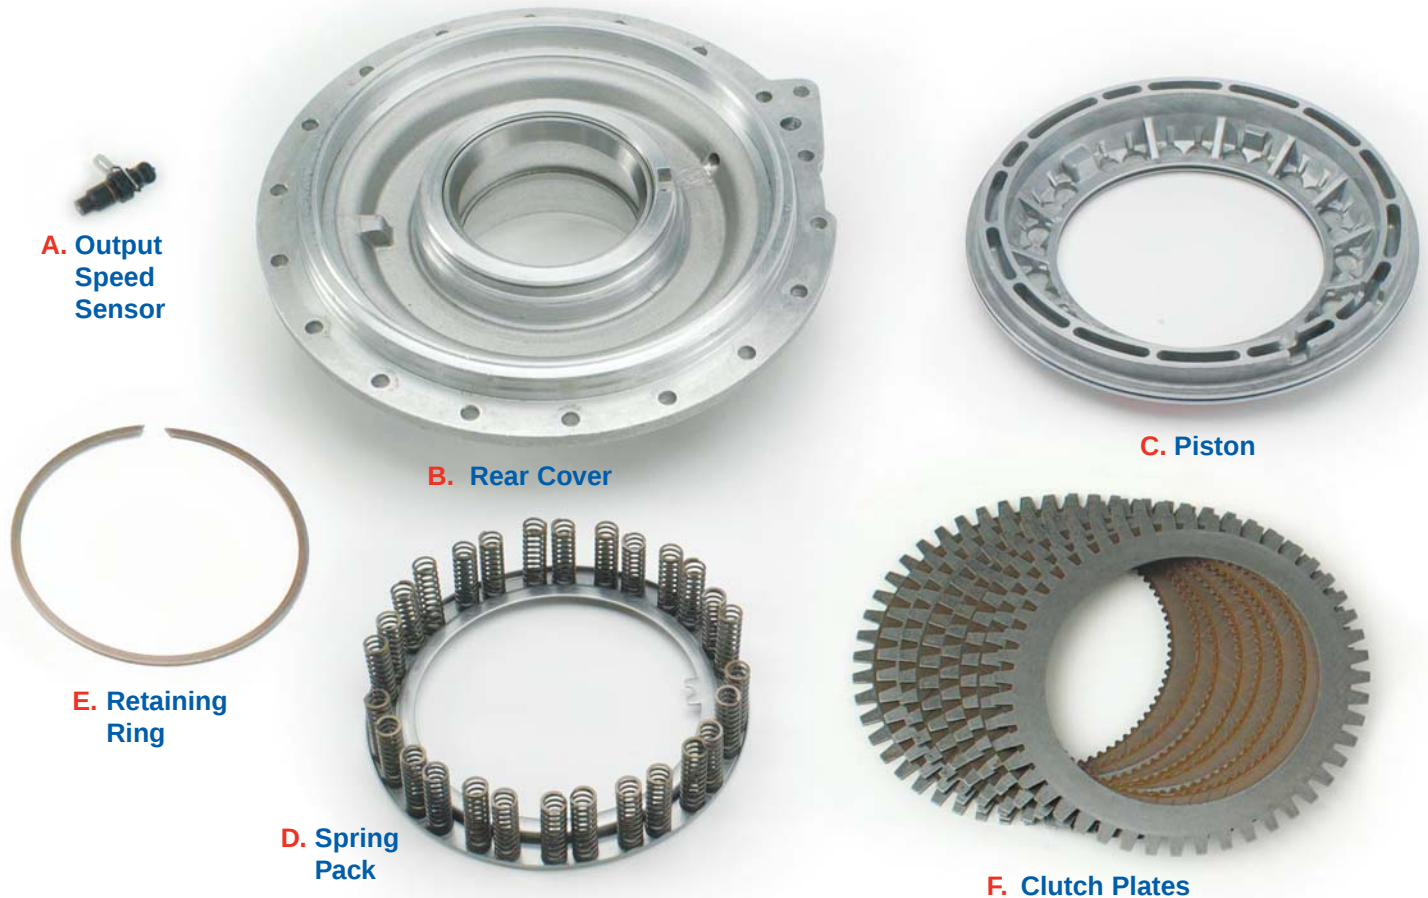
**A.** Inspect the output speed sensor for damage. Replace any sensor that has body, terminal or connector seat damage. Allowable output speed sensor resistance is 300 ohms plus or minus 30 ohms.

**B.** Inspect the rear cover following the “General Inspection Guidelines for Cast Parts and Machined Surfaces” section of this manual. High spots on machined surfaces can be removed using a soft stone or crocus cloth. Inspect the slot on the back side of the housing where the C5 piston tang indexes. Replace the rear cover if

damage to any machined surface cannot be repaired using a soft stone or crocus cloth. Replace the rear cover if it is cracked.

**C.** Inspect the C5 clutch piston following the “General Inspection Guidelines for Cast Parts and Machined Surfaces” section of this manual. Replace the piston if it fails to meet the inspection guidelines. Inspect the C5 piston tang for excessive wear.

**D.** Inspect the C5 clutch spring pack for damage due to rubbing adjacent parts and cracked or broken pieces. Check springs for wear, breakage and damage. Reference the Spring Data Charts in the Service Manual SM2457EN for spring specifications and identification.

**E.** Replace the C5 retaining ring if it is bent or distorted.

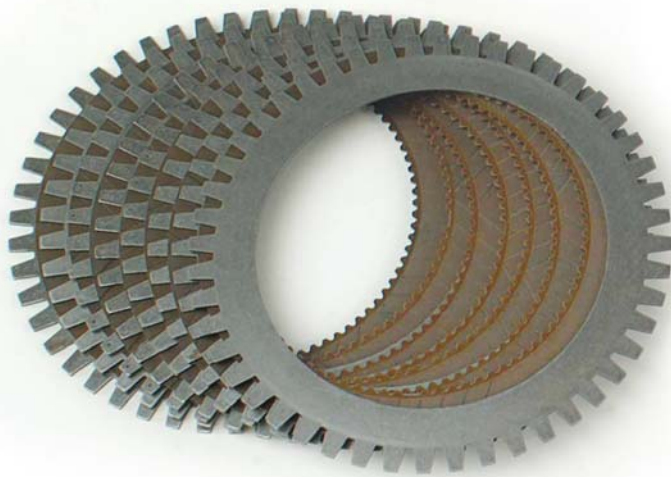
**F. Clutch Plates**

**F.** Inspect the C5 friction clutch plates following the “General Inspection Guidelines for Friction Plates” section of this manual. Discard any plates that do not meet the guidelines. Minimum allowable thickness for reuse is 3.48 mm (0.137 inch). Minimum oil groove depth for reuse is 0.20 mm (0.0008 inch). Maximum cone for reuse is 0.25 mm (0.010 inch).

**NOTE:** Battered and worn spline teeth may be an indicator of driveline issues. Replace the clutch plates and check the driveline.

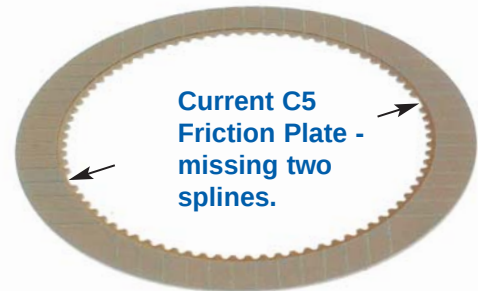
**Current C5 Friction Plate -**  
missing two splines.

**NOTE:** The current clutch friction plates were implemented April of 2000 starting with s/n 6610062126. Current clutch friction plates will have two or more missing splines. Former friction plates will either have one spline missing or none

**Clutch plate identification is made by counting the number of missing teeth.**

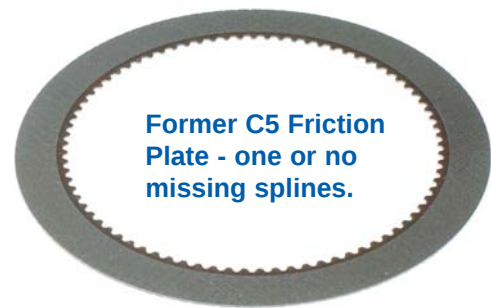
**Former C5 Friction Plate -**  
one or no missing splines.

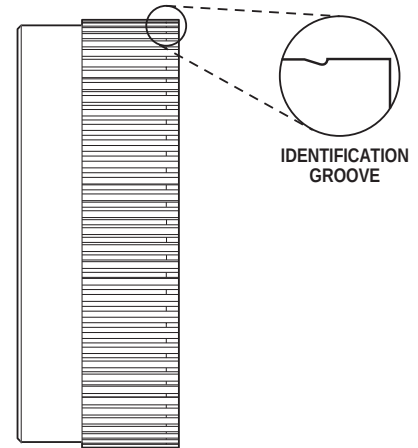
**FORMER (NON-HARDENED)  
P3 RING GEAR**

**Use C5 friction  
plate missing  
3 internal teeth.**

The P3 ring gear changed to a harder ring gear on s/n 6610027070. The current P3 ring gear identifier is a groove machined around the outer diameter of the gear. The P3 ring gear with a groove identifier requires the C5 friction with two missing splines if updating from former C5 frictions. If any

4000/B500 series model without the harder ring gear (no groove on O.D.) is being updated with current C5 frictions, then it will require the C5 friction that has three missing internal splines. The C5 friction plate missing three splines will exhibit spline wear if used with the current P3 ring gear with a groove identifier on the O.D. The former P3 ring gear (no groove on O.D.) will exhibit premature wear if used with the current C5 friction with two missing internal splines. No ECU calibration is necessary for updating C5 clutch plates.

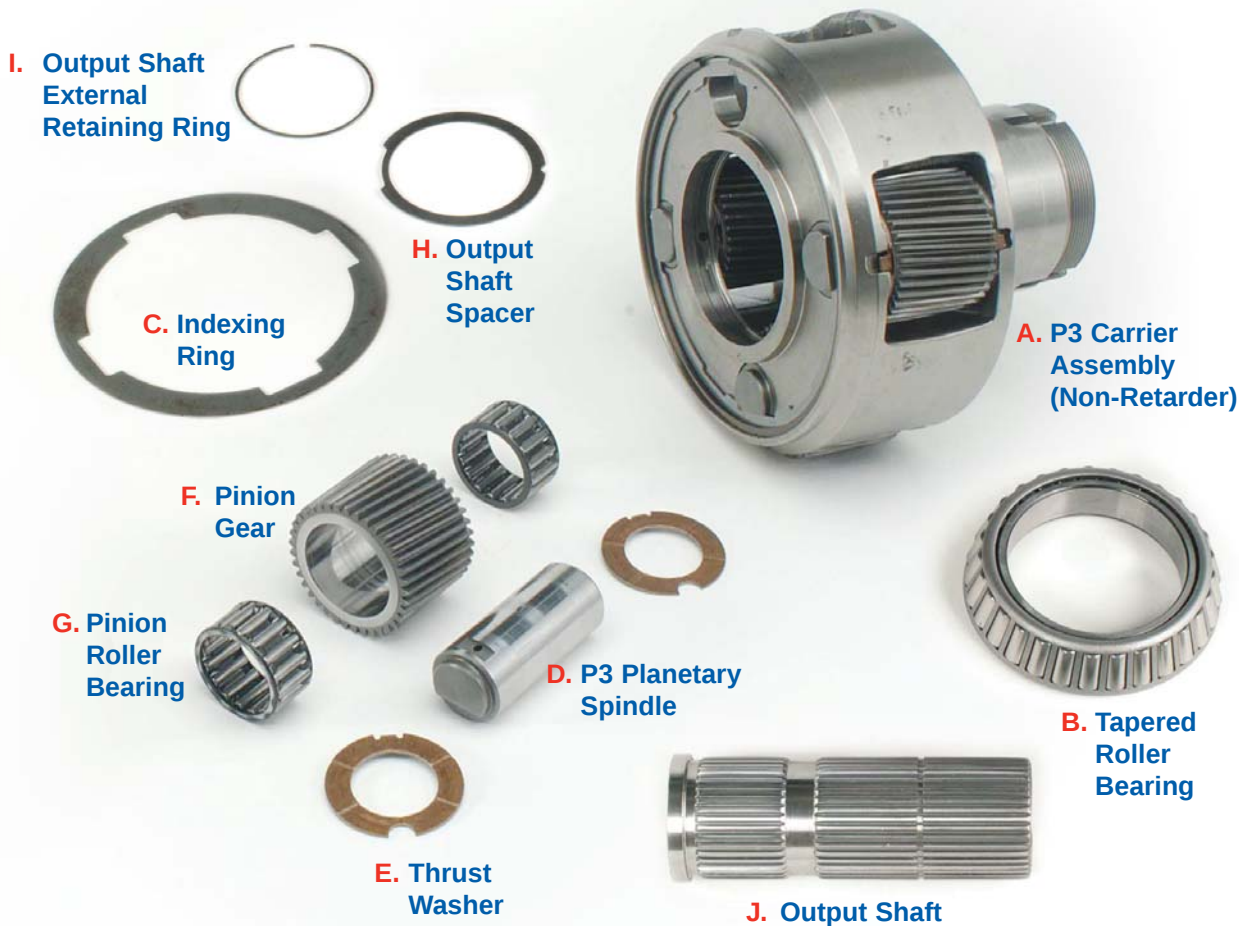
**A.** Verify a proper press fit between the P3 carrier and rear cover or retarder housing by inverting the carrier over a table or workbench. If the P3 carrier falls out of the rear cover or retarder housing without using a press or mallet, the press fit between the tapered bearings and P3 carrier no longer exists and the carrier must be replaced.

Inspect the P3 carrier for spline wear. Replace the carrier if spline wear exceeds 0.38 mm (0.015 inch). Inspect the pinion spindle bores in the carrier and the pinion thrust surfaces for excessive wear and damage. Replace the P3 carrier if a

spindle has more than 0.051 mm (0.002 inch) clearance in the bore. Inspect for thread damage on the carrier hub. Replace the carrier if threads are damaged.

**B.** Inspect the tapered roller bearings and races following the “General Inspection Guidelines for Bearings” section of this manual. Replace any bearings failing to meet the inspection guidelines. Bearing races are located in the rear cover housing and should also be inspected for wear and damage.

**C.** Inspect the P3 indexing ring for step wear in the area where it contacts the spindle. Replace the

indexing ring if it is broken or if it has excess step wear or damage which cannot be repaired using a soft stone or crocus cloth. Indexing rings with acceptable wear can be flipped during reassembly so that a new contact surface is used.

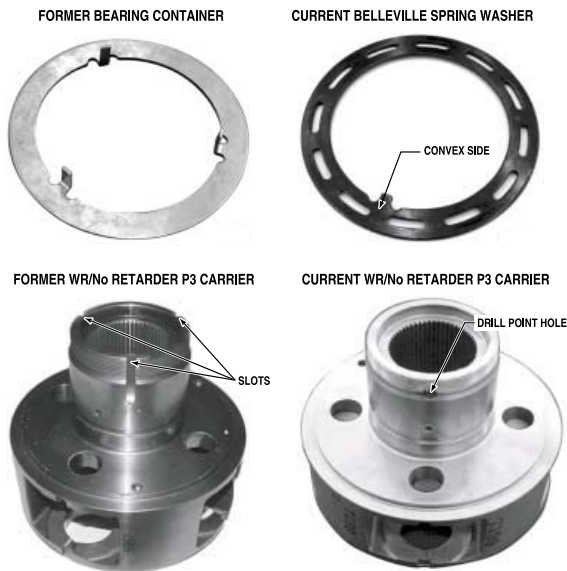
#### P3 Carrier Update - SIL 25-WT-01

Current P3 carriers use a drill point hole and a Belleville spring washer.

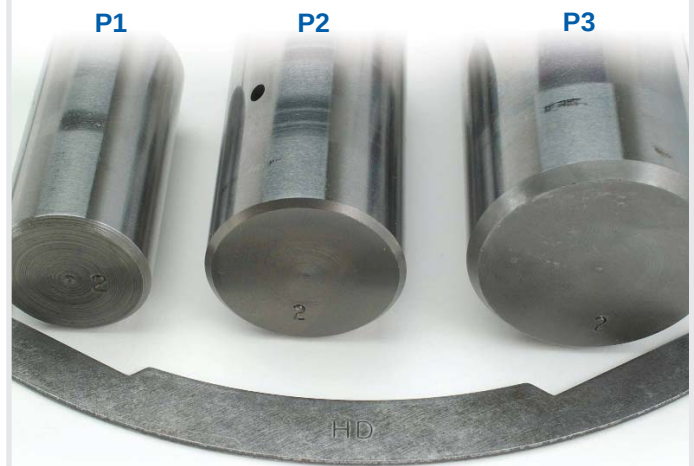
#### Planetary Spindle and Indexing Ring Updates - SIL 10-WT-00

Planetary spindles and indexing rings are backward compatible. Current spindles are stamped with the number "2." Indexing rings are stamped with the identifier "HD5."

**D.** Inspect planetary spindles for wear and damage. Discoloration is only a concern if spindle surface damage exists.

**E.** Inspect the pinion gear thrust washers for damage, distortion and signs of excessive wear. Minimum allowable thrust washer thickness is 1.39 mm (0.054 inch). Replace damaged or worn thrust washers.

**F.** Inspect the pinion gears following the "General Inspection Guidelines for Gears" section of this manual. Replace any gears which fail these inspection procedures or if the damage cannot be repaired using a soft stone.

**G.** Inspect the pinion roller bearings following the "General Inspection Guidelines for Bearings" section of this manual. Replace any bearings which fail these inspection procedures.

**H.** Replace the output shaft spacer if it is bent, cracked or if it is distorted in any way. An attempt can be made to repair some minor damage using a soft stone.

**I.** Inspect the output shaft external retaining ring. Replace the retaining ring if it is distorted or fits loosely on the shaft.

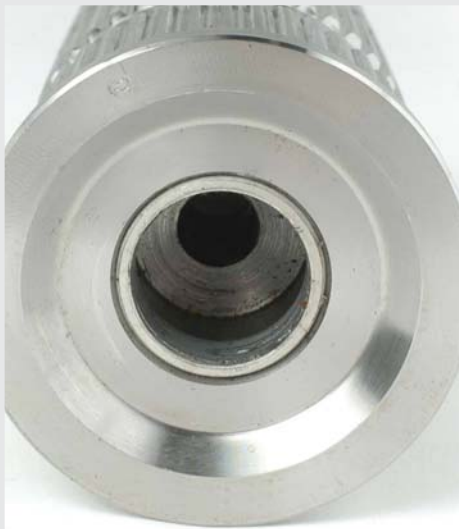
**J. Inspect the output shaft bushing for damage.**

**J.** Inspect the output shaft following the “General Inspection Guidelines for Cast Parts and Machined Surfaces” and the “General Inspection Guidelines for Splines” sections of this manual. Replace the output shaft if it fails these inspection procedures.

Inspect the output shaft bushing following the “General Inspection Guidelines for Bushings” section of this manual. Replace the bushing if it fails these inspection procedures. Maximum allowable bushing inside diameter is 36.14 mm (1.423 inch).

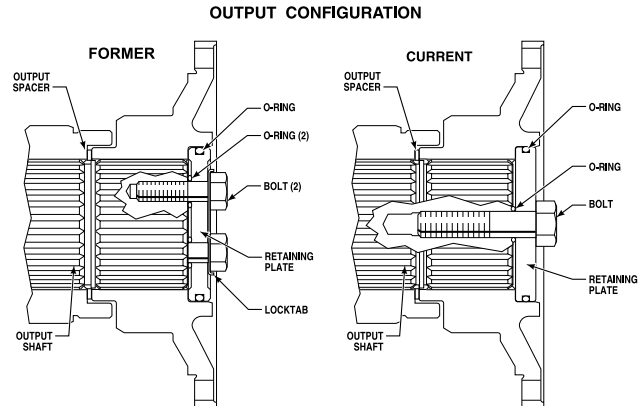
Flange / Yoke Retaining Bolt Update - Reference SIL 1-WT-99

**Single Bolt design increases clamp load.**

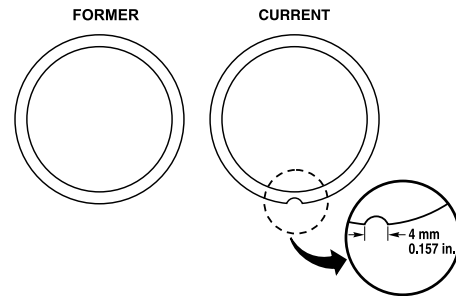
**Output spacers are not interchangeable between the former and current designs.**

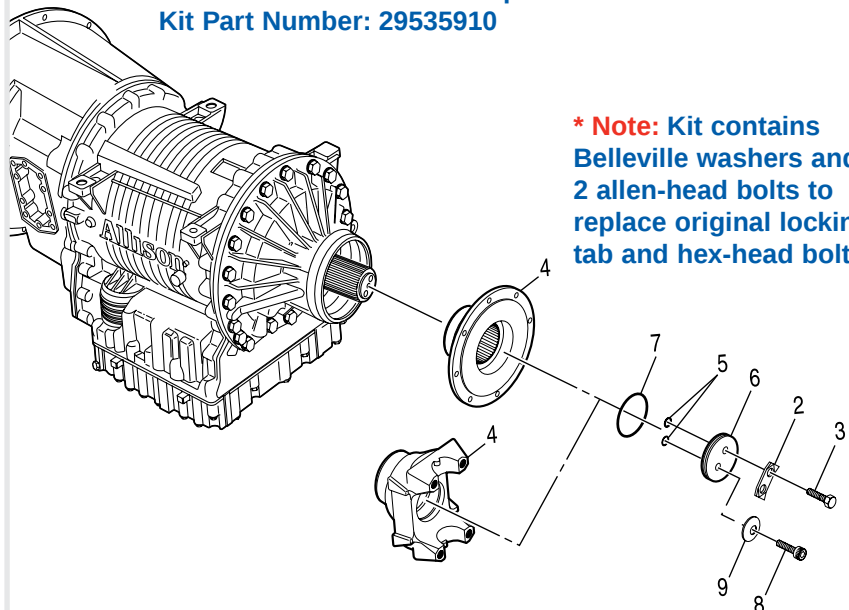
**Service Kit for Two-Bolt Output - SIL 15-WT-98**  
Kit Part Number: 29535910

**\* Note:** Kit contains Belleville washers and 2 allen-head bolts to replace original locking tab and hex-head bolts.

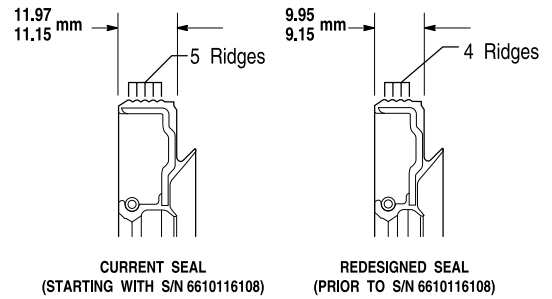
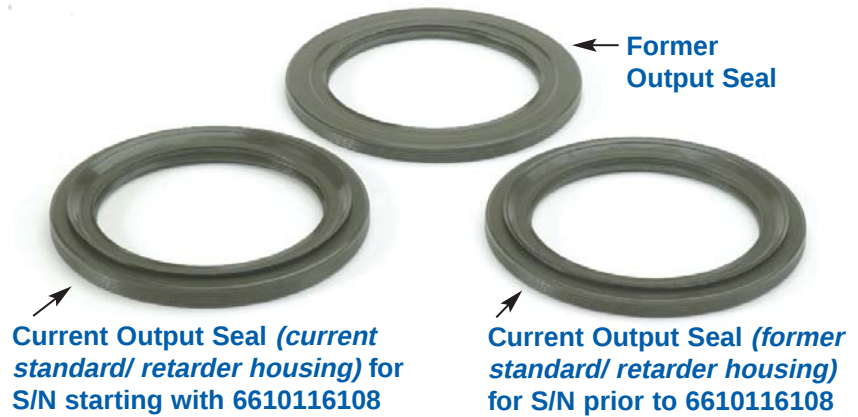
#### Output Seal Update - Reference SIL 4-WT-03

Two seals are currently available - to fit former and current rear covers. They are **NOT** interchangeable.

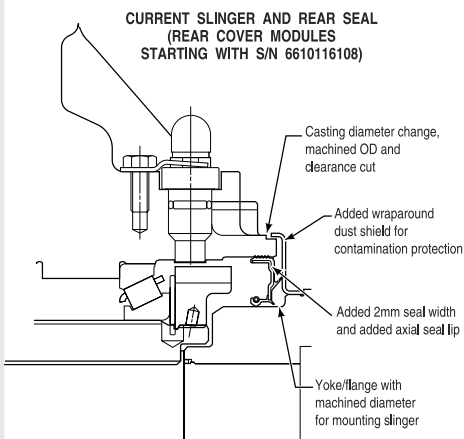
#### Output Yoke/Flange Update - Reference SIL 4-WT-03

Not all yoke / slinger combinations can be used with all transmissions. Rear cover design determines yoke / slinger combination.

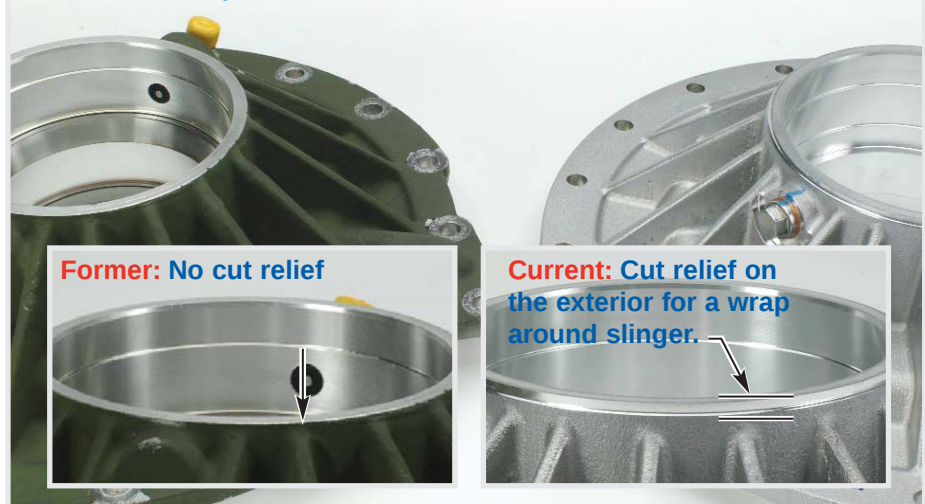
#### Rear Cover Update - Reference SIL 4-WT-03

Current rear cover has interior cut relief to accommodate 5-ridge output seal. Former rear cover has interior cut relief to accommodate 4-ridge output seal (reference *Output Seal Update Supersession Information*).

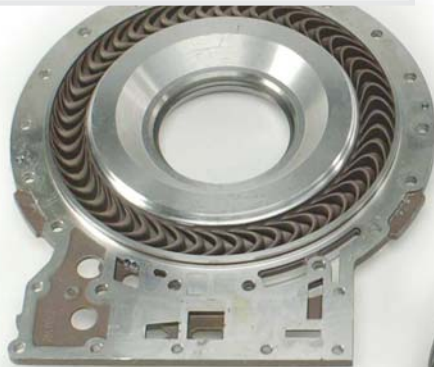
**B. Retarder Stator Housing**

**B.** Inspect the stator housing following the “General Inspection Guidelines for Cast Parts and Machined Surfaces” section of this manual. Some light housing imperfections can be removed using a soft stone. Discard and replace the housing if damage is excessive.

Inspect the slot on the back side of the housing where the C5 piston tang indexes for excessive wear. Replace the stator housing if damage to any machined surface cannot be repaired using a soft stone or crocus cloth. Replace the stator housing if it is cracked.

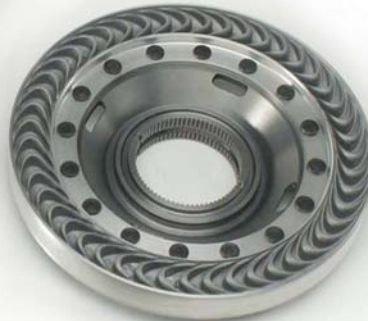
**C. Retarder Rotor**

**C.** Inspect the retarder rotor following the “General Inspection Guidelines for Cast Parts and Machined Surfaces” section of this manual. Check for loose, cracked or broken rivets. Replace the rotor if movement exists between the center hub and the vaned assembly. Inspect the rotor splines for wear.

Spline wear cannot exceed 0.38 mm (0.015 inch). Replace the rotor if it exceeds this wear limit.

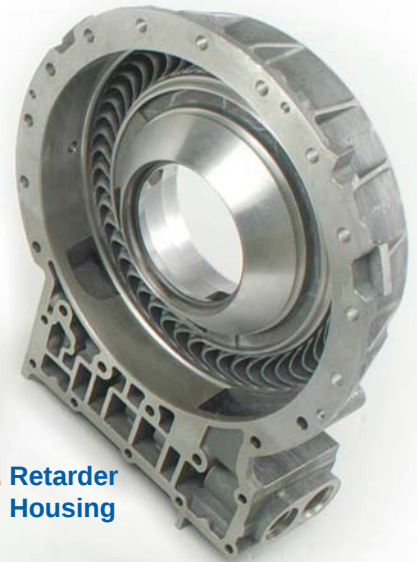
**A. Retarder Housing**

**A.** Inspect the retarder housing following the “General Inspection Guidelines for Cast Parts and Machined Surfaces” section of this manual. High spots on machined surfaces can be removed using a soft stone or crocus cloth. Replace the retarder housing if it is cracked or if machined surface damage cannot be removed using a soft stone or crocus cloth.

Install a “known good” rotor sealring in the retarder housing and measure sealring inside diameter. If the retarder housing is slightly grooved or worn, place the sealring directly in the grooved or worn area. Replace the housing if sealring

inside diameter is greater than 139.72 mm (5.501 inches). A bearing race fits into the housing and should be inspected for damage.

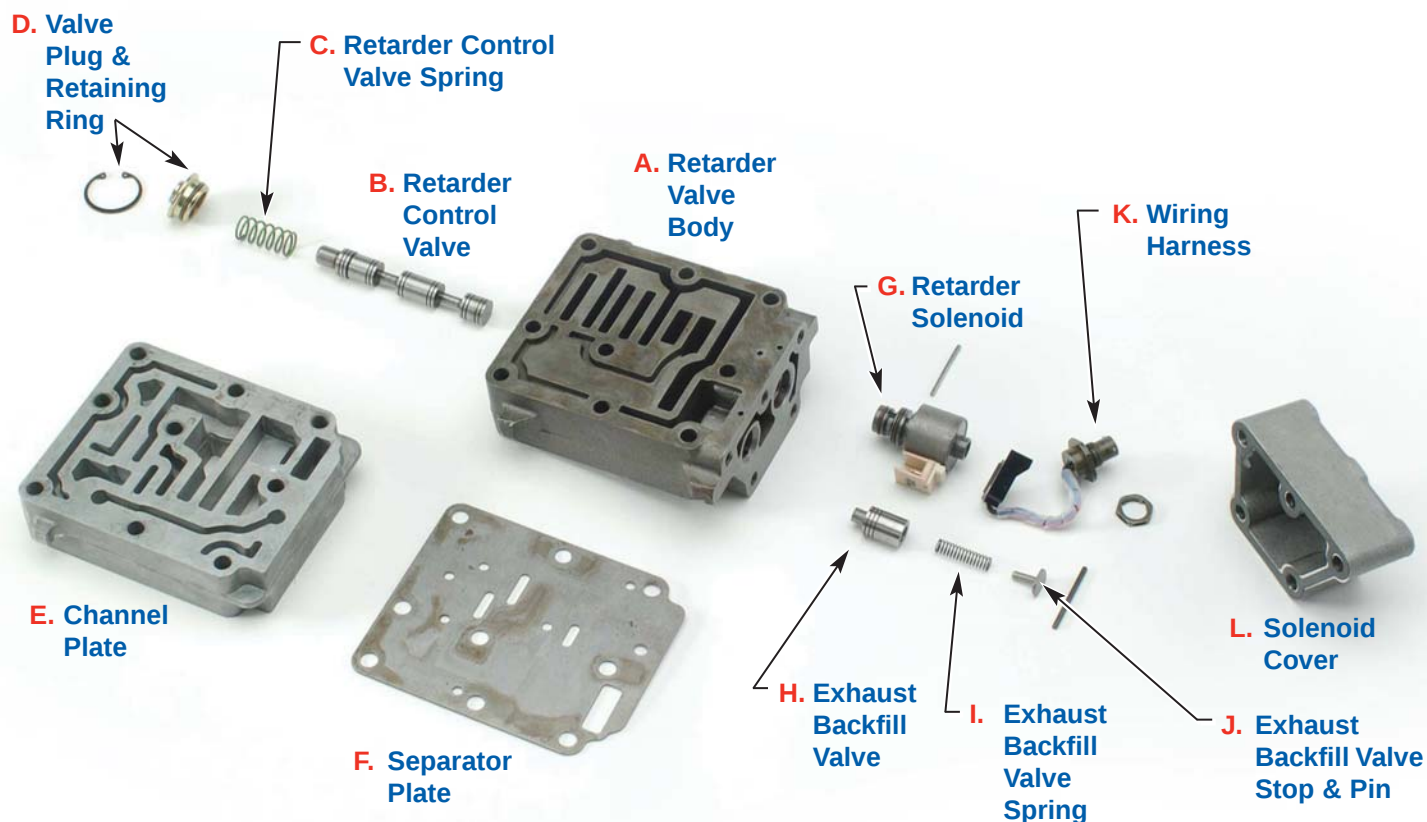
**A.** Inspect the retarder control valve body following the “General Inspection Guidelines for Cast Parts and Machined Surfaces” section of this manual. All passages must be clean and debris free. Valve bores must be free of nicks, burrs and scoring. Crocus cloth or a soft stone can be used to attempt removal of slight irregularities, however no honing of any kind is permitted.

**B & H.** Inspect the retarder control valve and exhaust backfill valve for nicks, burrs, scoring and other damage. A soft stone or crocus cloth can be used to attempt

**C & I.** Replace the retarder control valve spring or exhaust backfill spring for damage or permanent set. Reference the Spring Data Charts in the Service Manual for spring specifications and identification.

**D.** Inspect the valve plug for damage. Replace the plug if damage cannot be repaired using a soft stone or crocus cloth.

**E.** Inspect the channel plate following the “General Inspection Guidelines for Cast Parts and Machined Surfaces” section of this manual. Replace the channel plate if it fails any of these inspection procedures or if it has damage which cannot be repaired using a soft stone or crocus cloth. All passages must be clean and debris free.
