# TECHNICIANS' GUIDE

# INSPECTION AND ANALYSIS OF THE ALLISON 4000/B 500 PRODUCT FAMILIES

**NOTICE:** This guide is intended for use by technicians skilled in diagnosis and repair of automatic transmissions. Contact an authorized Allison Transmission service outlet for further information or clarification if required. All specifications provided in this manual are subject to change without notice.

The Technicians' Guide is intended to provide additional guidance with the inspection and analysis of transmission parts. This guide should be used by technicians who overhaul Allison 4000/B 500 automatic transmissions in conjunction with the 4000/B 500 Service Manual (SM2457EN) when inspecting parts to determine their serviceability and reuse.

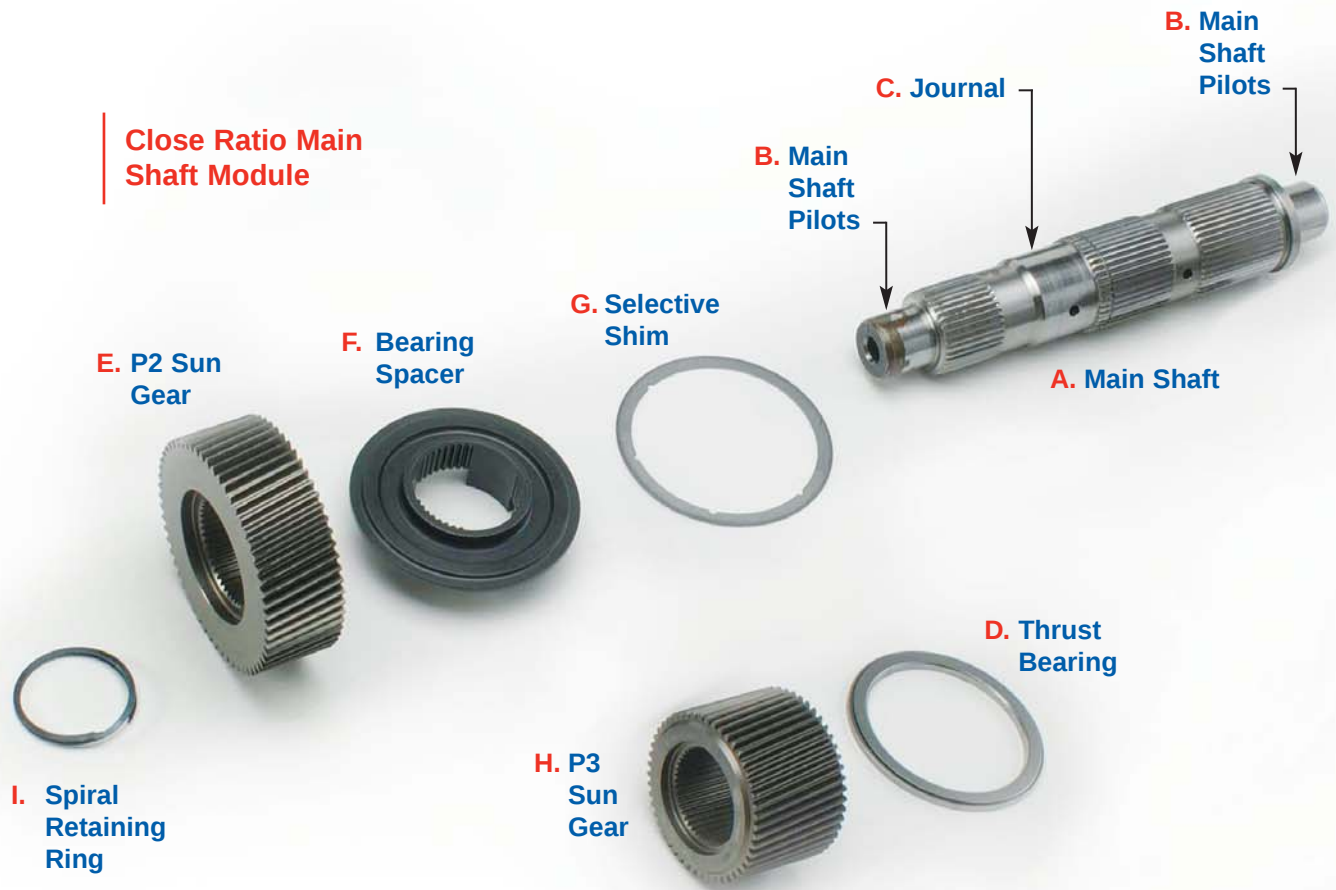
## CLOSE RATIO MAIN SHAFT MODULE

**A.** Inspect the main shaft following the “General Inspection Guidelines for Gears” and “General Inspection Guidelines for Splines” sections of this manual. Replace the main shaft if it fails any of these inspection procedures.

**B.** Inspect the front and rear main shaft pilots for damage. The front main shaft pilot fits inside the turbine shaft. The rear main shaft pilot fits inside the output shaft. Replace the main shaft if pilot outside diameter is less than 35.92 mm (1.414 inch).

**C.** Inspect the P2 bushing journal area for damage. Replace the main shaft if P2 planetary bushing

**D.** Inspect the thrust bearings following the “General Inspection Guidelines for Bearings” section of this manual. Replace any bearing that fails any of these inspection procedures.

**E.** Inspect the P2 sun gear following the “General Inspection Guidelines for Gears” and “General Inspection Guidelines for Splines” sections of this manual. Replace the gear if it fails any of these inspection procedures.

**G.** Inspect the selective shim for damage. Replace the shim if it is distorted or if damage cannot be removed by light stoning.

**H.** Inspect the P3 sun gear following the “General Inspection Guidelines for Gears” and “General Inspection Guidelines for Splines” sections of this manual. Replace the gear if it fails any of these inspection procedures.

**I.** Replace the spiral retaining ring if it is removed.

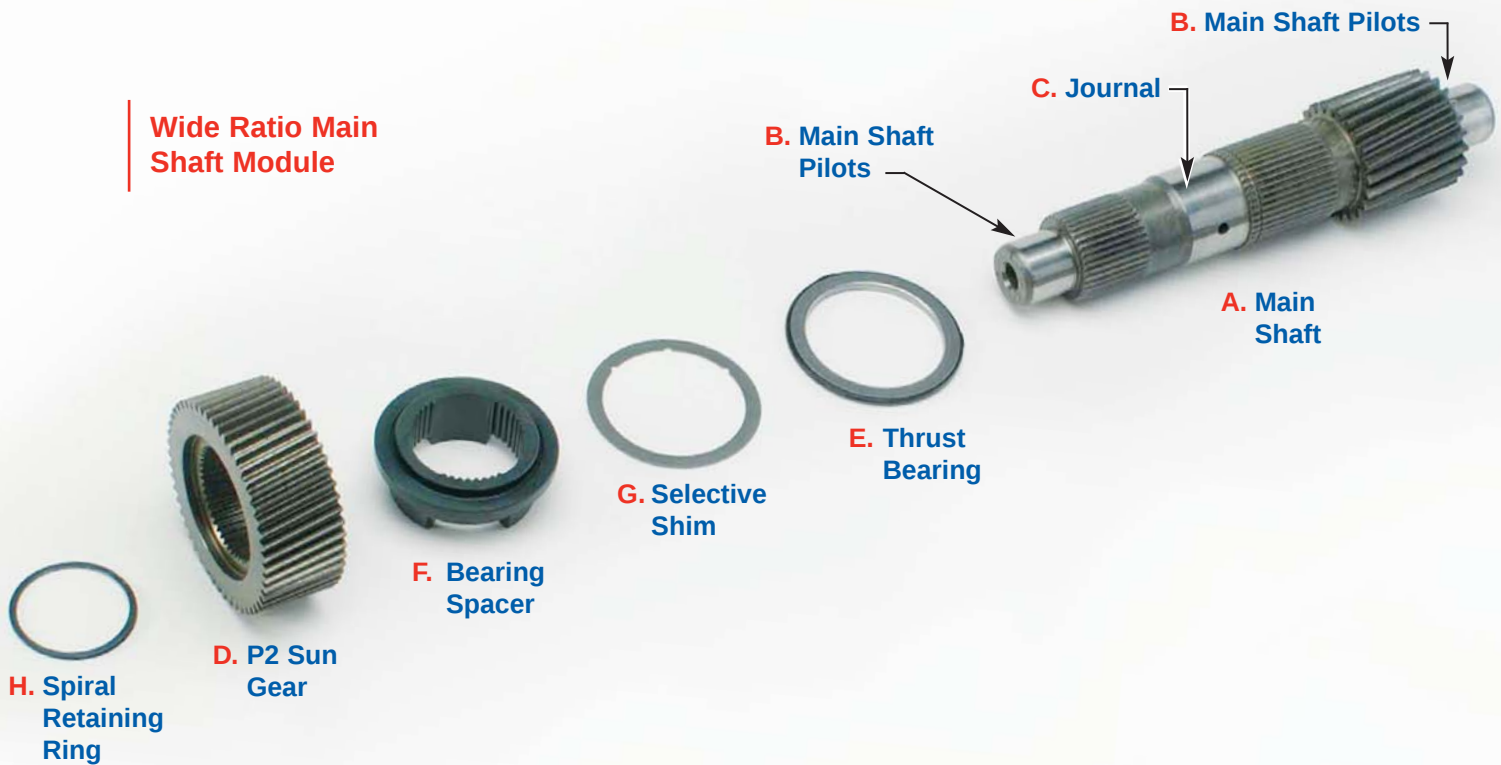
## WIDE RATIO MAIN SHAFT MODULE

**A.** Inspect the **main shaft** following the “General Inspection Guidelines for Gears” and “General Inspection Guidelines for Splines” sections of this manual. Replace the main shaft if it fails any of these inspection procedures.

**B.** Inspect the **front and rear main shaft pilots** for damage. The front main shaft pilot fits inside the turbine shaft. The rear main shaft pilot fits inside the output shaft. Replace the main shaft if pilot outside diameter is less than 35.92 mm (1.414 inch).

**C.** “Inspect the **P2 bushing journal** for damage. Replace the main shaft if P2 planetary bushing journal diameter is less than 52.98 mm (2.085 inch).

**D.** Inspect the **P2 sun gear** following the “General Inspection Guidelines for Gears” and “General Inspection Guidelines for Splines” sections of this manual. Replace the gear if it fails any of these inspection procedures.

**E.** Inspect the **thrust bearings** following the “General Inspection Guidelines for Bearings” section of this manual. Replace any bearing that fails any of these inspection procedures.

**F.** Inspect the **main shaft bearing spacer** following the “General Inspection Guidelines for Cast Parts and Machined Surfaces” “General Inspection Guidelines for Splines” sections of this manual. Replace the spacer if it fails any of these inspection procedures.

**G.** Inspect the **selective shim** for damage. Replace the shim if it is distorted or if damage cannot be removed by light stoning.

**H.** Replace the **spiral retaining ring** if it is removed.

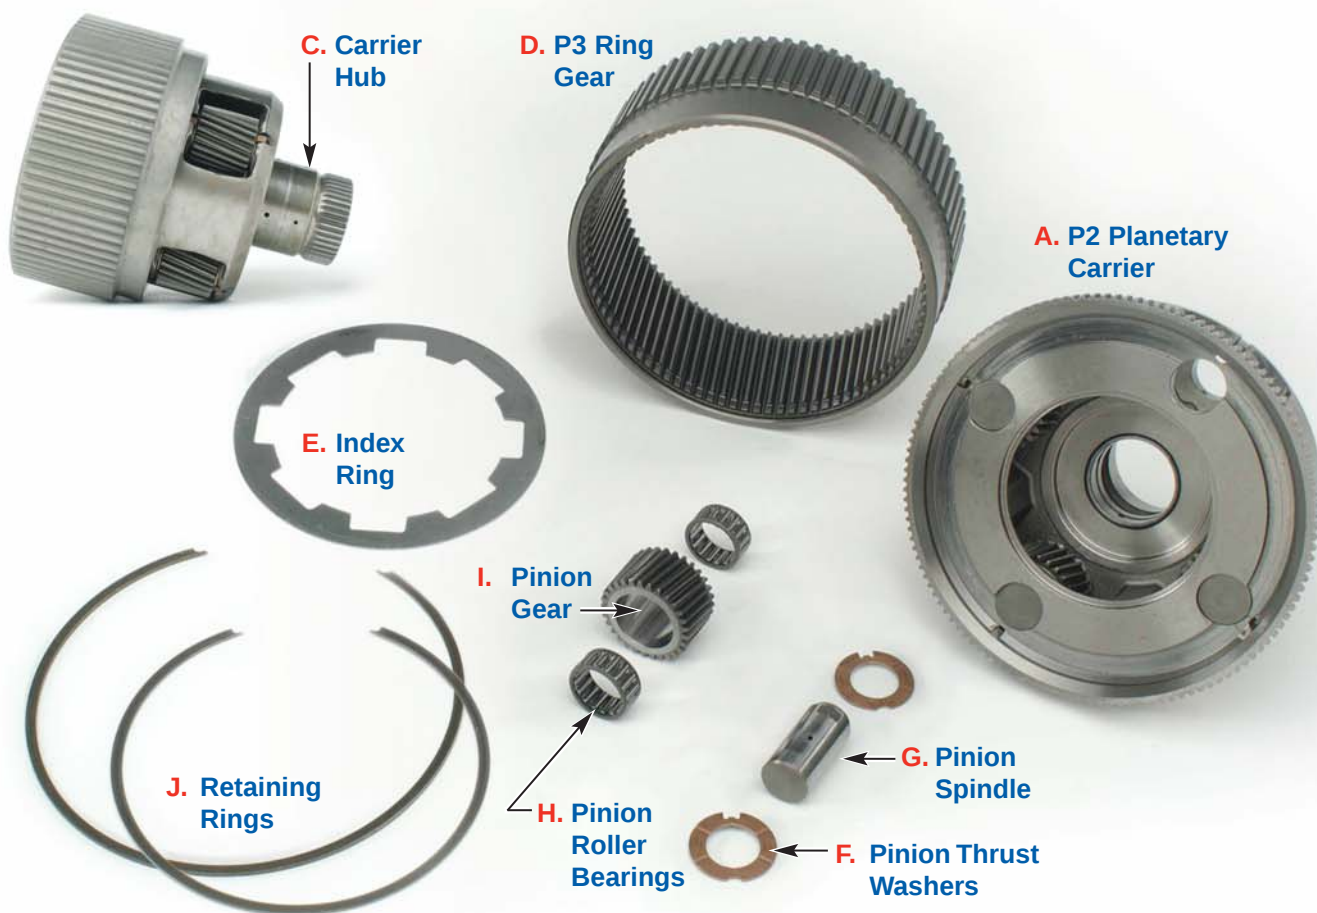
## P2 PLANETARY MODULE

**A.** Inspect the P2 carrier following the “General Inspection Guidelines for Cast Parts and Machined Surfaces” and the “General Inspection Guidelines for Splines” sections of this manual. Replace the carrier if any spindle has more than 0.051 mm (0.002 inch) clearance in its bore.

**B.** Inspect the P2 carrier bushing for damage. Replace the bushing if damaged. Replace the bushing if inside diameter exceeds 53.23 mm (2.096 inches).

**C.** Inspect the carrier hub for damage. Replace the carrier if damage cannot be repaired using a soft stone or crocus cloth.

**D.** Inspect the P3 ring gear following the “General Inspection Guidelines for Gears” and “General Inspection Guidelines for Splines” sections of this manual. Replace the ring gear if it fails any of these inspection procedures.

**E.** Inspect the P2 indexing ring for step wear in the area where it contacts the spindle. Replace the indexing ring if it is broken or if it has excessive step wear or damage. Indexing rings with acceptable wear can be flipped during reassembly so that a new contact surface is used.

**F.** Replace the pinion gear thrust washers if they are damaged, distorted, galled or showing signs of

excessive wear. Minimum allowable thrust washer thickness is 1.40 mm (0.055 inch). Maximum allowable thrust washer step wear is 0.12 mm (0.005 inch).

**G.** Replace planetary spindles if they are worn or damaged. Discoloration is only a concern if spindle surface damage exists.

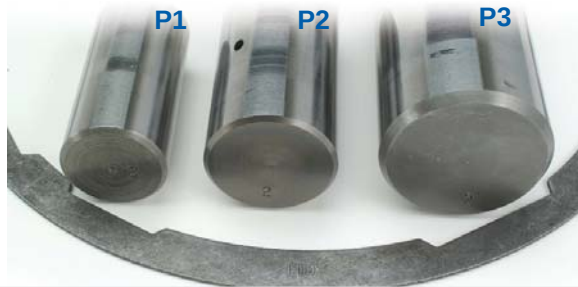
**Planetary Spindle and Indexing Ring Updates - Reference SIL 10-WT-00**

Planetary spindles and indexing rings are backward compatible. Current spindles are stamped with the number "2." Indexing rings are stamped with the identifier "HD5."

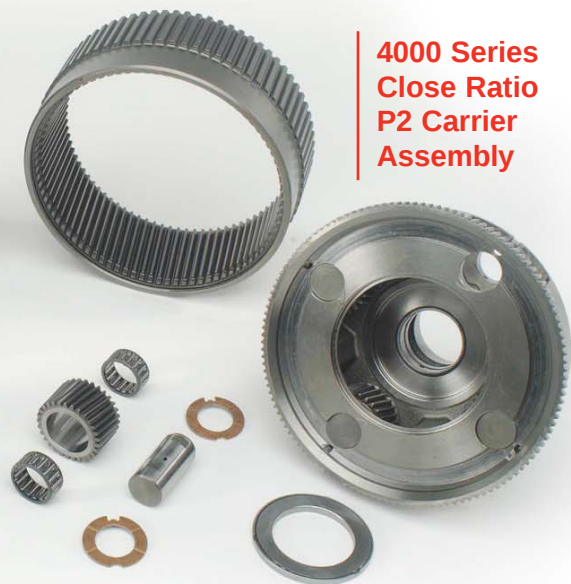
**4000 Series  
Close Ratio  
P2 Carrier  
Assembly**

**H.** Inspect the pinion roller bearings following the "General Inspection Guidelines for Bearings" section of this manual. Replace any bearing failing these inspection procedures.

**I.** Inspect the P2 pinion gears following the "General Inspection Guidelines for Gears" section of this manual. Replace any gear that fails these inspection procedures or if damage cannot be removed using a soft stone.

**J.** Inspect the P2 carrier retaining rings for damage or distortion. Replace any retaining rings with damage that cannot be removed using a soft stone.

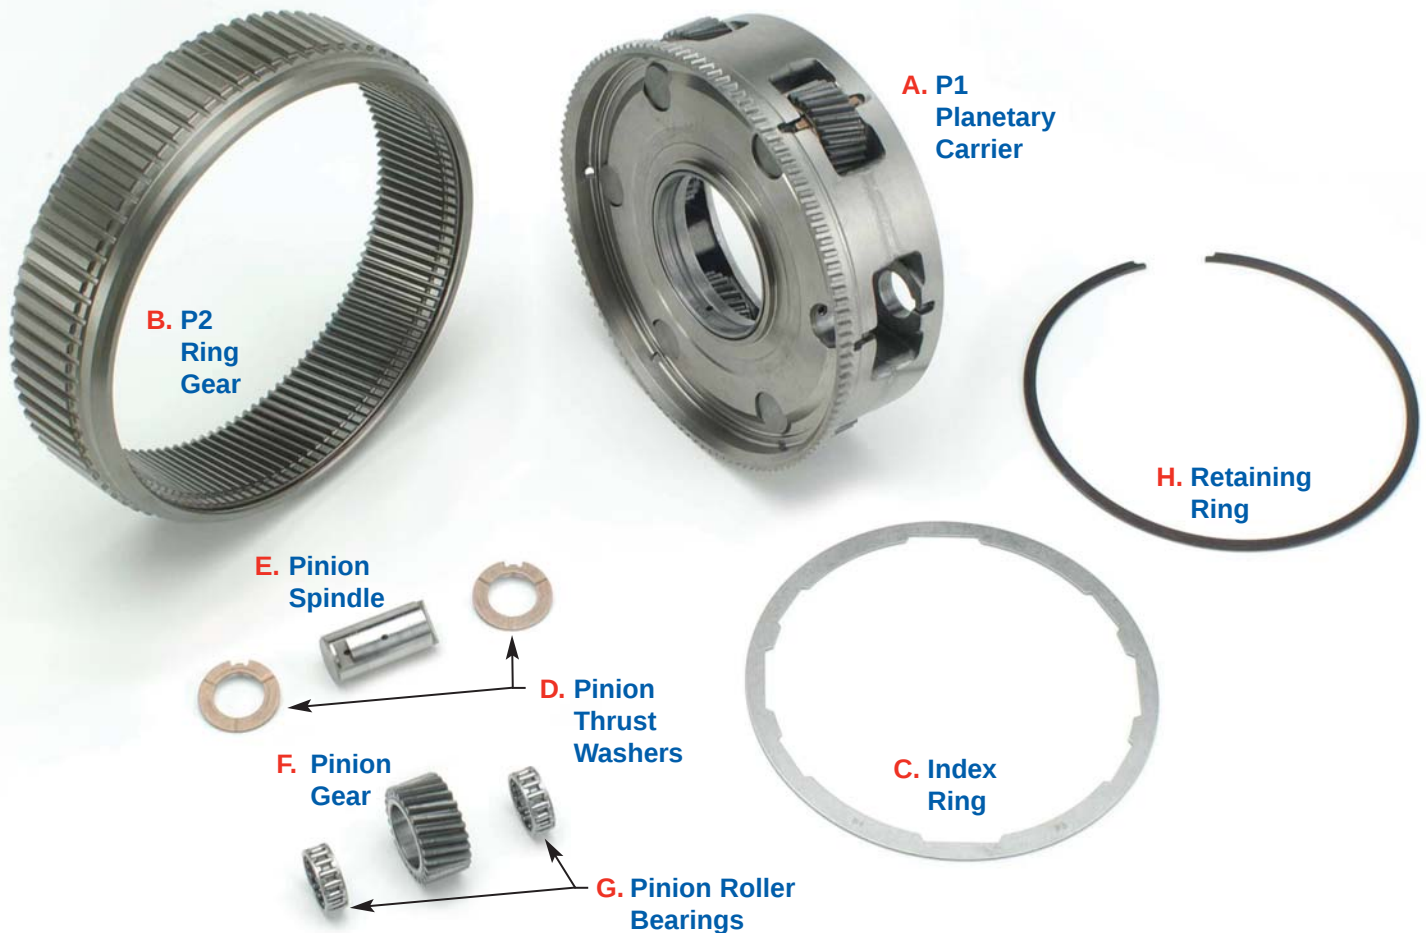
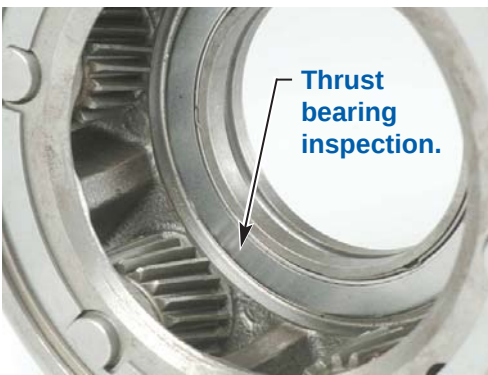
## P1 PLANETARY MODULE

**A.** Inspect the P1 carrier following the “General Inspection Guidelines for Cast Parts and Machined Surfaces” and the “General Inspection Guidelines for Splines” sections of this manual. Replace the carrier if any spindle has more than 0.051 mm (0.002 inch) clearance in its bore.

**Thrust bearings** fit on both sides of the P1 carrier. Inspect the thrust bearings following the “General Inspection Guidelines for Bearings” section of this manual. Replace any bearing that fails any of these inspection procedures.

**B.** Inspect the P2 ring gear following the “General Inspection Guidelines for Gears” and the “General Inspection Guidelines for Splines” sections of this manual. Replace the ring gear if it fails any of these inspection procedures.

**C.** Inspect the P1 indexing ring for step wear in the area where it contacts the spindle. Replace the indexing ring if it is broken or if it has excessive step wear or damage. Indexing rings with acceptable wear can be flipped during reassembly so that a new contact surface is used.

**D.** Replace the pinion gear thrust washers if they are damaged, distorted, galled or showing signs of excessive wear. Minimum allowable thrust washer thickness is 1.39 mm (0.054 inch).

**E.** Replace planetary spindles if they are worn or damaged. Discoloration is only a concern if spindle surface damage exists.

**F.** Inspect the P1 pinion gears following the "General Inspection Guidelines for Gears" section of this manual. Replace any gear that fails these inspection procedures or if damage cannot be removed using a soft stone.

**G.** Inspect the pinion roller bearings following the "General Inspection Guidelines for Bearings" section of this manual. Replace any bearing failing these inspection procedures.

**H.** Inspect the P1 carrier retaining rings for damage or distortion. Replace any retaining rings with damage that cannot be removed using a soft stone.

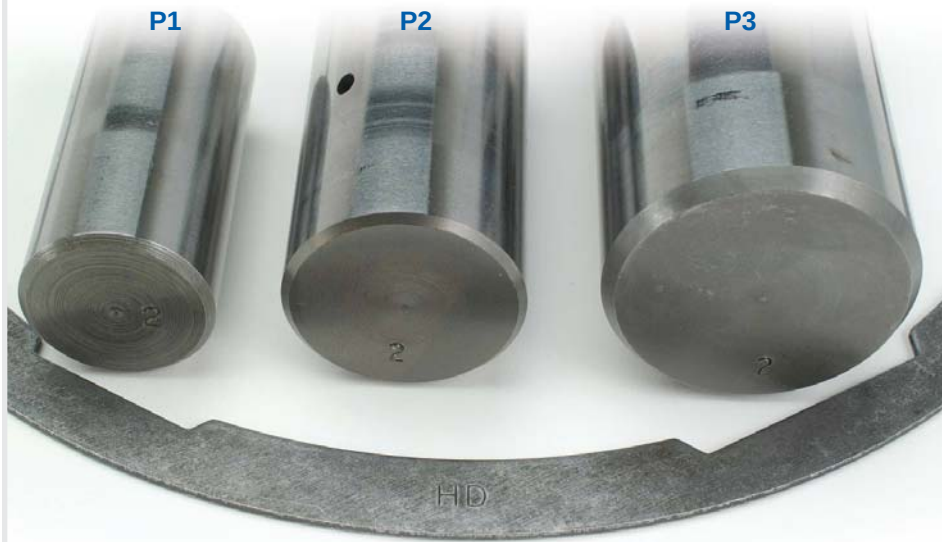
#### Planetary Spindle and Indexing Ring Updates - SIL 10-WT-00

Planetary spindles and indexing rings are backward compatible. Current spindles are stamped with the number "2." Indexing rings are stamped with the identifier "HD5."

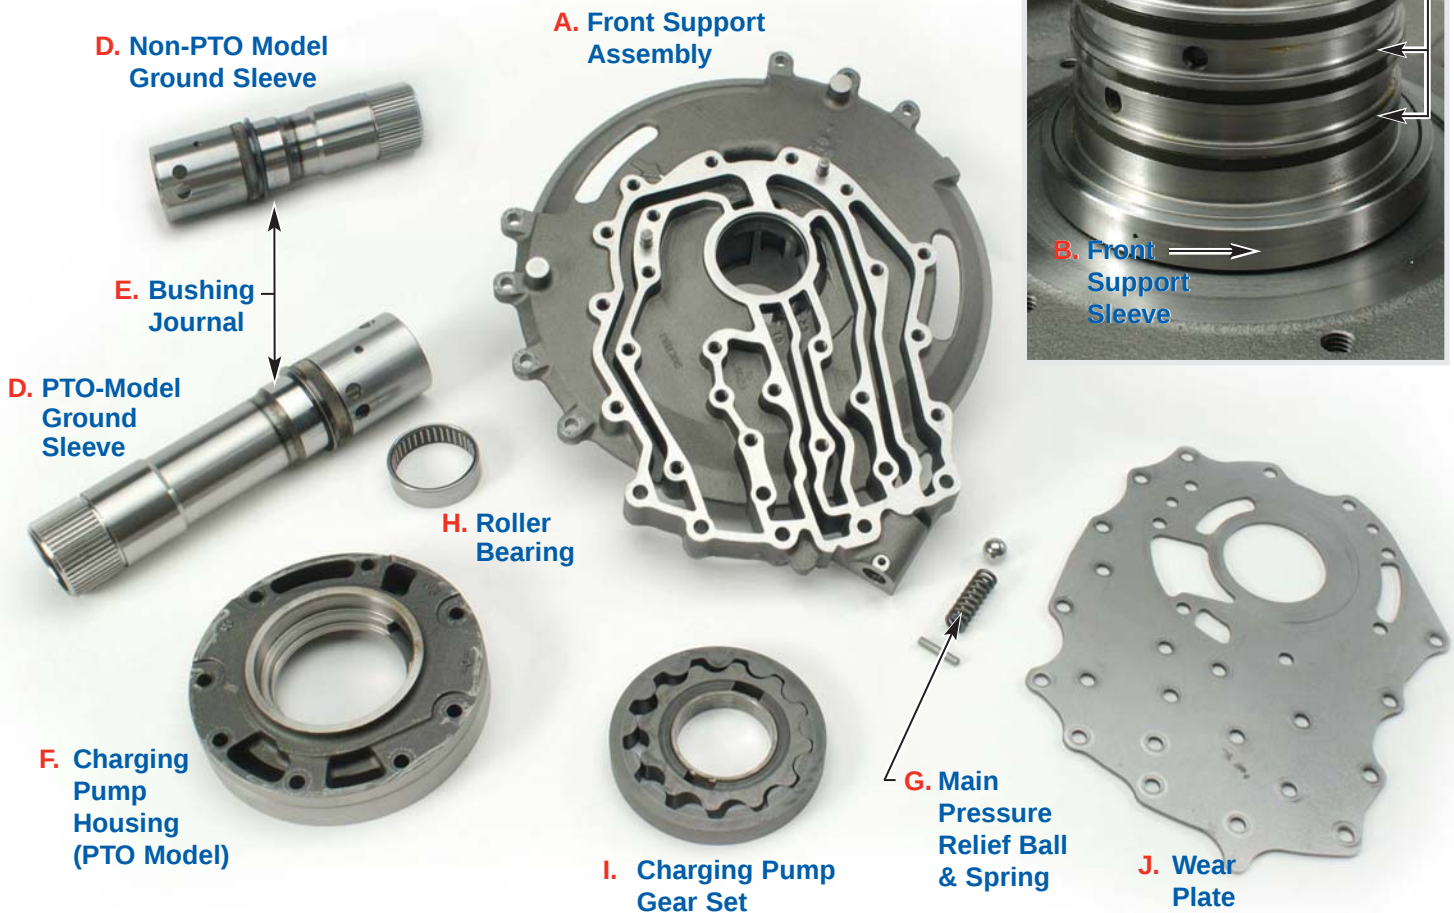
## FRONT SUPPORT & OIL PUMP MODULE

**B.** Replace the front support if the sleeve has damage that cannot be repaired using a soft stone or crocus cloth. Minimum allowable front support sleeve diameter is 119.81 mm (4.717 inches).

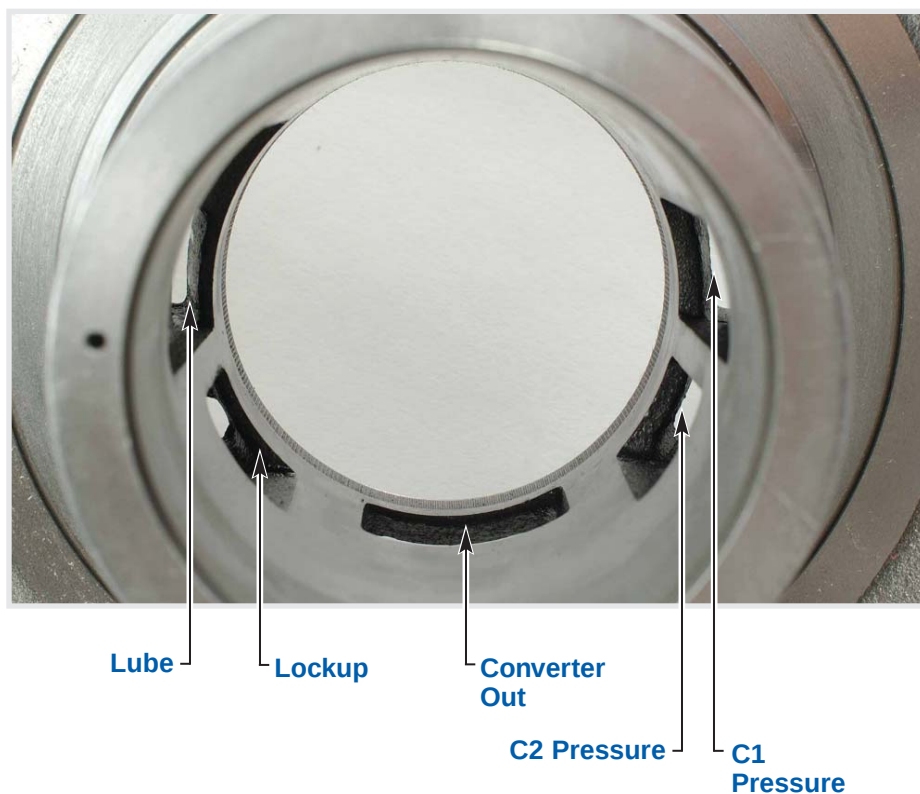
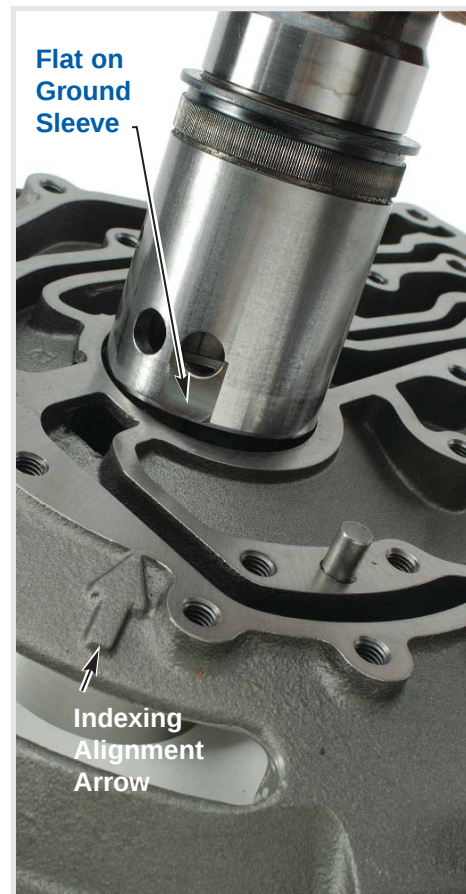
Oil passage detail -  
inside hub.

**F.** Inspect the charging pump housing following the “General Inspection Guidelines for Cast Parts and Machined Parts” section of this manual. Replace the housing if it fails any of these inspection procedures. Replace the charging pump housing if gear cavity depth exceeds 19.04 mm (0.750 inches). Replace the charging pump housing if gear cavity diameter exceeds 150.25 mm (5.915 inches).

**G.** Replace the main pressure relief ball if it is damaged. Inspect the main pressure relief spring following the “General Inspection Guidelines for Springs” section of this manual. Replace the spring if it is bent, broken, distorted or shows signs of wear from rubbing adjacent parts. Reference the Spring Data Charts in the Service Manual for spring identification and specifications.

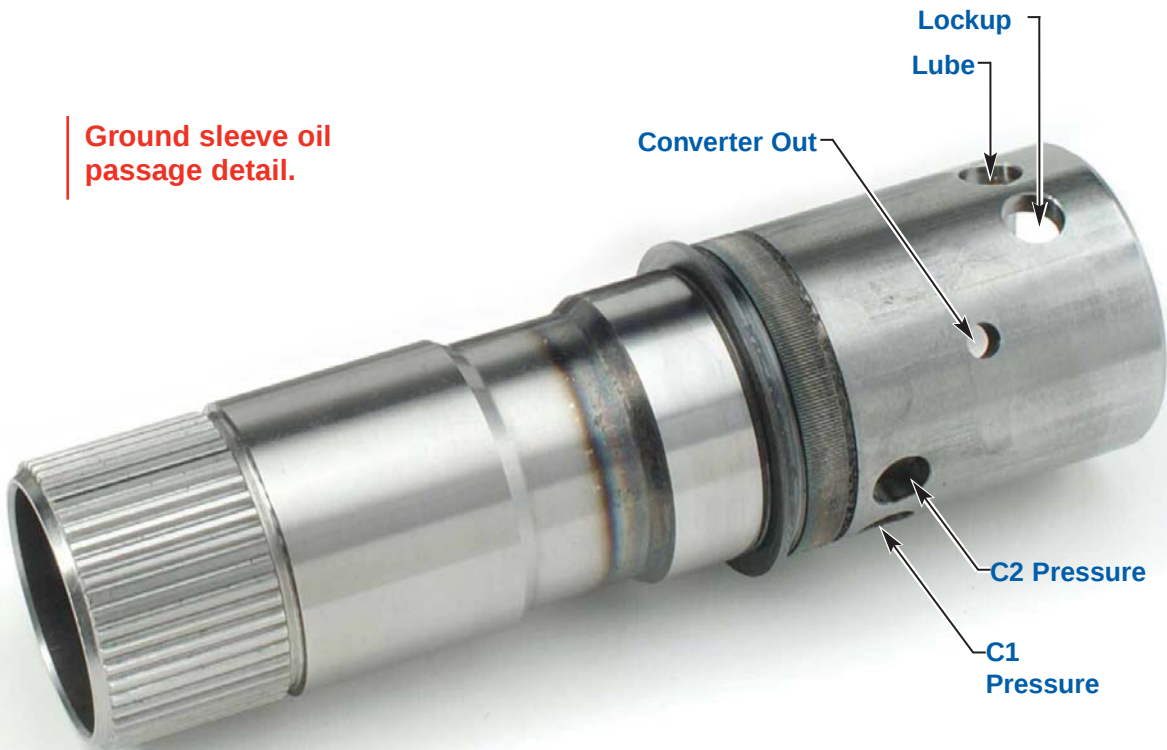
Ground sleeve oil passage detail.

**I.** Replace the charging pump gear set if the sides, faces or gear teeth are damaged. Replace the gear set if the inside gear shows damage or battering at the point where the torque converter drive tangs (or the PTO drive hub tangs) index into the gear. Replace the gear set if the bushing inside diameter exceeds 57.30 mm (2.256 inch). Minimum allowable outside diameter of the outer gear is 149.94 mm (5.903 inch).

**J.** Replace the wear plate if it is galled or moderately scored. Pay particular attention to the area where the charging pump gear set rides. Minimum allowable wear plate thickness is 4.70 mm (0.0185 inch). Replace the wear plate if it is worn past service limits or if it has damage that cannot be repaired using a soft stone or crocus cloth.

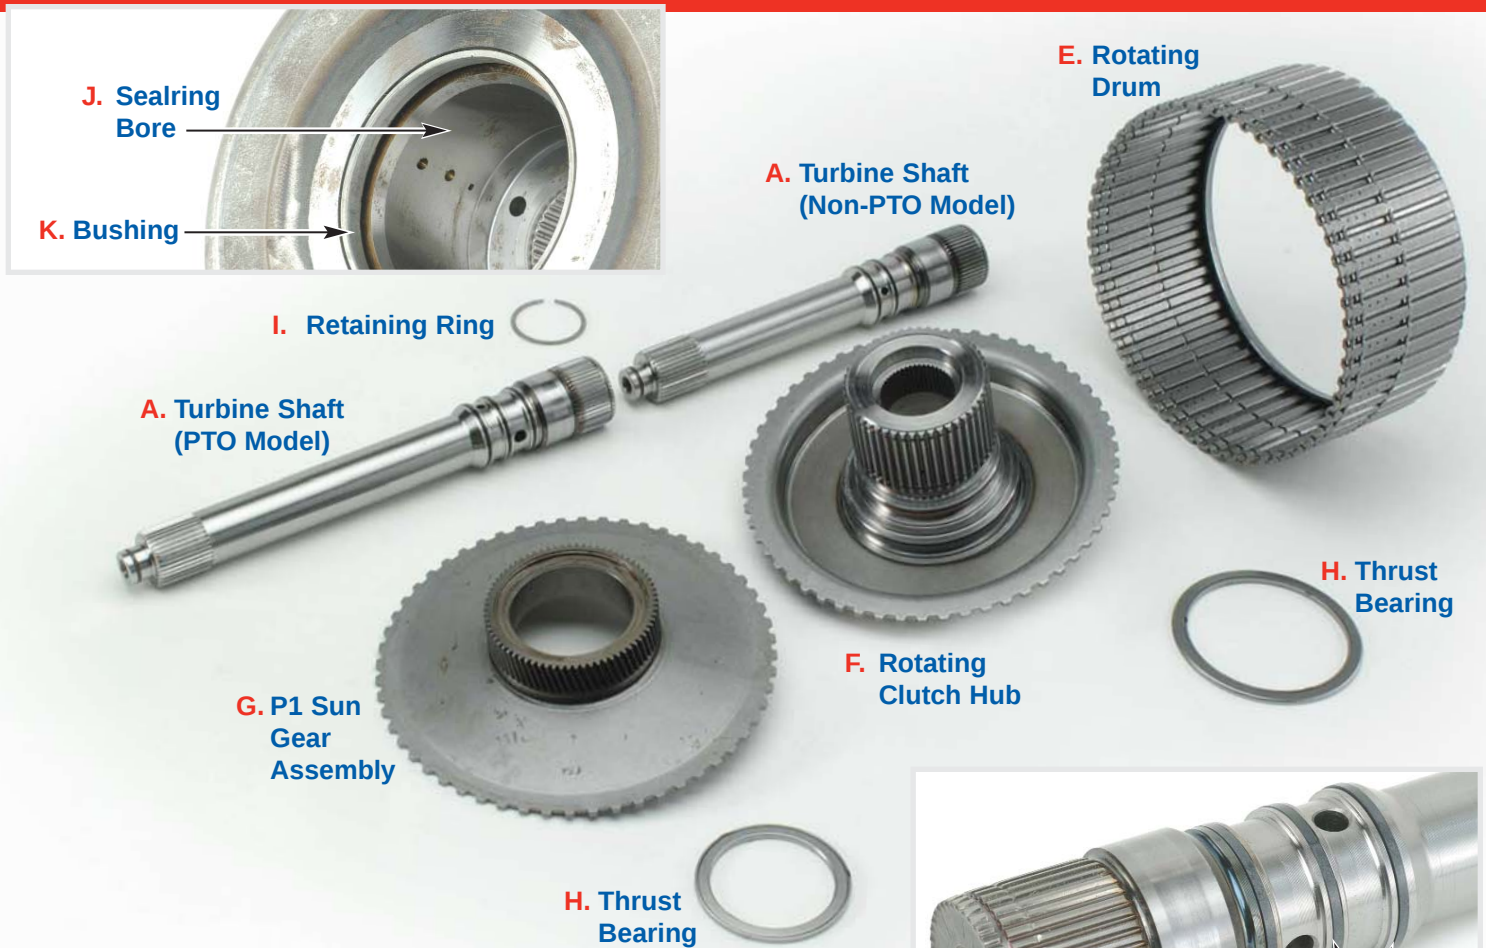
# ALLISON 4000 / B 500 PRODUCT FAMILIES ROTATING CLUTCH MODULE

**A.** Inspect the turbine shaft following the “General Inspection Guidelines for Cast Parts and Machined Surfaces” section of this manual. Replace the turbine shaft if it fails any of these inspection procedures. Maximum allowable spline wear is 0.38 mm (0.015 inch).

**B.** Inspect the turbine shaft bushing following the “General Inspection Guidelines for Bushings” section of this manual. Replace the bushing if it fails any of these inspection procedures. Maximum allowable bushing inside diameter is 36.14 mm (1.423 inch).

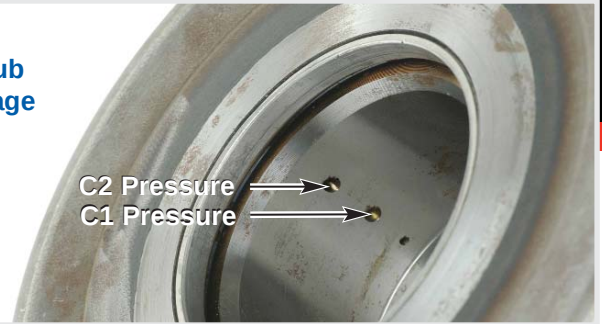
Rotating clutch hub oil passage detail.

C2 Pressure  
C1 Pressure

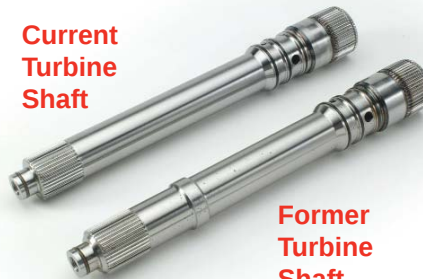
Current  
Turbine  
Shaft

Former turbine shafts include a raised area toward the torque converter end of the shaft.

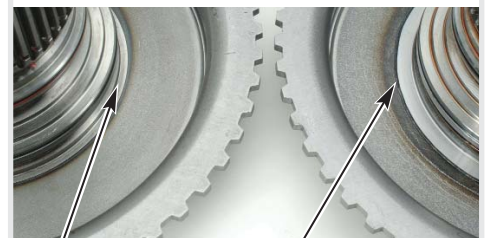
Rotating Clutch Hub Update -  
Reference SIL 8-WT-99, Rev. A

Former  
(No Weld)

Current  
(Weld)

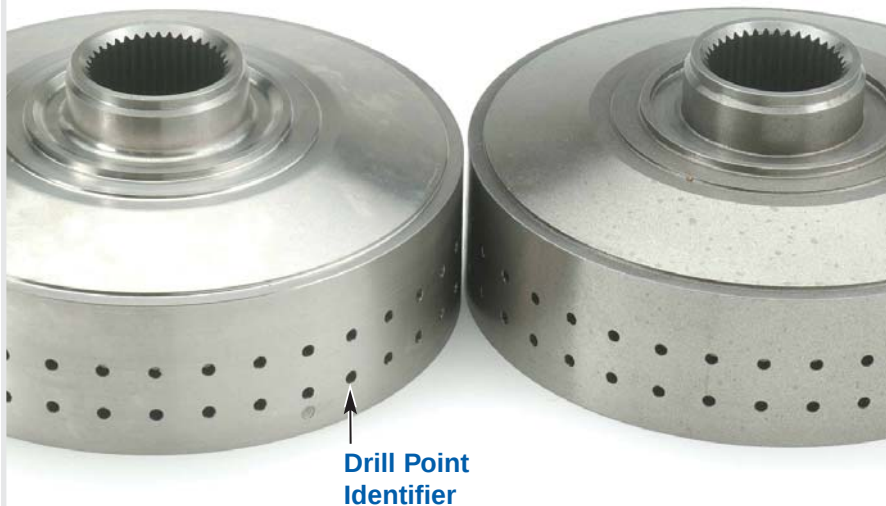
**Current: C1  
Drive Hub**

**Former: C1  
Drive Hub**

Drill point identifies the current hub which is backward compatible.

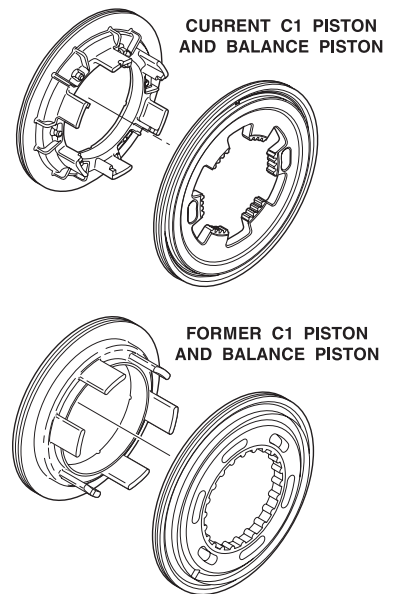
C1 Clutch Piston and Balance Piston Re-design - Reference SIL 30-WT-04

Former and current components can NOT be mixed.

**NOTE:** Transmissions built prior to S/N 6610032320 used two identical C1 pressure plates. Transmissions built after that used different plates. The current C1 apply pressure plate (next to the C1 piston) is approximately 2 mm thinner and has a different shape than the current C1 backplate (opposite end of the C1 clutch pack). When replacing the former pressure plates in a transmission with the current plate, both current plates must be used. Mixing former and current plates will result in C1 clutch failure.

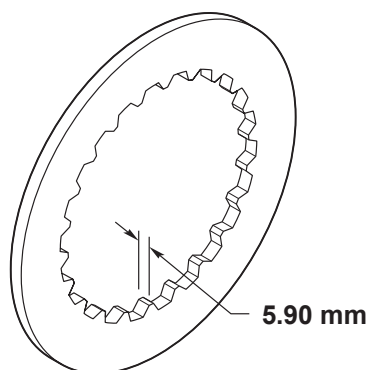
**NEW STYLE APPLY PLATE**

**C1 Backing and Apply Plate Updates -  
Reference SIL 22-WT-98, Rev. A**

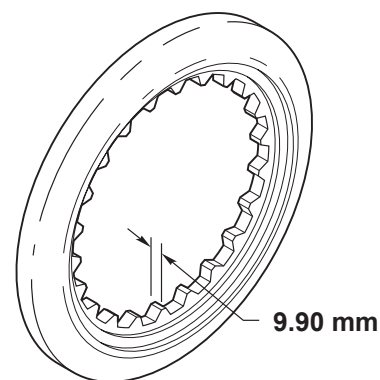
**NEW STYLE BACKING PLATE**

**Former and current  
components can NOT be mixed**

from former frictions to current frictions in C1 through C4 for a 4000 Series or B500 with a WTEC III ECU with a calibration prior to October 25, 1999 will require an updated ECU calibration from Allison Transmission. Do not intermix both former and current friction plates in a clutch pack.

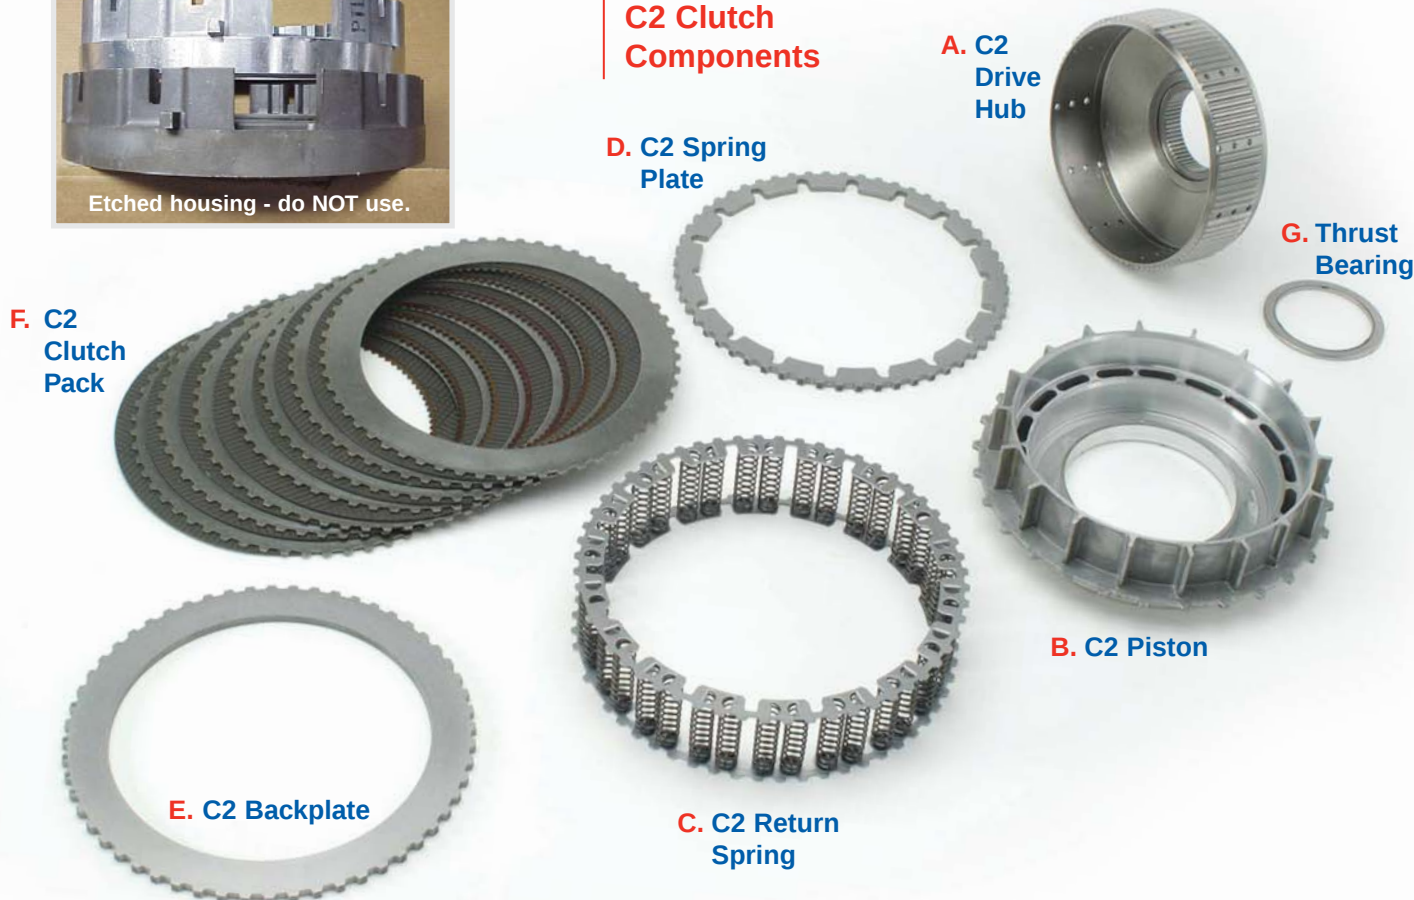
### C2 Clutch Components

**A.** Inspect the C2 drive hub following the “General Inspection Guidelines for Cast Parts and Machined Surfaces” and the “General Inspection Guidelines for Splines” sections of this manual. Replace the hub if it fails any of these inspection procedures. Maximum allowable spline wear is 0.38 mm (0.015 inch).

**B.** Inspect the C2 clutch piston following the “General Inspection Guidelines for Cast Parts and Machined Surfaces” section of this manual. Replace the piston if it fails any of these inspection procedures.

**C.** Replace the C2 return spring assembly if it has permanent spring set, wear due to rubbing adjacent parts or if springs are cracked or broken in any way. Reference the

**D.** Replace the C2 spring plate if it is cracked, broken or showing any signs of distortion or wear.

**E.** Inspect the C2 backplate for damage. Replace the plate if damage cannot be removed using a soft stone or crocus cloth. C2 backplate minimum allowable thickness is 7.90 mm (0.311 inch) when measured at the backing plate wear area. Maximum allowable distortion from flat is 0.015 mm (0.006 inch).

**F.** Inspect the C2 clutch friction plates following the “General Inspection Guidelines for Friction Plates” section of this manual. Replace any plates failing these inspection procedures. Minimum allowable friction plate thickness is 2.92 mm (0.115 inch). Minimum allowable oil groove depth is 0.20 mm (0.008 inch). Maximum allowable plate coning is 0.25 mm (0.010 inch).

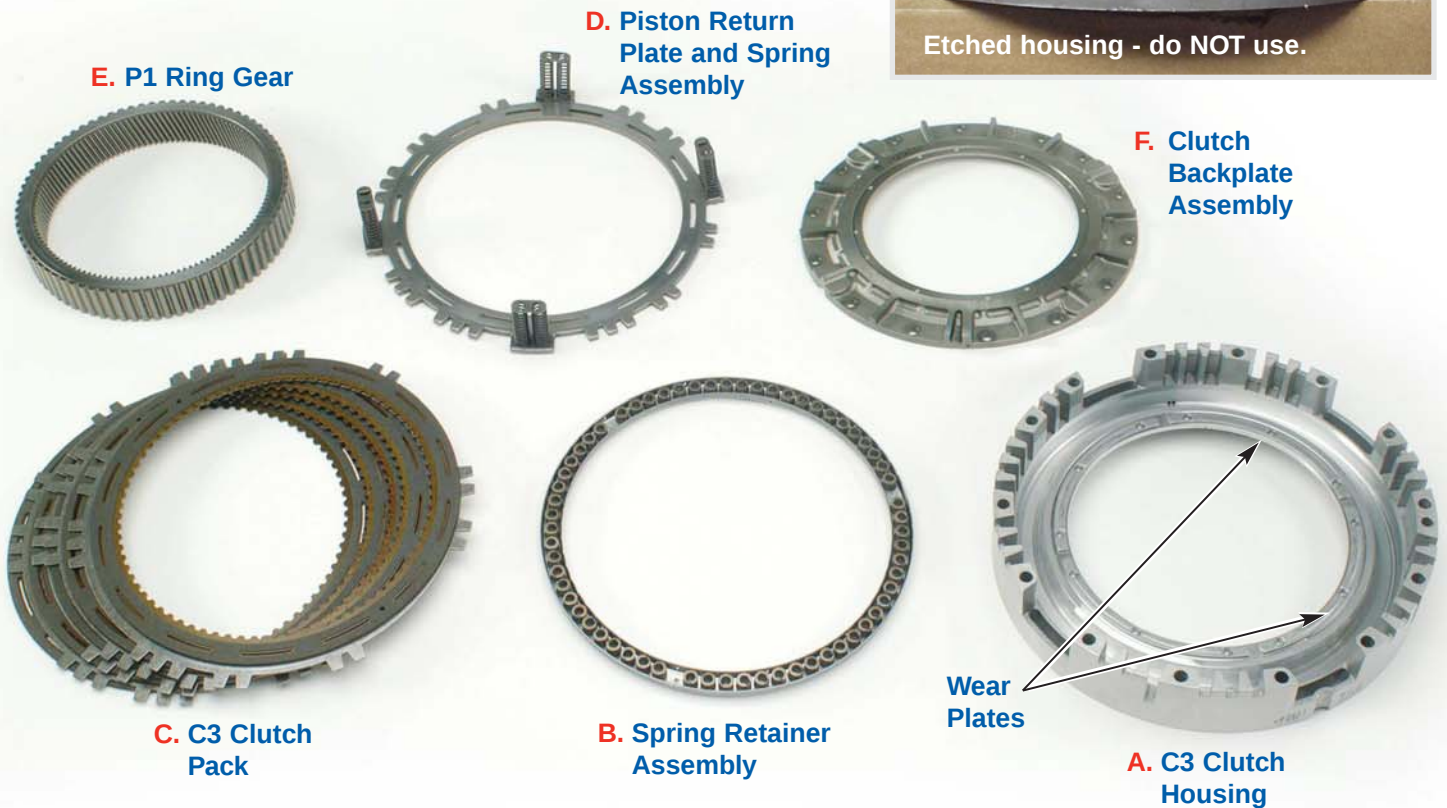
## C3 Clutch Components

**A.** Inspect the C3 clutch housing following the “General Inspection Guidelines for Cast Parts and Machined Surfaces” section of this manual. Replace the housing if it fails any of these inspection procedures. Check for C3 housing spline wear. Maximum allowable spline wear is 1.15 mm (0.045 inch). Replace the C3 housing if excessive spline wear exists. Check the C3 housing wear plates for flatness. Maximum allowable distortion is 0.15 mm (0.006 inch). Minimum allowable wear plate thickness is 2.82 mm (0.111 inch).

**B.** Inspect the C3 spring retainer assembly following the “General Inspection Guidelines for Cast Parts and Machined Surfaces” section of this manual. Inspect the assembly for wear due to rubbing adjacent parts and cracked, broken or

**C.** Inspect the C3 clutch friction plates following the “General Inspection Guidelines for Friction Plates” section of this manual. Replace any plates failing these inspection procedures. Minimum allowable friction plate thickness is 3.485 mm (0.137 inch). Maximum allowable plate coning is 0.25 mm (0.010 inch).

Inspect the C3 clutch reaction plates following the “General Inspection Guidelines for Reaction Plates” section of this manual. Replace any plates failing these inspection procedures. Minimum allowable reaction plate thickness is 2.41 mm (0.010 inch). Maximum allowable reaction plate coning is 0.25 mm (0.010 inch). (continued)

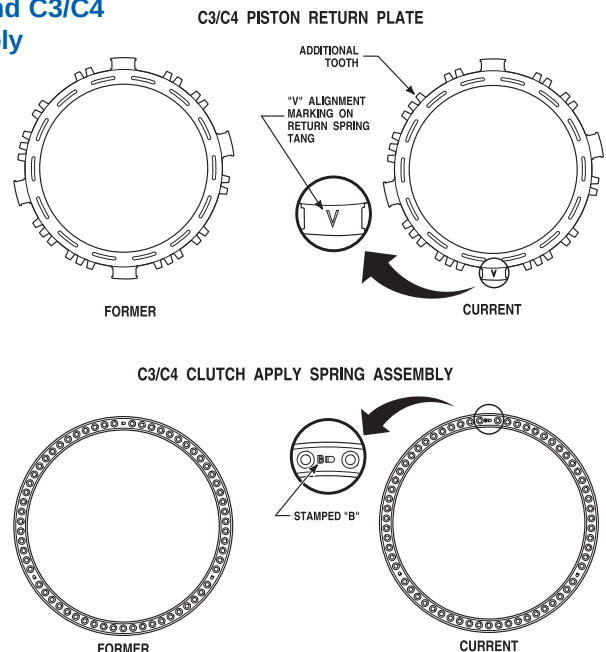
### C3/C4 Return Plate and C3/C4 Apply Spring Assembly Update - SIL 9-WT-04

**Former and current components can NOT be mixed in the same clutch pack.**

**NOTE:** The C3/C4 spring retainer assemblies (sometimes referred to as clutch apply spring assemblies) and the C3/C4 piston return plate were updated starting with S/N 6610137389. Do not mix former and current parts in the same clutch pack. The identifier for the current return plate is a letter “V” stamped in the face with an additional external spline on the outside diameter. The identifier for the current apply spring assembly is the

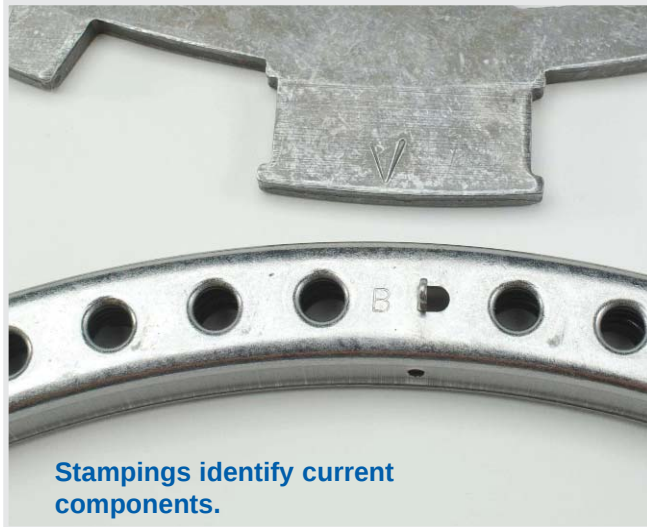
Stampings identify current components.

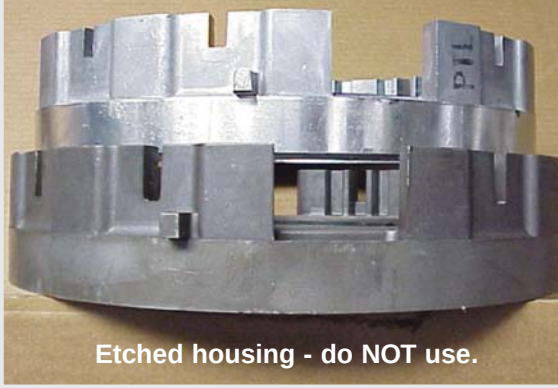
Housing in good condition - reuse.

Etched housing - do NOT use.

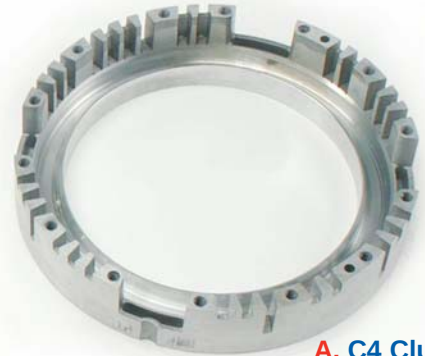
**A. C4 Clutch Housing**

**A.** Inspect the C4 clutch housing following the “General Inspection Guidelines for Cast Parts and Machined Surfaces” section of this manual. Replace the housing if it fails any of these inspection procedures. Check for C4 housing spline wear. Maximum allowable spline wear is 1.15 mm (0.045 inch). Replace the C4 housing if excessive spline wear exists.

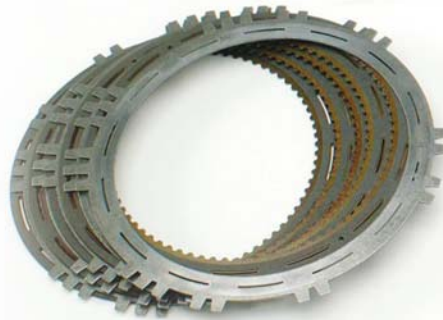
**C. C4 Clutch Pack**

**C.** Inspect the C4 clutch friction plates following the “General Inspection Guidelines for Friction Plates” section of this manual. Replace any plates failing these inspection procedures. Minimum allowable friction plate thickness is 3.485 mm (0.137 inch). Maximum allowable plate coning is 0.25 mm (0.010 inch).

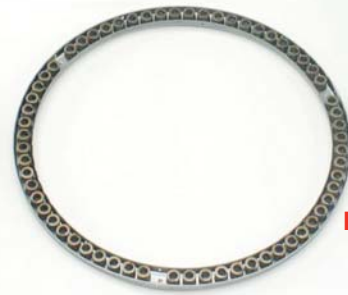
**B. Spring Retainer Assembly**

**B.** Inspect the C4 spring retainer assembly following the “General Inspection Guidelines for Cast Parts and Machined Surfaces” section of this manual. Inspect the assembly for wear due to rubbing adjacent parts and cracked, broken or permanently set springs. Reference the Spring Data Charts in the Service Manual for spring specifications and identification.

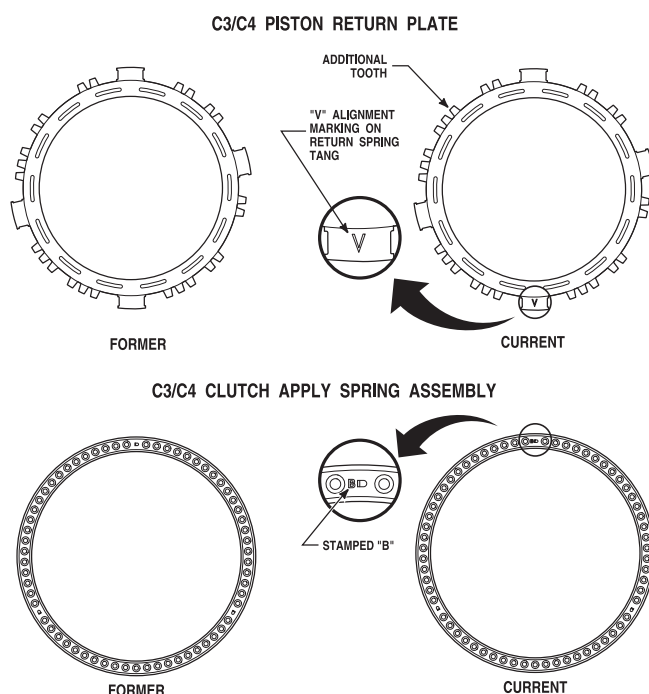
#### C3/C4 Return Plate and C3/C4 Clutch Apply Spring Assembly Update - SIL 9-WT-04

Former and current components can NOT be mixed in the same clutch pack.

**NOTE:** The C3/C4 spring retainer assemblies (sometimes referred to as clutch apply spring assemblies) and the C3/C4 piston return plate were updated starting with S/N 6610137389. Do not mix former and current parts in the same clutch pack. The identifier for the current return plate is a letter “V” stamped in the face with an additional external spline on the outside diameter. The identifier for the current apply spring assembly is the letter “B” stamped in the spring retainer. Reference SIL 9-WT-04.

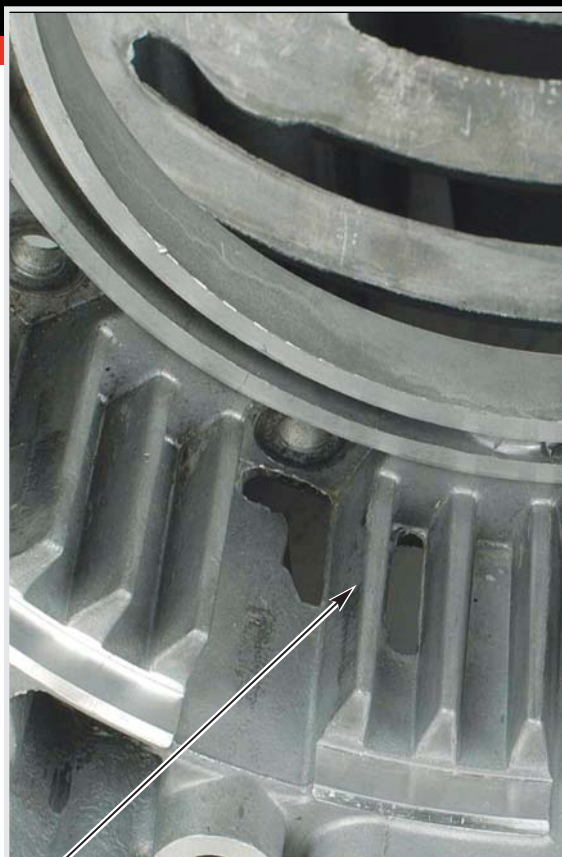
Check for spline wear.

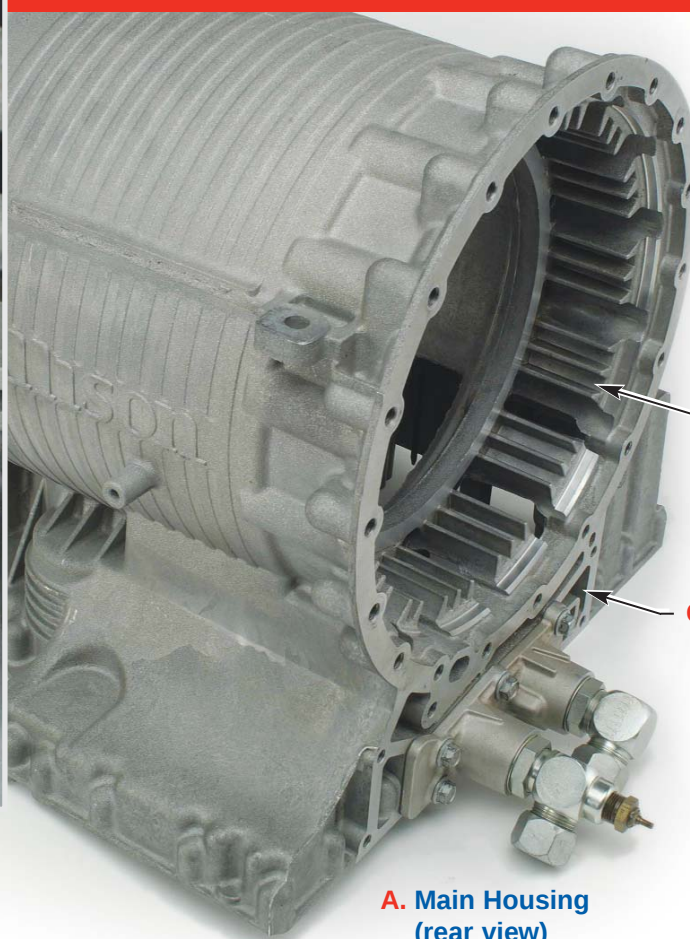
B. Splines

C. Fluid Passages
