# TECHNICIANS' GUIDE

# INSPECTION AND ANALYSIS OF THE ALLISON 4000/B 500 PRODUCT FAMILIES

**NOTICE:** This guide is intended for use by technicians skilled in diagnosis and repair of automatic transmissions. Contact an authorized Allison Transmission service outlet for further information or clarification if required. All specifications provided in this manual are subject to change without notice.

The Technicians' Guide is intended to provide additional guidance with the inspection and analysis of transmission parts. This guide should be used by technicians who overhaul Allison 4000/B 500 automatic transmissions in conjunction with the 4000/B 500 Service Manual (SM2457EN) when inspecting parts to determine their serviceability and reuse.

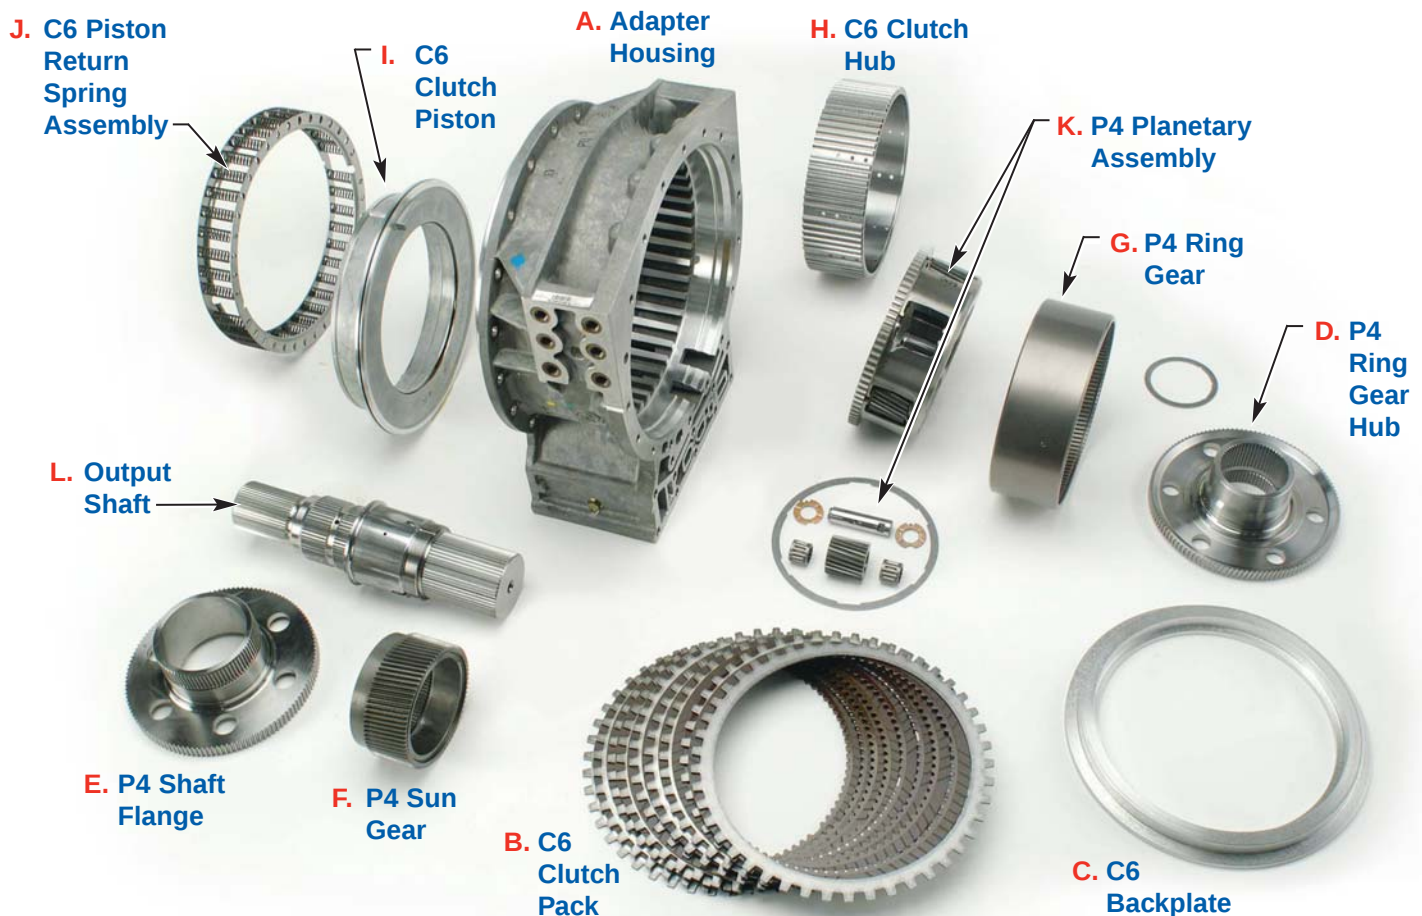
# ALLISON 4000 / B 500 PRODUCT FAMILIES C6 ADAPTER HOUSING MODULE

**A.** Inspect the adapter housing following the “General Inspection Guidelines for Cast Parts and Machined Surfaces” and “General Inspection Guidelines for Splines” section of this manual. Replace the housing if it fails any of these inspection procedures or if the damage cannot be repaired using a soft stone or crocus cloth. Maximum clutch spline wear is 1.15mm (0.045 inch). Inspect all fluid passages for obstructions, porosity and cracks. Inspect bolt holes for stripped or damaged threads. Replace the housing if damage cannot be repaired.

**B.** Inspect the C6 clutch friction plates following the “General Inspection Guidelines for Friction Plates” section of this manual. Replace any plates failing these inspection procedures. Minimum allowable friction plate thickness is 3.68 mm (0.145 inch). Maximum allowable plate coning is 0.25 mm (0.010 inch).

**D. E. F. G. & H.** Inspect the P4 ring gear hub, P4 shaft flange, P4 sun gear, P4 ring gear and C6 clutch hub following the “General Inspection Guidelines for Gears” and General Inspection Guidelines for Splines” sections of this manual. Replace any components failing any of these inspection procedures. Replace any components with damage which cannot be repaired using a soft stone or crocus cloth.

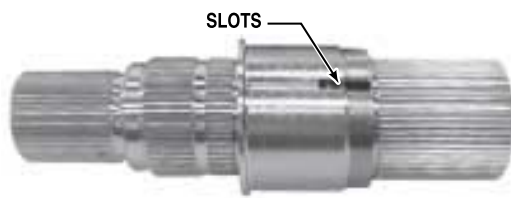
**Former 4070  
Non-Retarder  
Output Shaft**

**4070 Output Shaft Update -  
Reference SIL 25-WT-01**

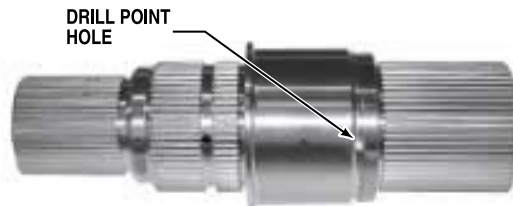
**Current 4070  
Non-Retarder  
Output Shaft**

**Current output shaft requires  
current bearing retainer locknut  
and Belleville washer.**

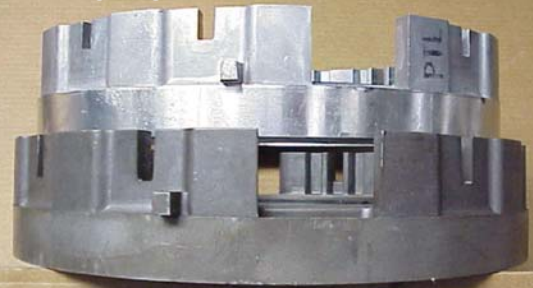
**Housing in good condition - reuse.**

**Etched housing - do NOT use.**

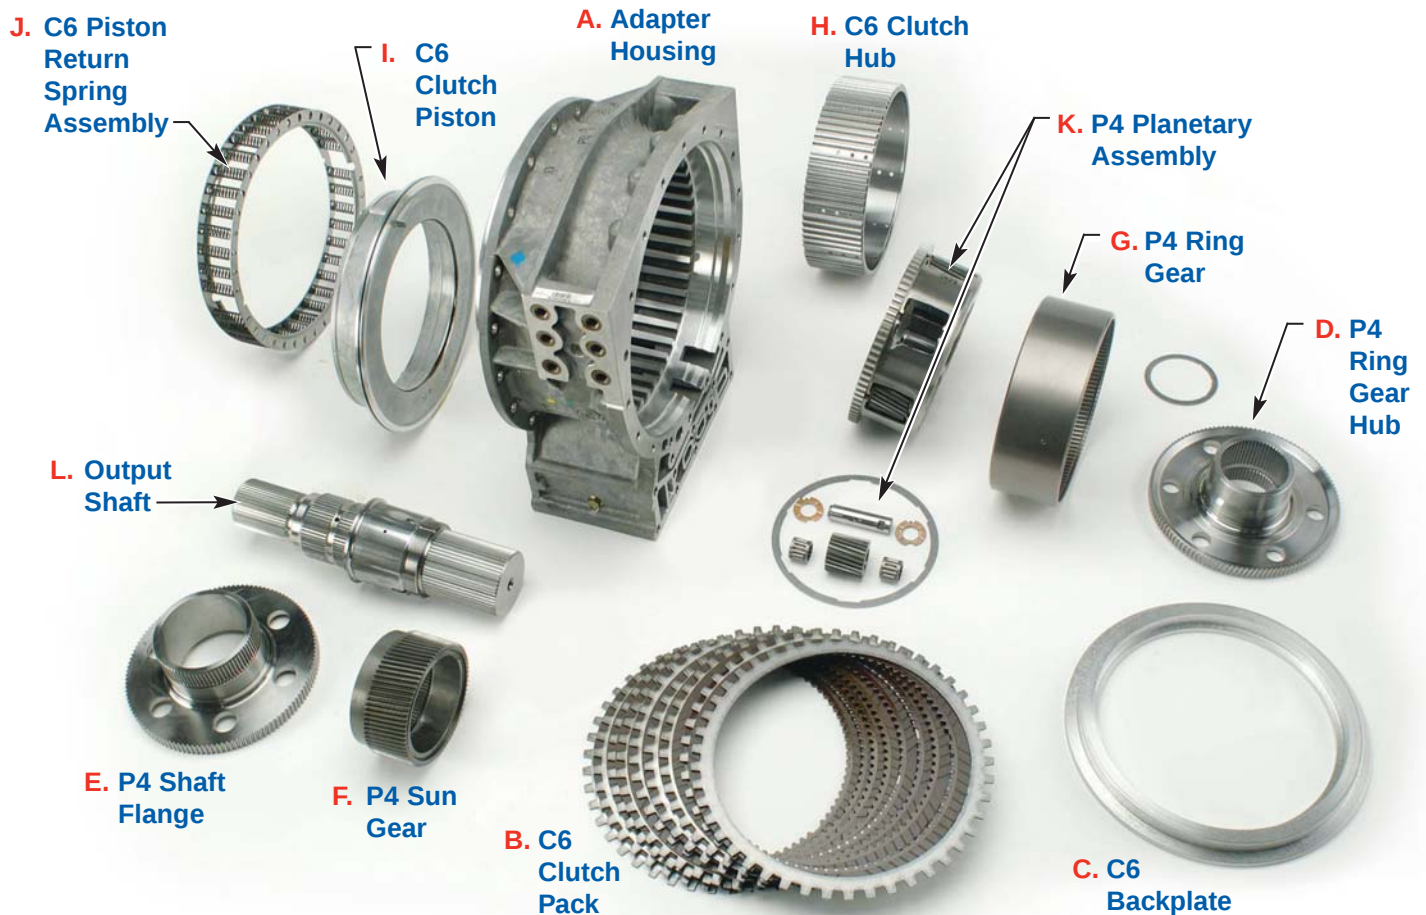
## ALLISON 4000 / B 500 PRODUCT FAMILIES (continued) C6 ADAPTER HOUSING MODULE

Inspect the P4 carrier indexing ring for wear and damage, especially where the spindles make contact with the ring. Replace the indexing ring if it shows signs of spindle battering or has damage which cannot be repaired using a light stone.

Replace the pinion gear thrust washers if they are damaged, distorted or showing signs of overheating. Minimum allowable thrust washer thickness is 1.40 mm (0.055 inch).
