## Troubleshooting Guide

# Eaton Hybrid Drive Systems MY09 TRTS2000 EN-US

### MY09 PEC Models

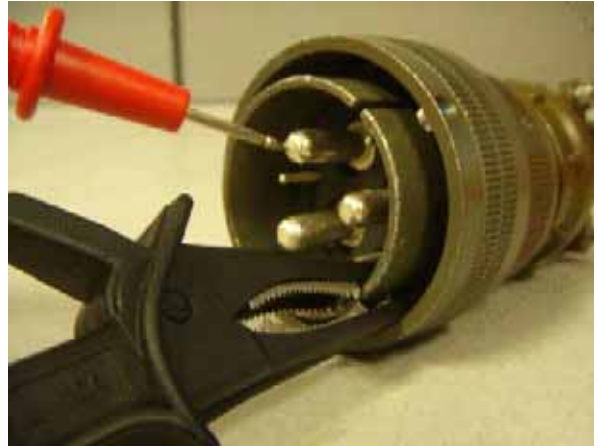
**Note:** The AC cable should still be connected to the Motor/Generator.

- Pin A to Cable Shield
- Pin B to Cable Shield
- Pin C to Cable Shield

- If moisture or contamination is found, this is a non-Eaton failure. See OEM for repair direction.
- If resistance is OL or outside range, go to **Step E.**
- If resistance is between 0–220K ohms, go to **Step C.**

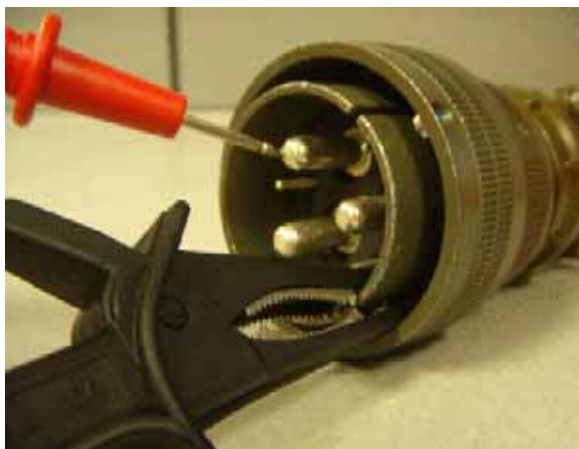
3. Measure the resistance at the AC Cable between the following Pins:

- Pin A to Cable Shield
- Pin B to Cable Shield
- Pin C to Cable Shield

- If resistance reading is "OL", remeasure the AC cable on the inverter side.
- If resistance among any AC connector pin to Cable Shield in is OL, go to **Step D.**
- If any resistance/continuity is found replace OEM supplied AC Cable, go to **Step D.**

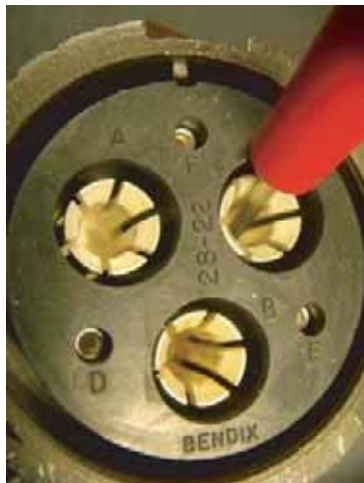
2. If you are coming here from Step 1 the high voltage AC Cable should be disconnected from the inverter and the Motor / Generator. If steps 1 and 2 have been completed continue to step 3.
3. Measure 3-phase sockets at the Motor / Generator.
  - Socket A to Motor / Generator case
  - Socket B to Motor / Generator case
  - Socket C to Motor / Generator case

- If any resistance or continuity is found, replace the Motor/Generator. See the **MY09 Motor/Generator Removal and Installation** procedure in TRSM2000. After repairs are made, go to **Step V.**
- If resistance is OL the Motor / Generator is not shorted to ground, go to **Step V.**

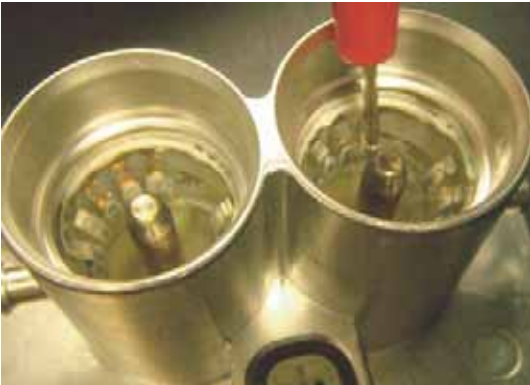
2. Measure the resistance within the Inverter positive to Case (Ground) on the Inverter High Voltage pins on the DC side.
  - Positive (+) to Inverter Case
  - Negative (-) to Inverter Case

- If open or OL, go to **Step H.**
- If resistance is 0-220K Ohms, replace the Inverter (see **MY09 Inverter Removal and Installation**). After repairs are made, go to **Step V.**

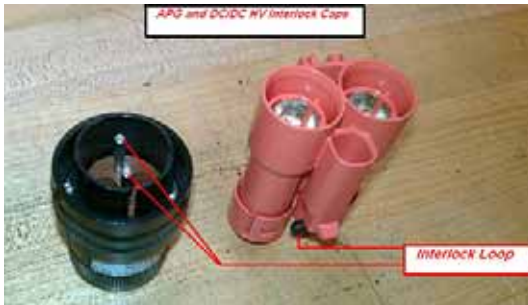
1. Key off.
2. If vehicle is equipped with Export Power PEC, perform "High-Voltage Service Shutdown and Power-Up Procedure" on page 4, then remove High-Voltage DC/DC and/or APG High-Voltage Cable from the PEC. Install Interlock Caps if available:
